Whitemills Backchannel

Location: Whitemills, Earls Barton

Completion date: December 2018

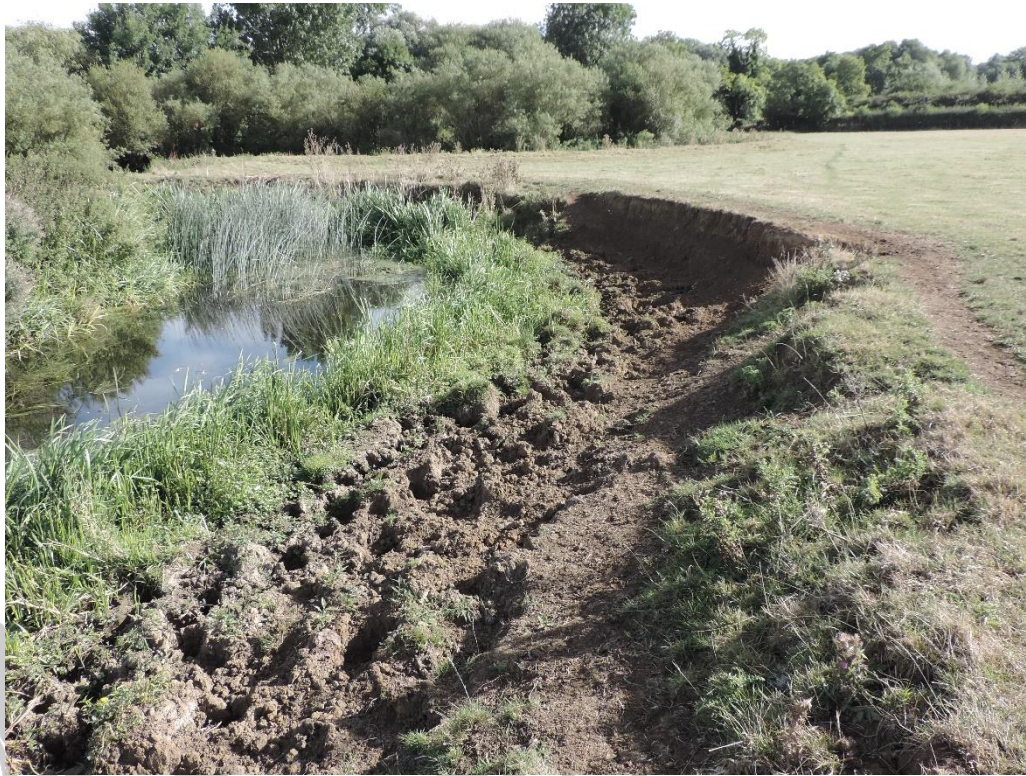
The banks of White Mills Lock Back Chanel had been severely damaged by cattle poaching and this resulted in significant fine sediment inputs to the River Nene. The primary purpose of the proposed works was to repair the eroded banks, prevent further erosion and improve marginal wetland habitat. Tree planting and tree management would enhance riparian and instream habitats with the bank re-profiling improving conveyance. Figure 1 is a map of the area where Whitemills back channel is and highlights the area where work was completed. Figure 2 shows the condition part of the back channel was in prior to the project being completed. It is clear to see the impact the cattle had whilst grazing on the bank. Due to grazing the bank had collapsed, erosion rate had increased, and the channel was widened. This also meant that lots of sediment was entering the backchannel, impacting the quality of the in-stream habitat.

Figure 2 Extent of poaching before the project

Activity 3 – Bank regrading to repair banks badly damaged by cattle poaching, to reduce fine sediment inputs.

Using a 360° tracked excavator with a suitable reach, the steeply eroded banks were re-profiled to form a stable slope behind a wet berm on which a fringe of wetland vegetation can develop naturally. A berm is a flat strip of land, raised bank, or terrace bordering a river. During on-site consultation with the local Environment Agency Asset Performance Officer it was noted that for some time now, the Environment Agency has been planning to undertake works to improve conveyance and increase channel capacity immediately upstream of the culverts under the road at the bottom of the restoration reach. So, at the Asset Performance team's request, it was agreed that this project will take this extra work in partnership with the EA while suitable machinery was available on site. The additional works formed part of the

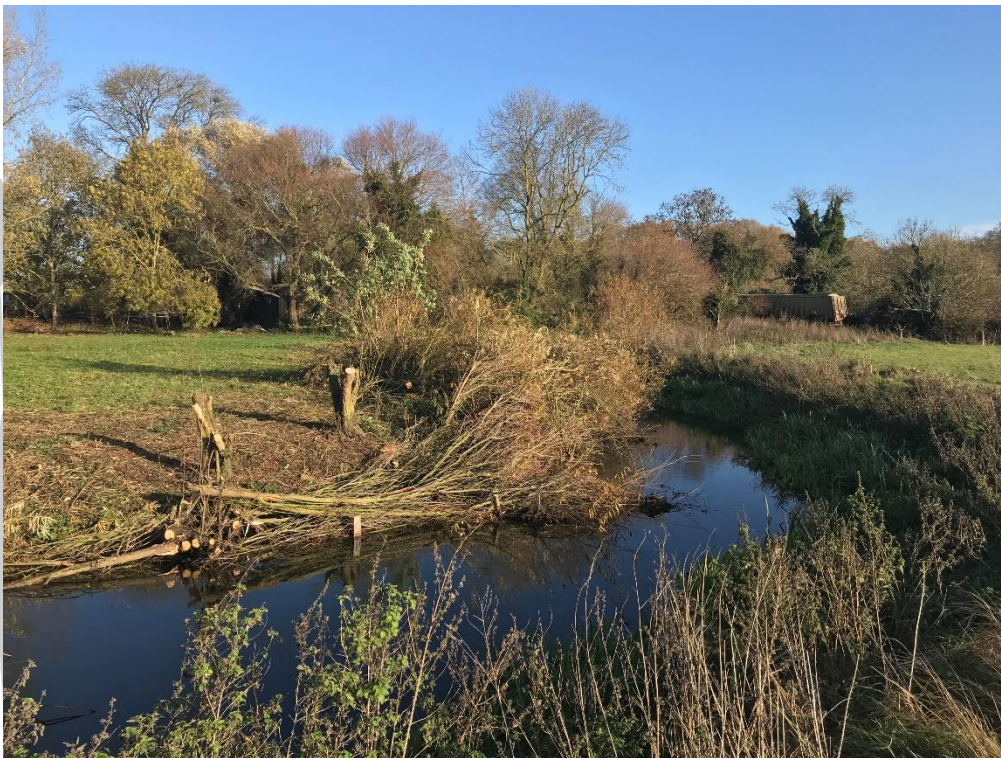
Figure 3 Hinging and pinning at Whitemills

This is where large limbs or whole small trees have a notch cut into the base of the trunk (a hinge) and are dropped on to the bank or into the water in a controlled way before being pinned into the bank using hardwood stakes and heavy-duty wire. This technique was carried out twelve times across the back channel to increase woody habitat, providing refuge for juvenile fish such as Chub and invertebrates as well as birds and mammals throughout the year. Figure 3 shows one of the fifteen trees that were hinged and pinned in to the back channel.

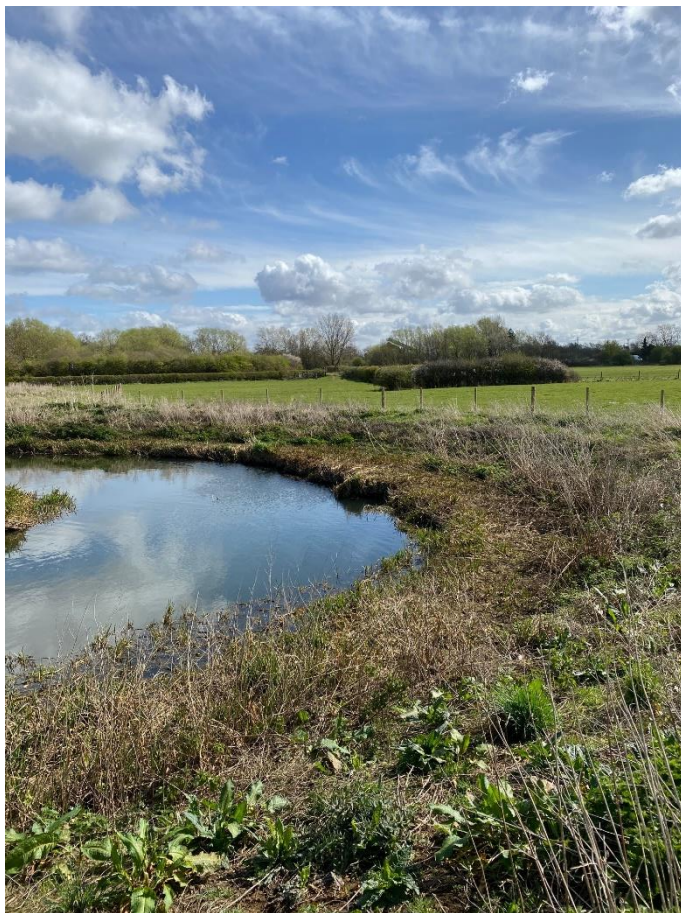
Figure 4 Regraded banks at Whitemills 16 months after completion

bank re-profiling activity whereby the height of the land enclosed by the meander at the downstream end of the reach was reduced to 30cm above normal water level in the back channel. Topsoil was stripped and stockpiled for replacement after the re-profiling was completed. The arising sub-soils were used to infill a low area in the field and to reconstruct the earth bund on an alignment further south on the existing high ground. Following the replacement of the topsoil the area was grass seeded to restore the grass lost during the regrading. A single small tree, which was in poor condition, was removed to facilitate this operation, but additional planting further upstream will mitigate this loss.
