Water Framework Directive Delivery

River Frome Rehabilitation Plan: Louds Mill 2013

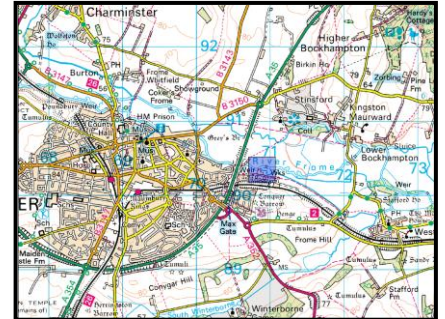
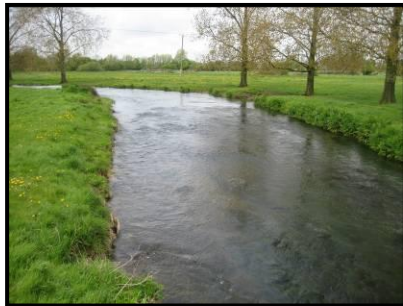
The reach downstream of Louds Mill was an over wide channel with little marginal vegetation and poor in channel bed morphology. During low flows the river was spread over the whole width of the channel leading to a shallow river. Spawning potential in the reach were limited due to compacted and over silted gravels. There was also very little cover and in channel structure provided by tree and in channel woody debris.

The River Frome Rehabilitation Plan states the main proposals to improve the SSSI condition and WFD objectives of unit 1b and to incorporate as part of the Louds Mill Enhancement were to: a) **reprofile banks** (to narrow the low flow channel and improve the marginal zone) b) **to reprofile river bed** (to clean the gravels of silt break its compacted nature – improving spawning potential) c) introduce **large woody debris** to the reach (d) **new riparian tree planting** (willow whips to be inserted into the bank edges and soft margins at key locations).
