RIVER NAR RIVER REHABILITATION

March 2011

‘AS BUILT’ SUMMARY OF PROJECT IMPLEMENTATIONS @ West Lexham, Castle Acre & Narborough

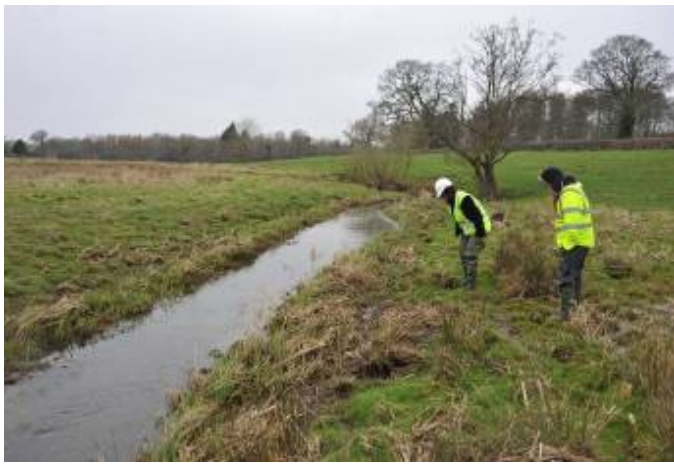
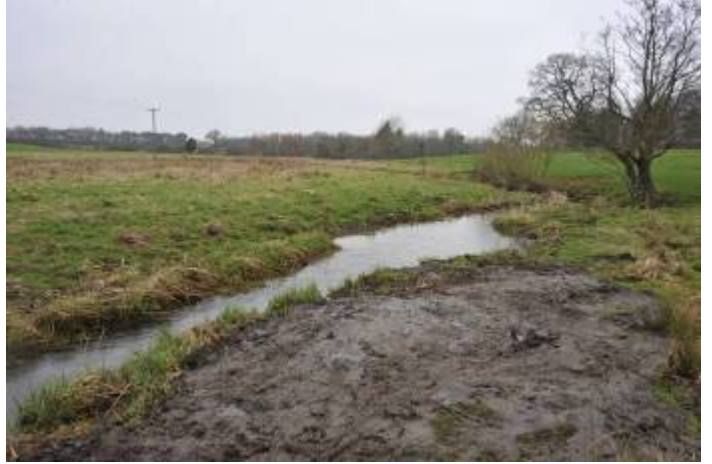
Nar West Lexham – upstream pool and run formed – (Photo ref: WL6)

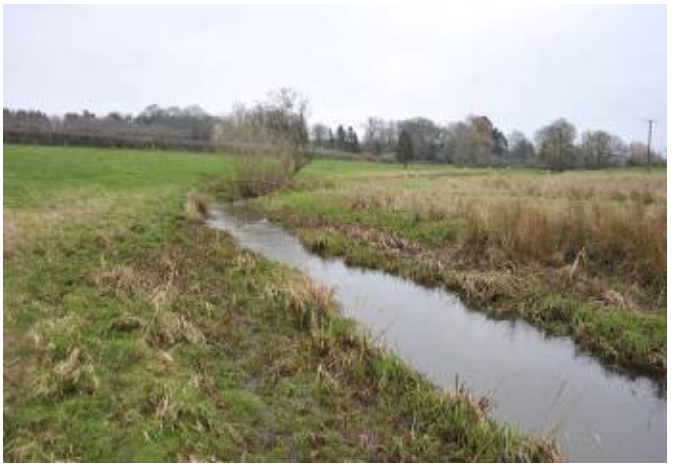
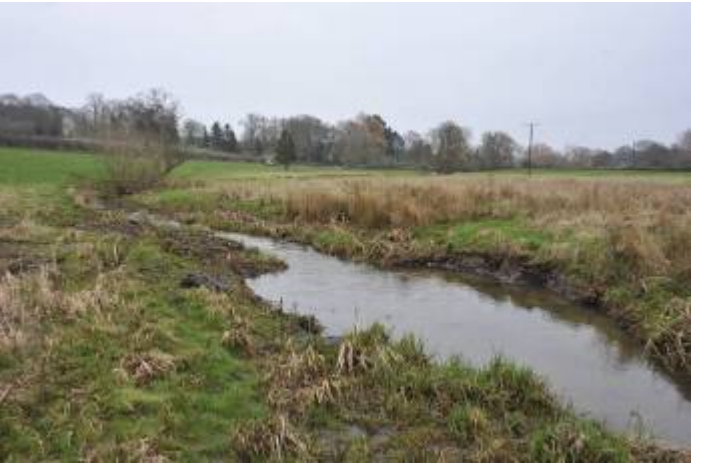
Nar West Lexham –pool and run formed d/s dilapidated bridge – run seeded with gravel from bed (Photo ref: WL5)

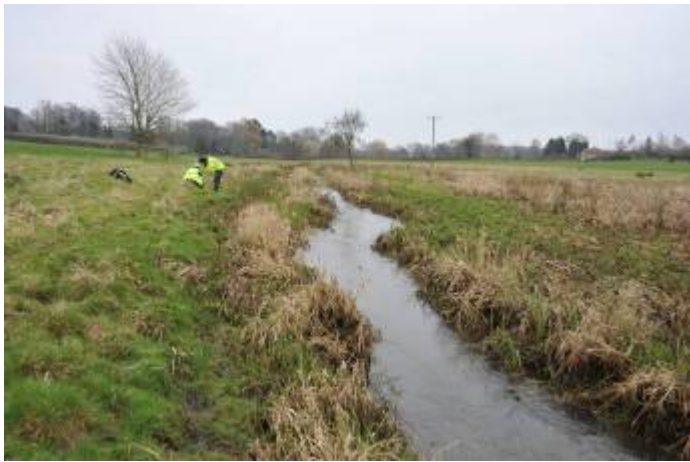
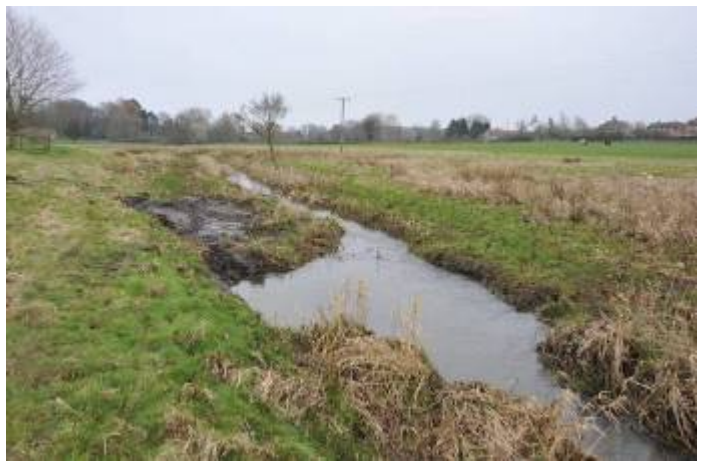
Nar West Lexham – middle pool and run formed – (Photo ref: WL4)

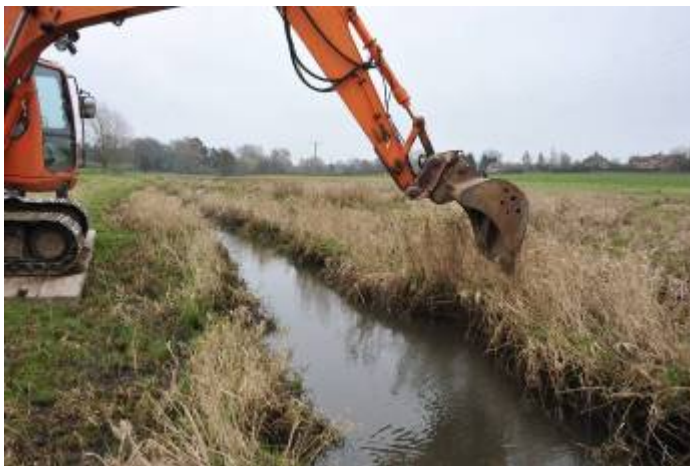
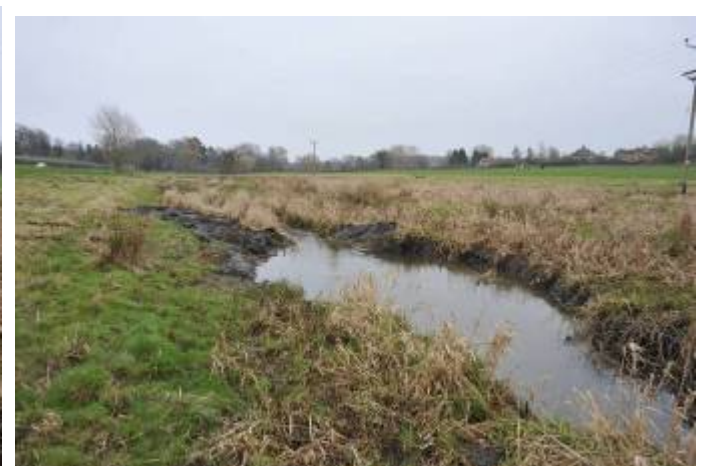
Nar West Lexham – downstream pool and run formed – (Photo ref: WL3)

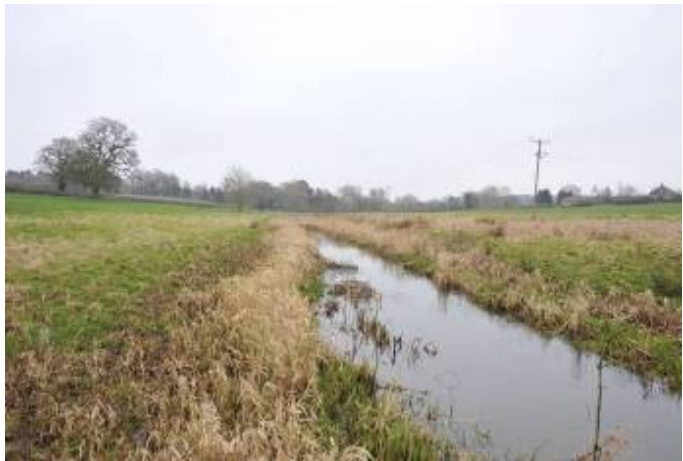
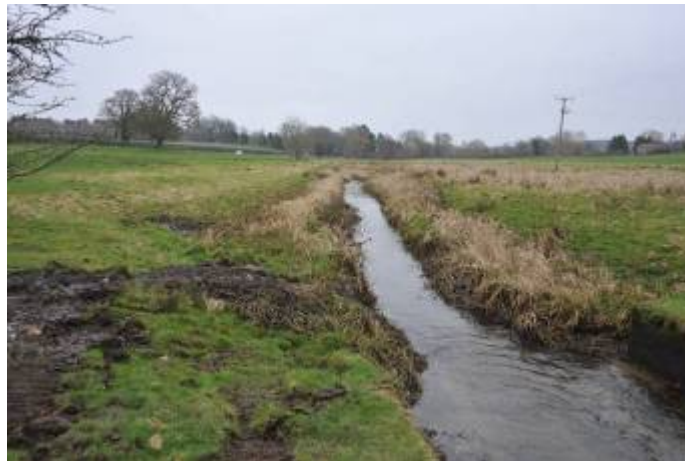
Nar West Lexham – effect on upstream channel of removal of impoundment– (Photo ref: WL2)

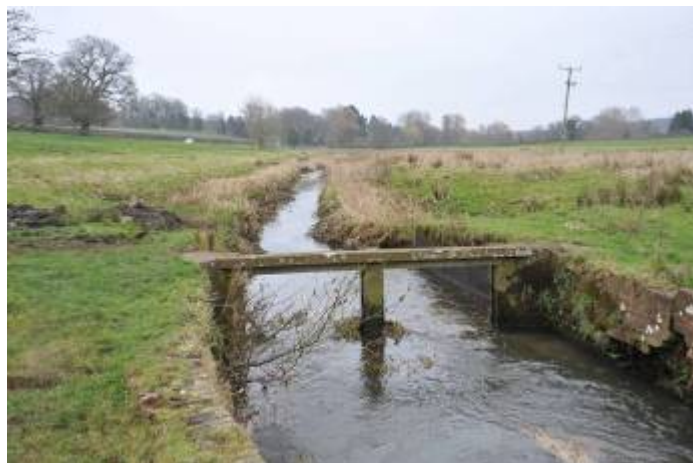
Nar West Lexham – removal of sluice impounding concrete ‘boards’ – (Photo ref: WL1)

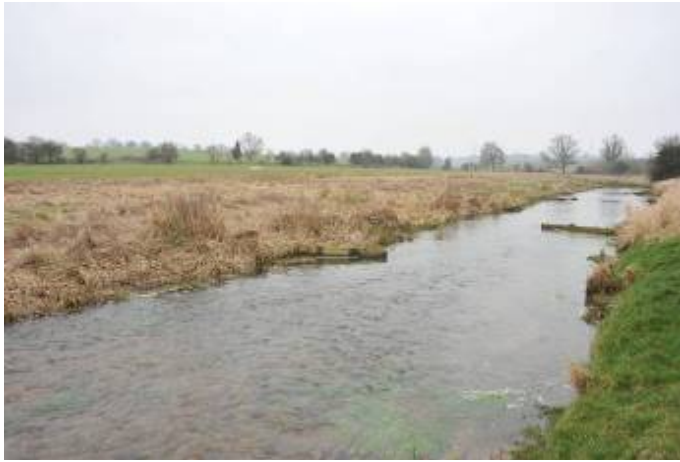
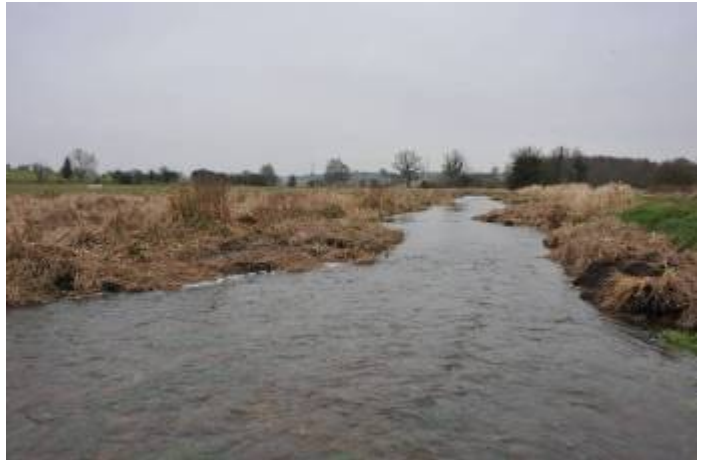
Nar Castle Acre – narrowing and pool formation (Photo ref: CA1)

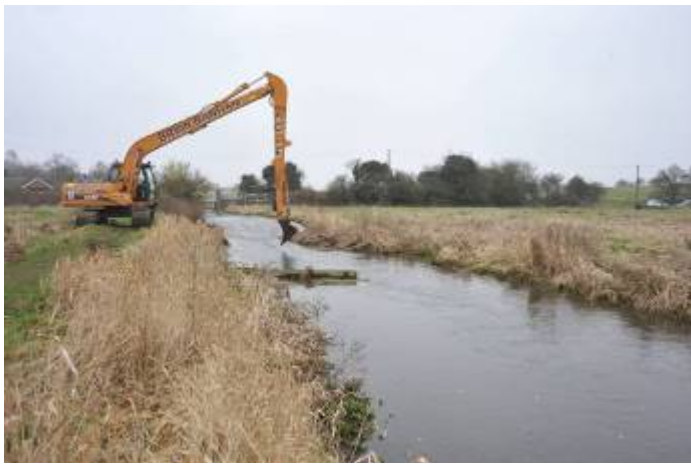
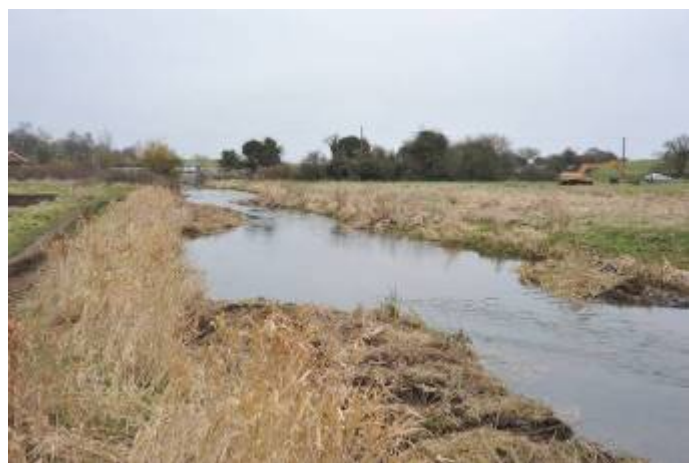
Nar Castle Acre – narrowing and pool formation (Photo ref: CA2)

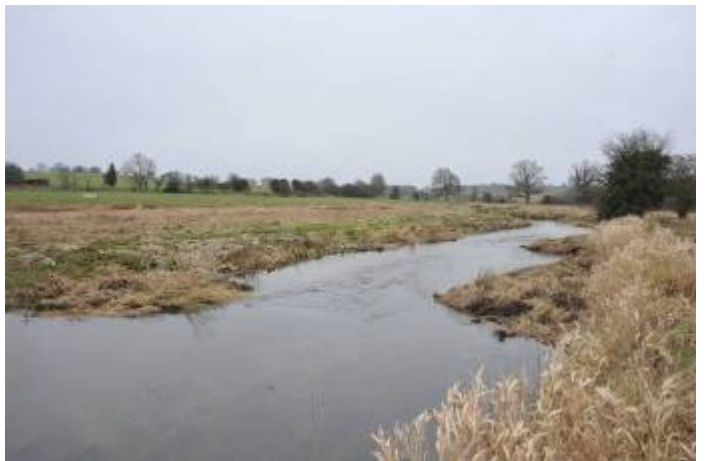
Nar Castle Acre – narrowing and pool formation (Photo ref: CA4)

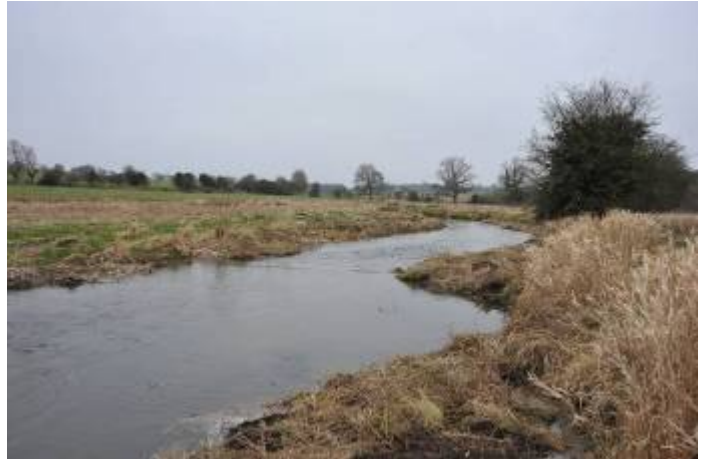
Nar Castle Acre – narrowing and pool formation (Photo ref: CA5)

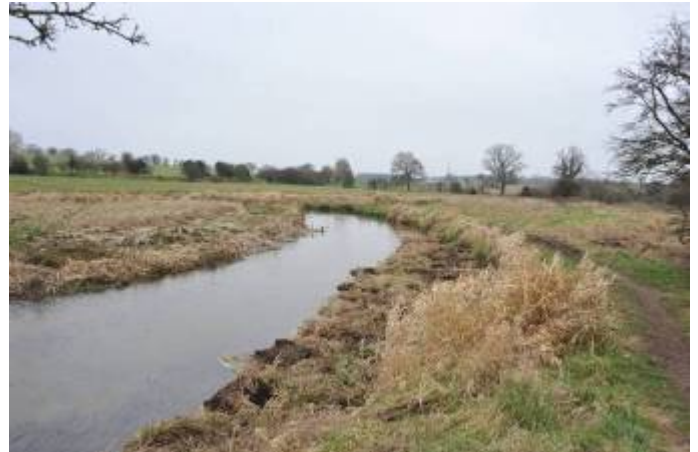
Photos 6U/D show simple narrowing of the channel only. Around the first large meander loop there was considerable narrowing on the left bank (Photo 7) followed by the formation of a small pool and then a run downstream formed from re-distributed gravels and considerable narrowing – again on the left bank (photos 8-9). Narrowing continued downstream on the inside of the meander where a wide and deep expanse of silt was present (photo 10). At the bend a small pool was created, with the material dragged to the edge of the channel below the bank on the meander. This material was not very cohesive, and not placed in the most appropriate location to be sustained in the future; however it was minor attempt to reduce erosion on the bank that is close to the footpath.

Nar Castle Acre – narrowing (Photo ref: CA6)

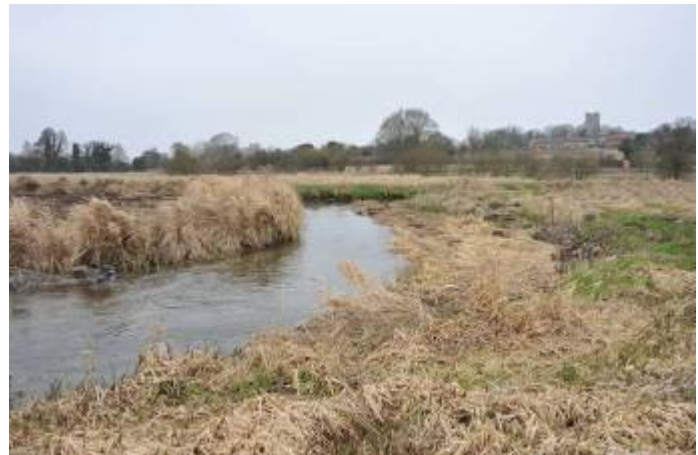
Nar Castle Acre – narrowing (Photo ref: CA7)

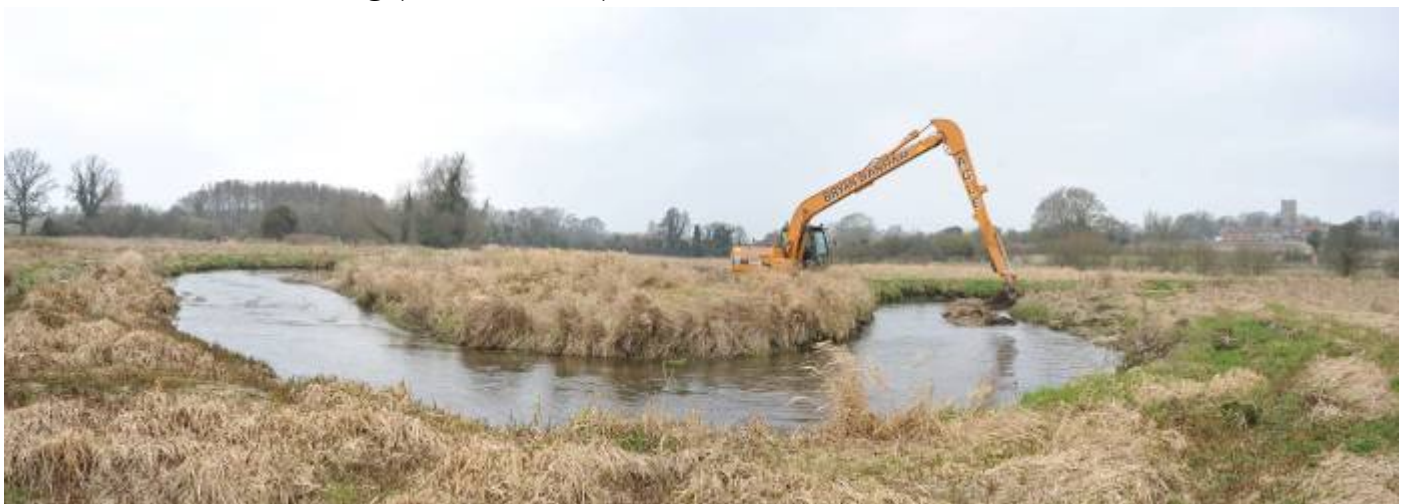
Nar Castle Acre – narrowing, pool and gravel run formation (Photo ref: CA8)

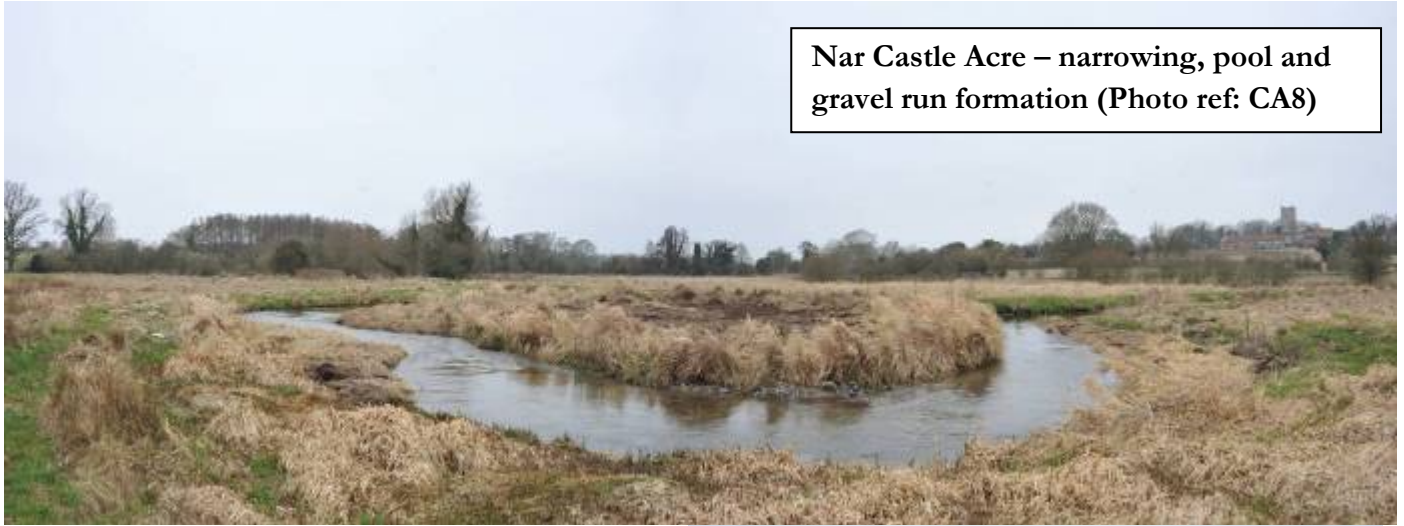
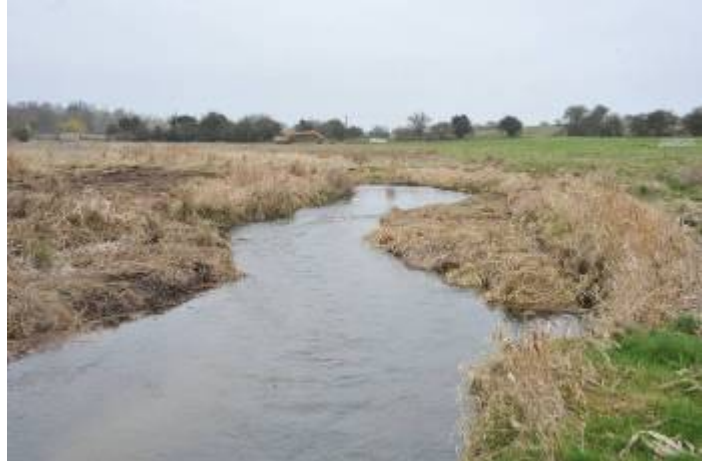
Nar Castle Acre – narrowing and shallow run/riffle formation (Photo ref: CA9)

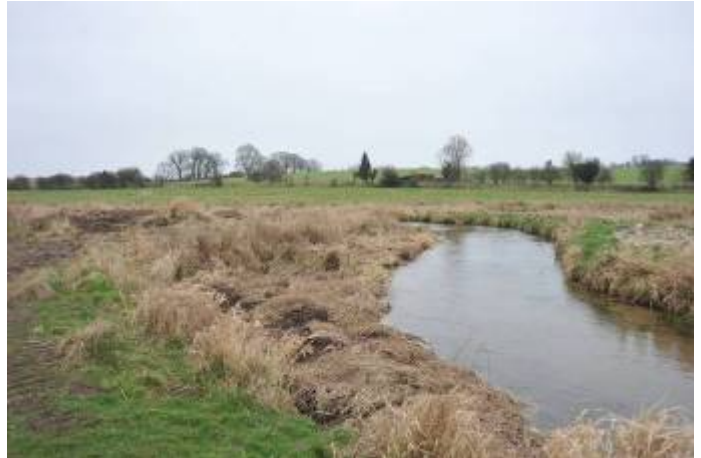
Nar Castle Acre – narrowing (Photo ref: CA10)

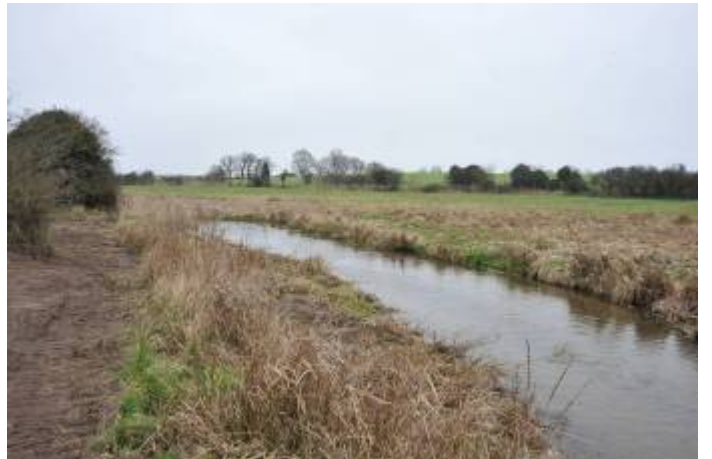
Photos 11D/U show extensive narrowing in a wide part of the channel, and Photos 12D/U show slight narrowing and bank re-profiling. The former section could be effectively narrowed as it was not very deep; the latter could not as it was very deep, and adjacent reed was not bound tightly with earth (sandy) so no large ‘sods’ could be added to the river.

Nar Castle Acre – narrowing (Photo ref: CA11)

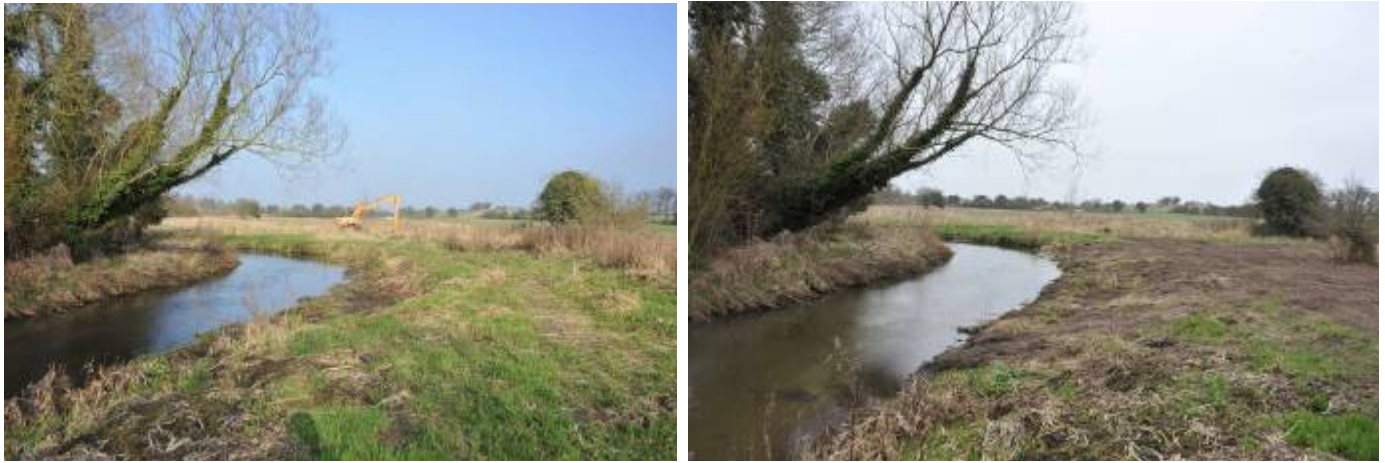
Nar Castle Acre – slight narrowing and bank re-profiling (Photo ref: CA12)

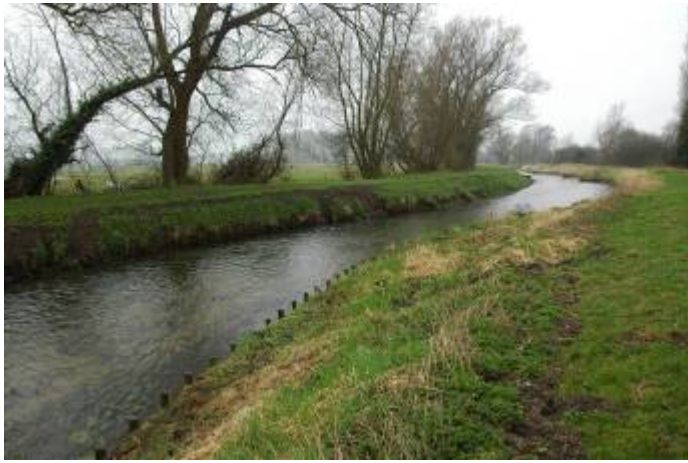
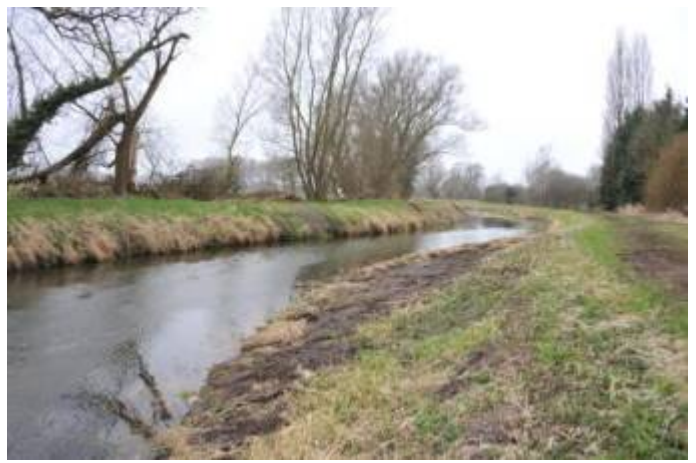
Narborough ‘Berm’ – previous berm formation modified. Posts and faggots precluding natural edge development compressed – these were compressed into the bed and draped with reed from upper edge of the berm

Nar Narborough - Berm re-profiling

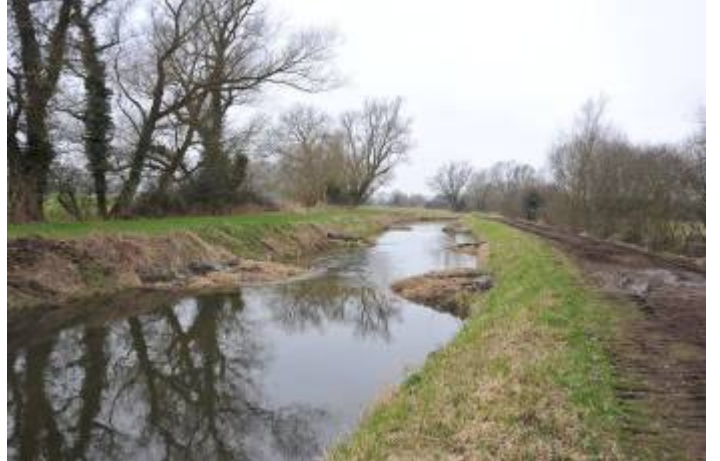
Narborough pool 1: Very distinct pool formed; upstream shoulders formed from firm chalky clay and topped by *Phalaris*. Centre seeded with gravel. Ideal form and perfect state that should be stable and enhance over time.

Nar Narborough - Pool 1 looking d/s

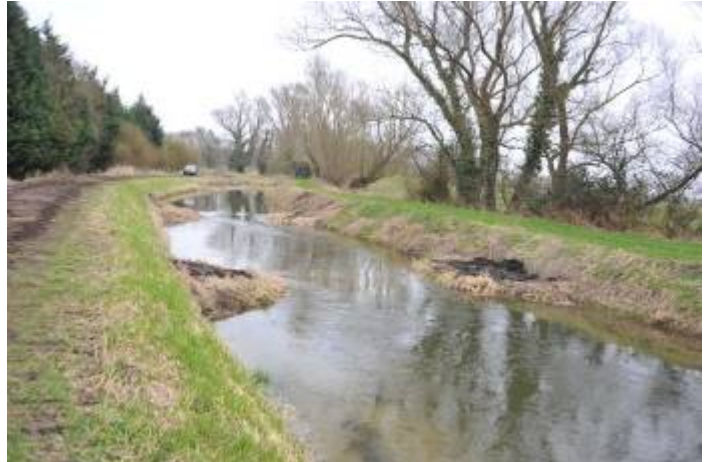
Narborough pool 2: Very distinct pool formed; upstream shoulders formed from firm chalky clay and topped by *Phalaris*. Centre seeded with gravel. Near-ideal form that should be stable and enhance over time – less dramatic contrast between upstream run and pool than pool 1.

Nar Narborough - Pool 2 looking u/s

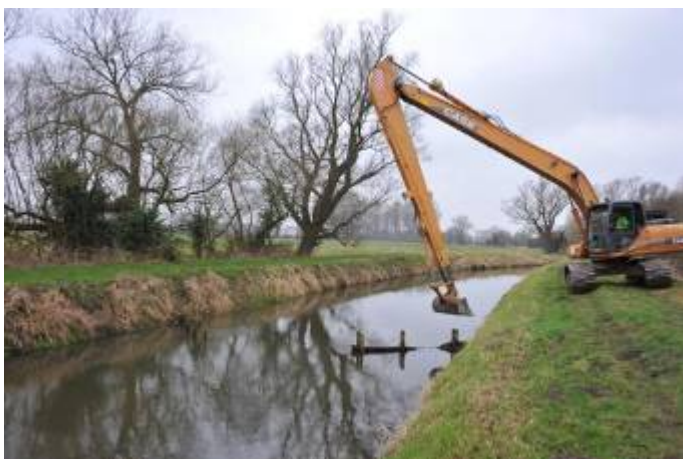
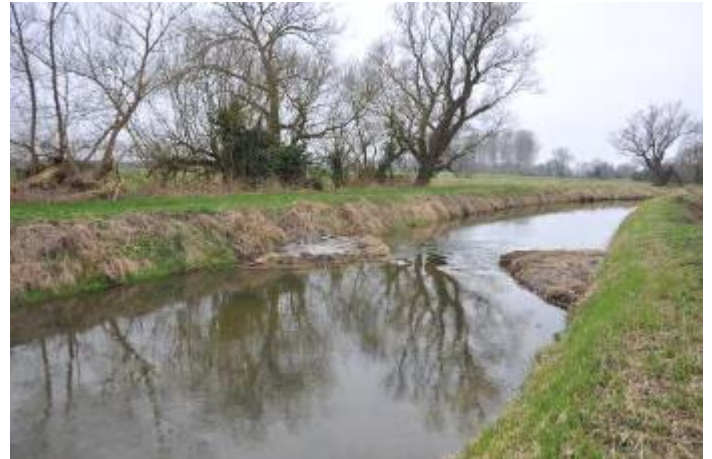
Narborough pool 3: Very distinct pool formed; upstream shoulders formed from firm chalky clay and topped by *Phalaris*. Centre seeded with gravel. As 2.

Nar Narborough - Pool 3 looking d/s

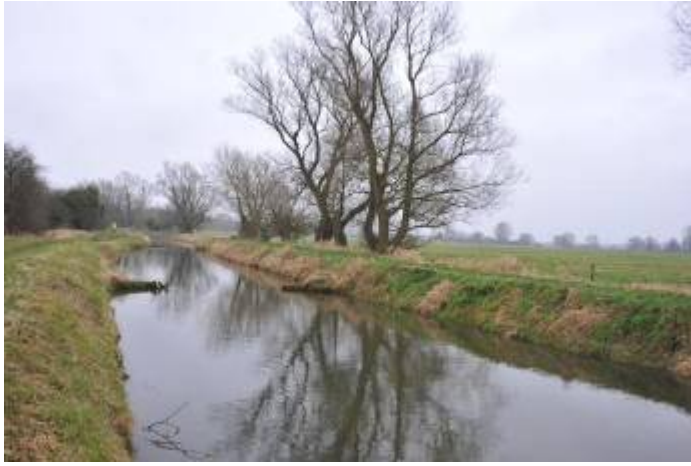
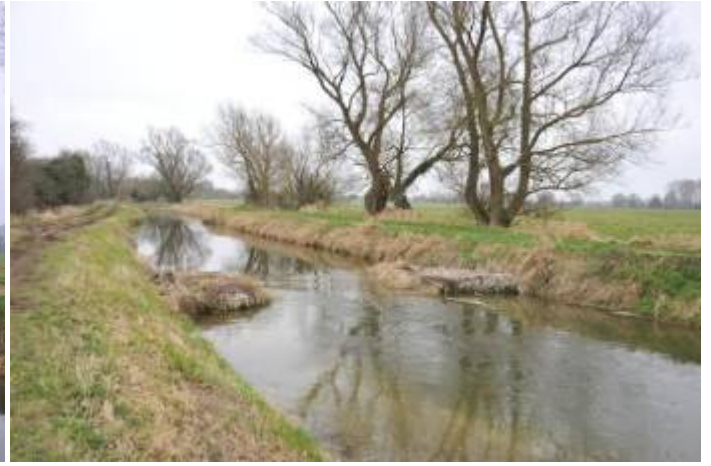
Nar Narborough - Pool 4 looking u/s – note old pole deflectors still visible

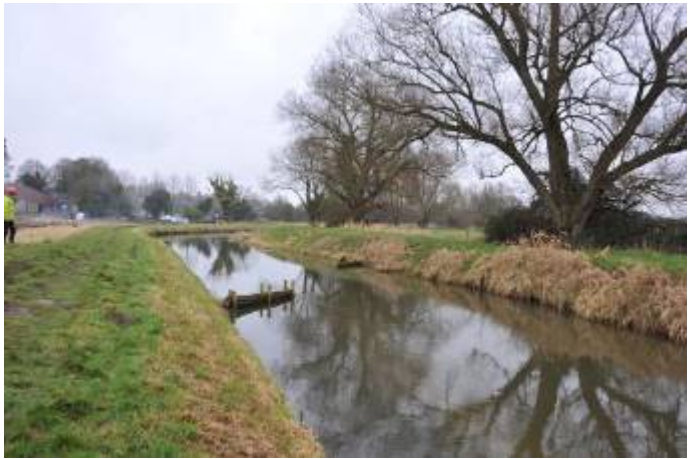
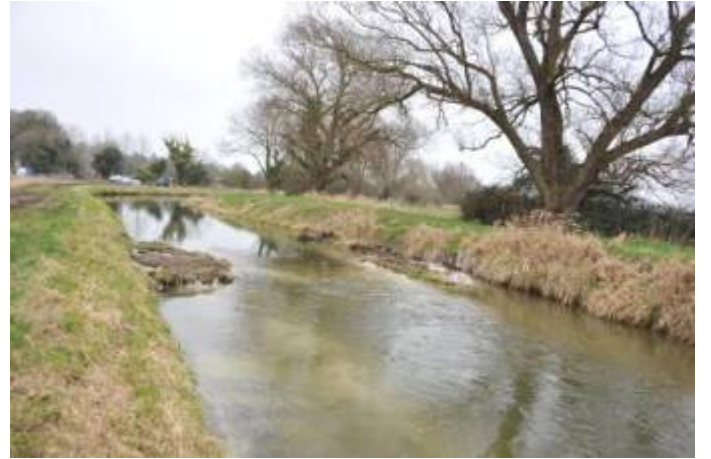
Nar Narborough - Pool 5 looking u/s

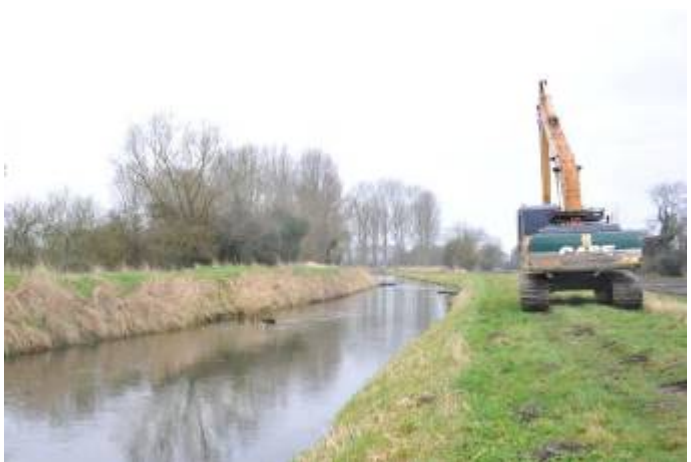
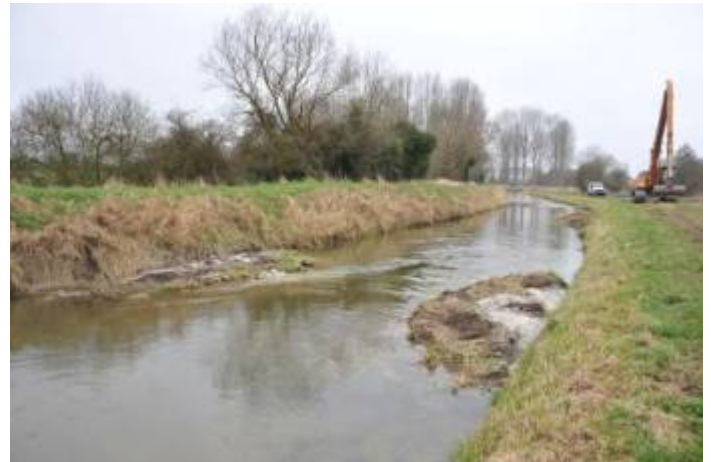
Nar Narborough - Pool 6 looking d/s with pools 7A and 7B in the background

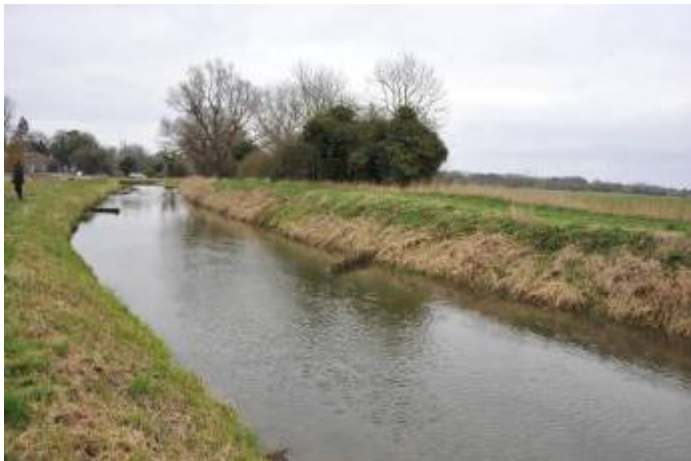
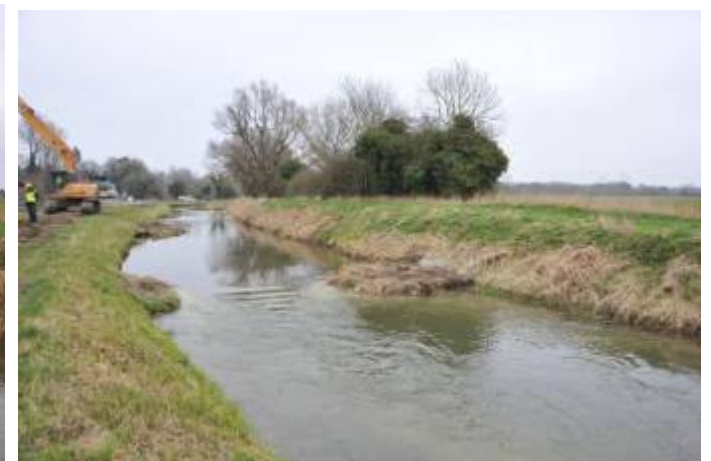
Nar Narborough - Pool 7B looking u/s with pools 7A, 6 & 5 in the background

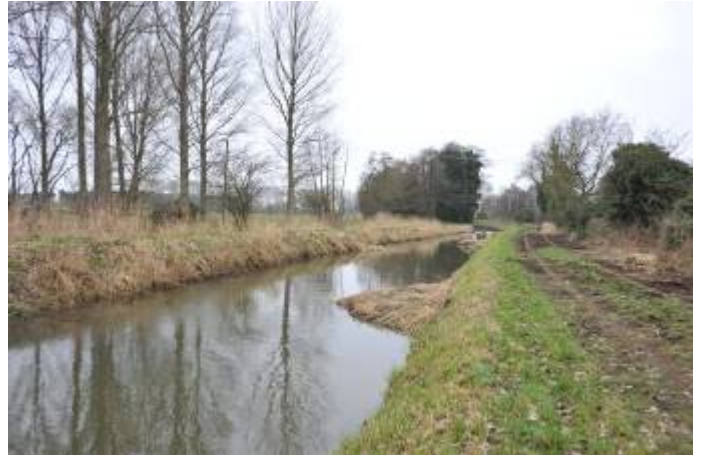
Narborough pools 9 & 10: Two very indistinct pools and shoulders formed from PURE and very soft peat; upstream shoulders topped by *Phalaris*. As Complex 8, shoulders short due to unsuitable material. Project implementation helped by presence of wooden deflectors that now form the downstream edge of the shoulders and held the very soft peat in place before reed topping added. Expect to shoulders to stay in place but pools will never be distinct.

Nar Narborough – ‘Pools’ 9 & 10 plus shoulder formed over old deflector – soft peat shoulders with reeds; indistinct deepening – non-existent pools (looking d/s with pool 11 in background)

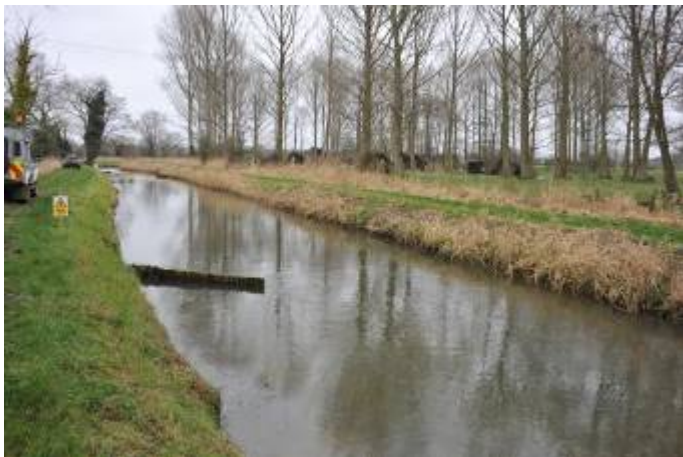
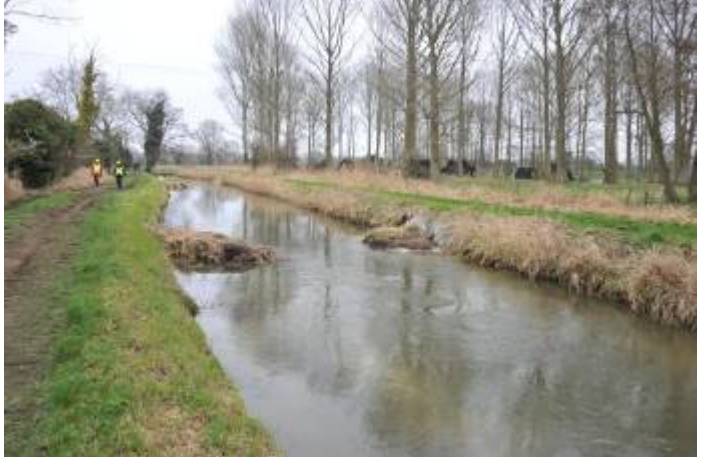
Narborough pool 11: Reasonably distinct pool and right bank shoulder formed from chalky clay topped by *Phalaris*. Expect to stay in place and unlike pools 8-11 should remain distinct, or even become more pronounced.

Nar Narborough – Pool 11 – looking upstream; firm chalky bed enables discrete pool creation

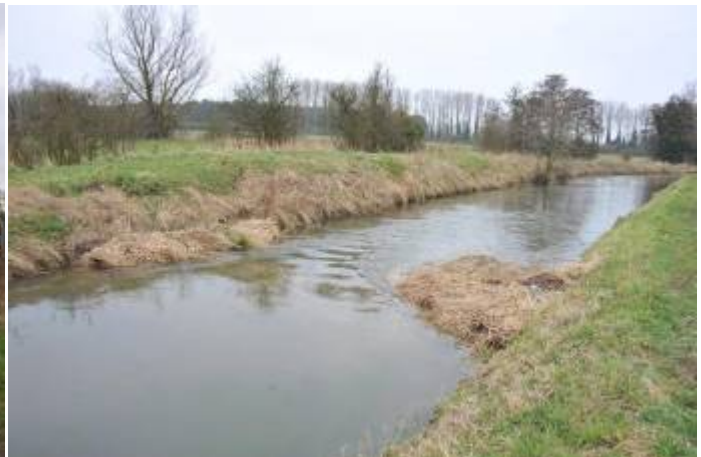
Narborough pool 12: Very distinct pool formed; upstream shoulders formed from firm chalky clay and topped by *Phalaris*. Centre slightly raised with dredging and then seeded with gravel. Perfect example. Should get even better over time.

Nar Narborough – Pool 12 – looking d/s; firm chalky bed enables discrete pool creation

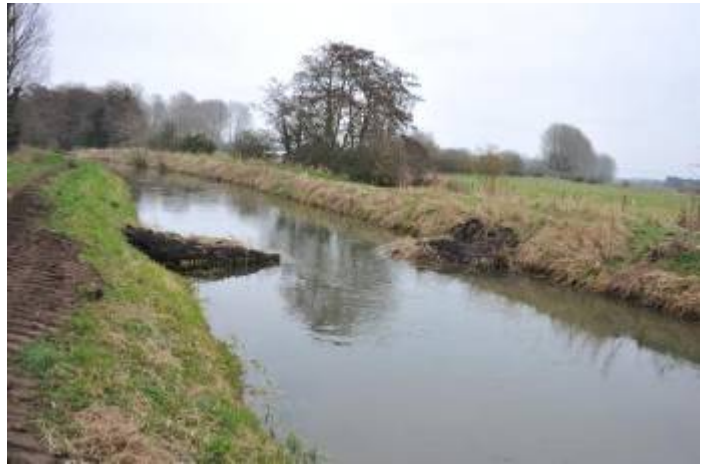
Narborough pools 13 & 14: Two very indistinct pools and shoulders formed from PURE and very soft peat; upstream shoulders topped by *Phalaris* (limited amounts available here so relatively shallow and small). Shoulders short also due to unsuitable material. Project implementation helped by presence of wooden deflectors that now form the downstream edges of the shoulders and held the very soft peat in place before reed topping added. Expect to stay in place but pools will never be distinct.

Nar Narborough – Non-existent ‘Pool’ 13 plus shoulder formed over old deflectors – very soft peat shoulders with limited reeds – looking u/s

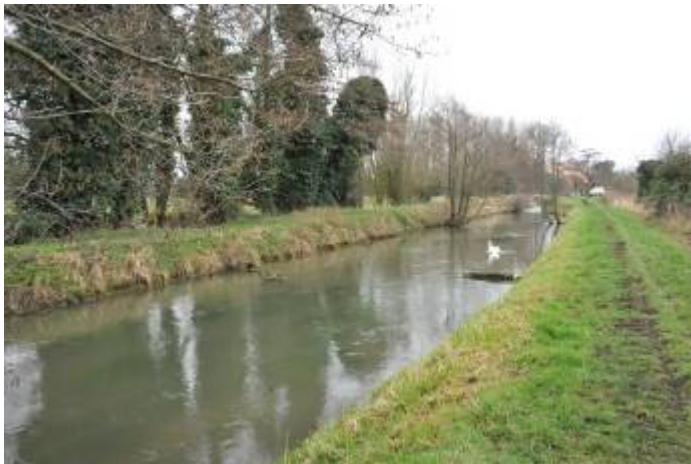
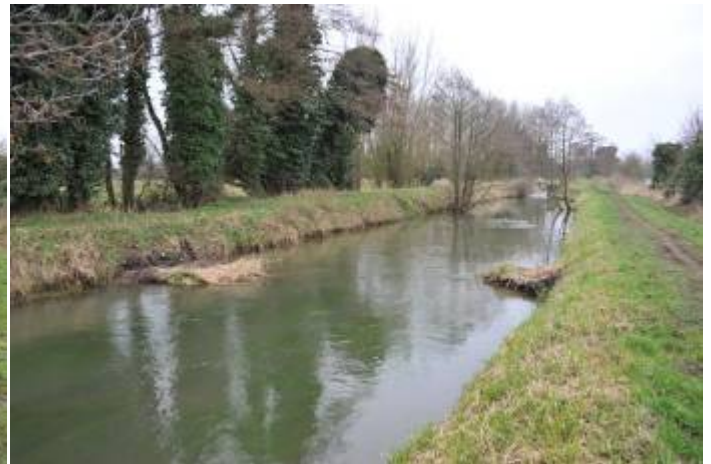
Nar Narborough – Non-existent ‘Pool’ 14 plus shoulder formed over old deflectors – very soft peat shoulders with limited reeds – looking d/s

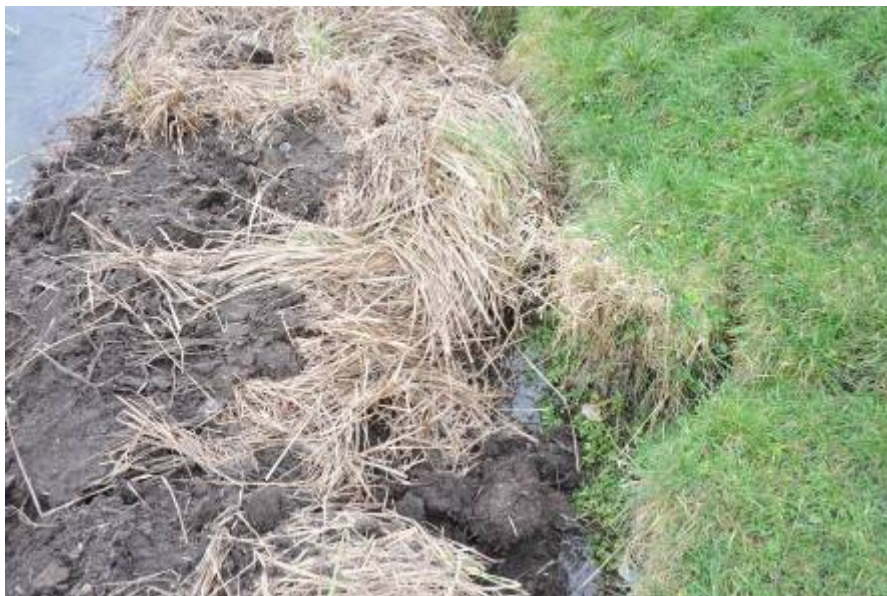
Example of retained gap between in-fill to narrow the channel and the existing bank
