Water Framework Directive Delivery

River Frome Rehabilitation Plan: Unit 3a – Hurst Bridge 2013

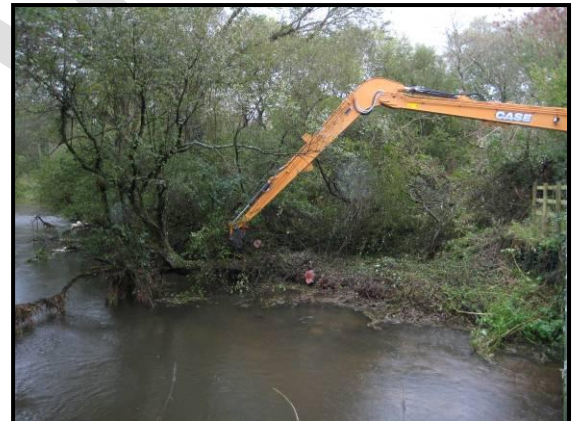
At the farm across bridge within this reach a large willow has been overhanging into the channel upstream of the bridge for several years. During the high flows of 2012 this was resulting in increased bank erosion which was feared could lead in the medium term to eroding the bridge abutments. Due to its size and location this was more complicated than simple riparian tree management that the fishing syndicate to undertake. It was agreed that while the skilled chainsaw workers of Ops Delivery and the excavator were on site this tree could be managed to minimise the bank erosion risk. The tree has been kept almost whole and is lined up to be used as LWD in future projects downstream.
