Long Preston Deeps SSSI Restoration: Phase II Works Description

Final

October 2012

Environment Agency

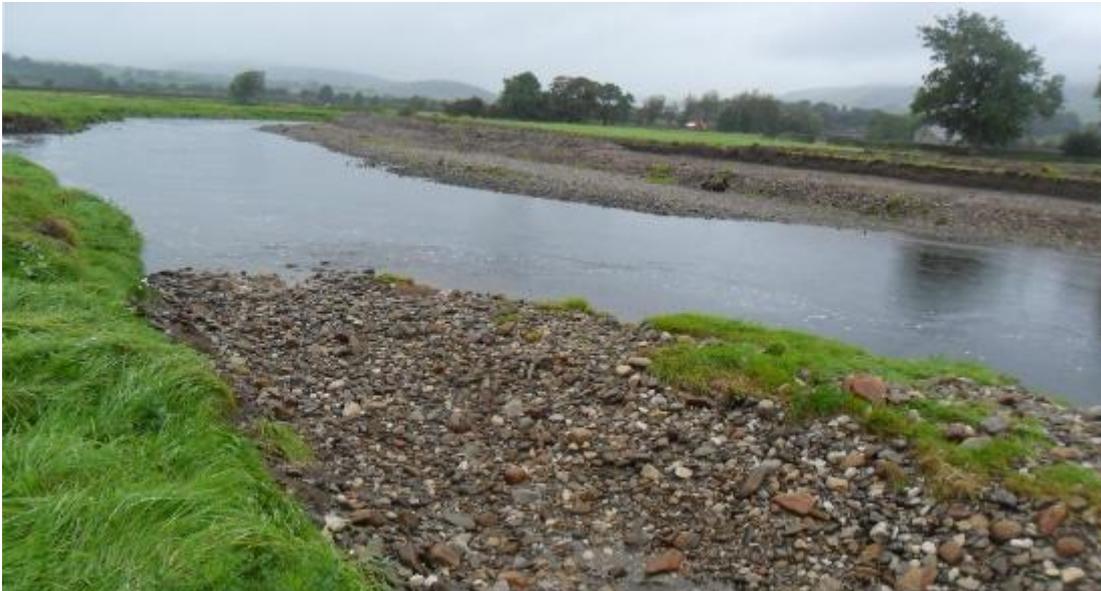
Figure 2. Upper left bank reprofiling on the River Ribble.

Three floodplain scrapes were proposed, however, only the two on the left bank were executed following landowner consent. The reprofiling removed silt from over the underlying gravels (Figure 2 & 3) lowering the level of the feature and to ensure more frequent flood inundation.

Flows 0.5 m above the normal range inundate the both new gravel surfaces.

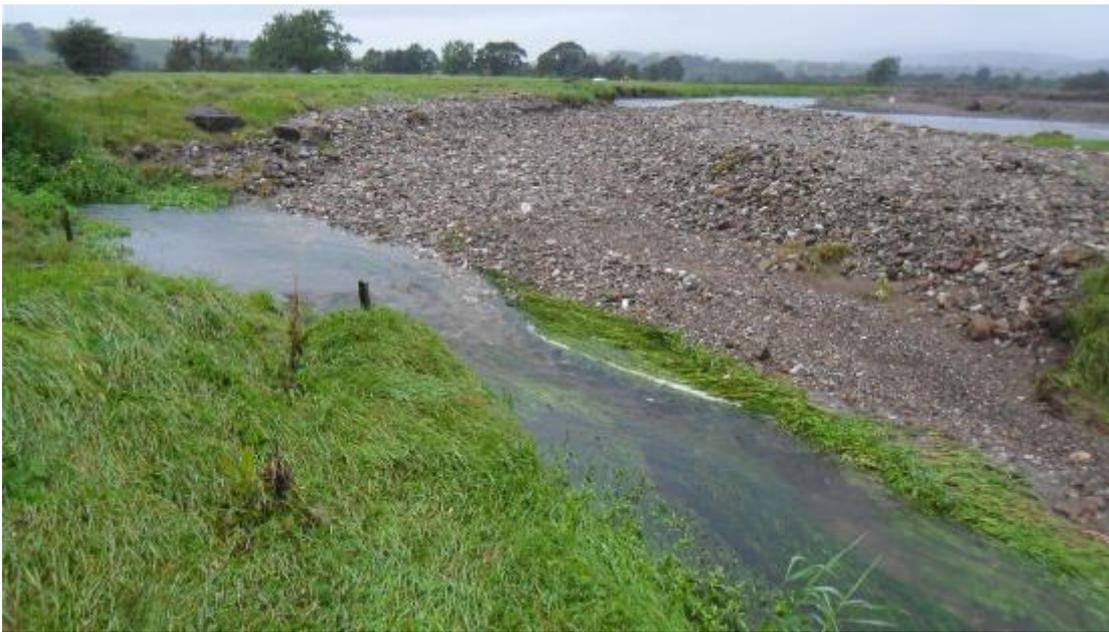
Figure 4. Chute channel creation on the River Ribble.

The right bank gravel bar was altered to create an inner bank flood channel (Figure 4). This channel will become active at the upper range of normal flows in the river and will reduce the flow concentration presently directed at the outer bank opposite.

It is anticipated that flood flows will keep the new chute open and may cause it to develop further, however, frequent and often substantial movement of river gravel has been observed on the river and there is a risk the chute channel may become infilled.

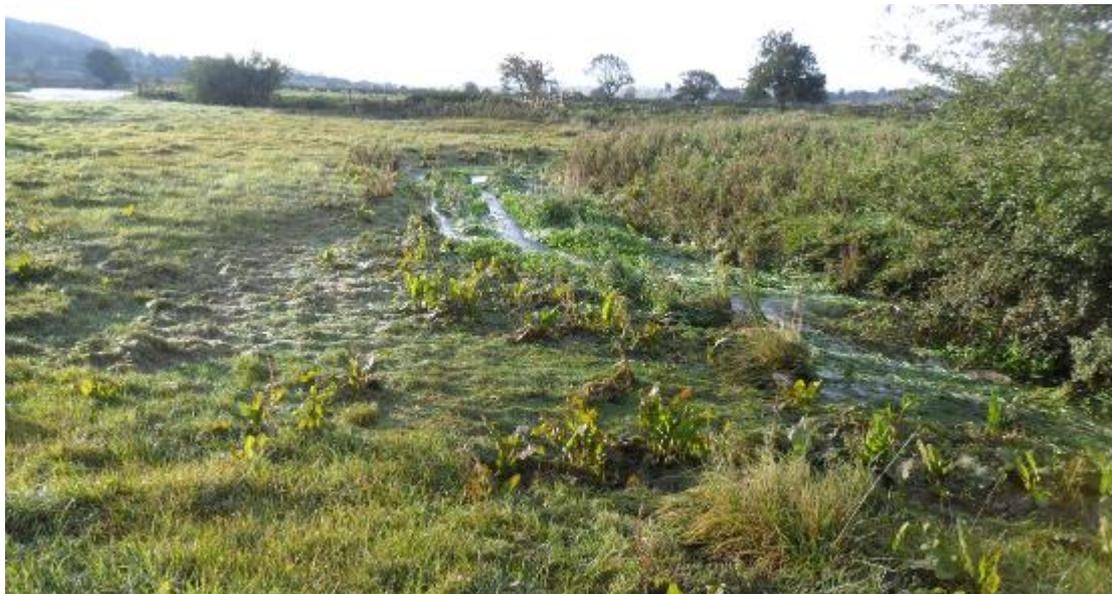
Figure 5. Flowing channel conditions created following culvert interception.

Several palaeo-channels were excavated and reconnected to the main channel over the right bank floodplain. This excavation intercepted a field drain to create an open flowing channel downstream (Figure 5) and a set of ponded backwater reaches upstream and off of the main channel (Figures 6 & 7). The wetting of natural riparian zones will result in rapid ecological gains. Artificial backwaters will take a few seasons to before vegetative colonisation results in ecological gains.

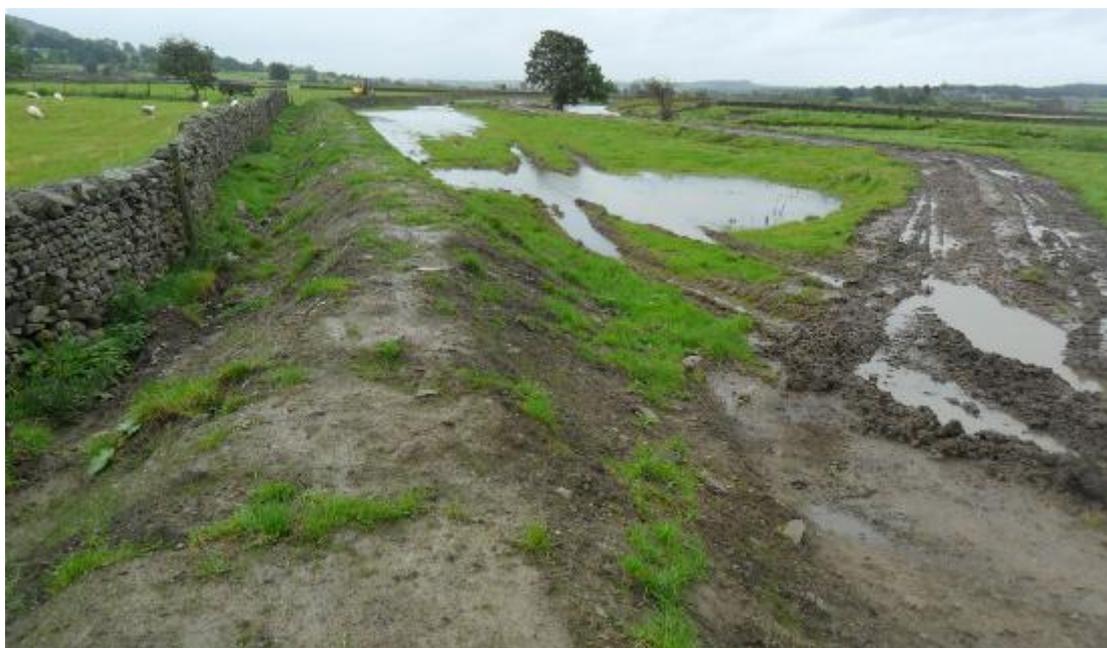
Figure 8. Left bank flood bank realignment showing reconnected floodplain.

The adjacent flood bank on the left bank was realigned 25m back across the floodplain. Although this is a narrow strip it has already been inundated on several occasions and will act as a fine sediment deposition zone and flow energy reduction zone leading to reduced in-channel gravel movement and sediment unit stabilisation.

Standing water zones appear to be forming on the reconnected floodplain (Figure 8).

Planting will occur across the reconnected floodplain area.

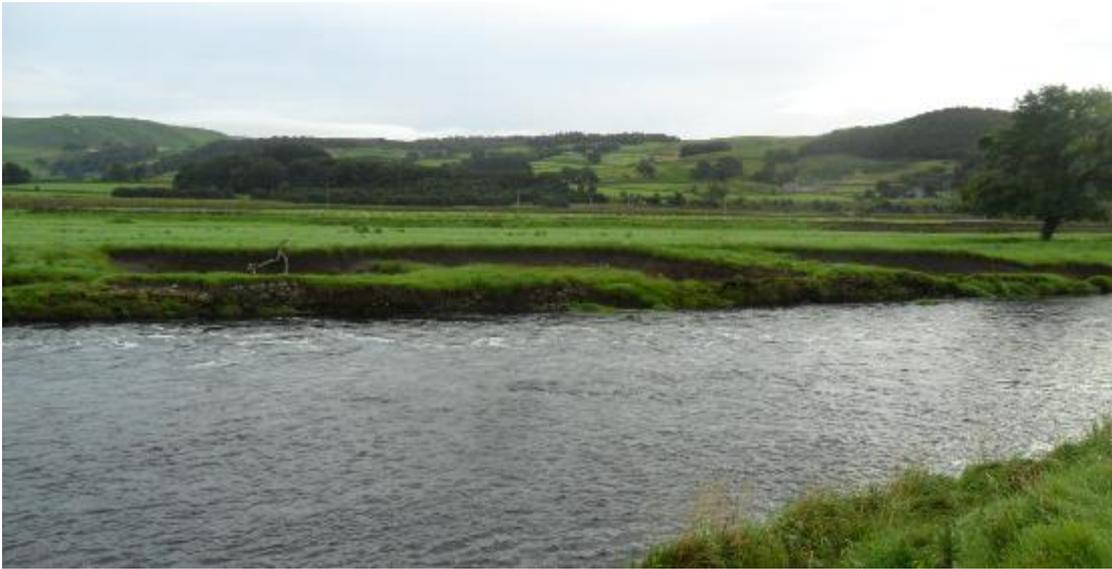
Figure 9. Retained revetment along the River Ribble.

Several lengths of revetment were proposed for removal. Fisheries concerns meant that much of this remained in place.

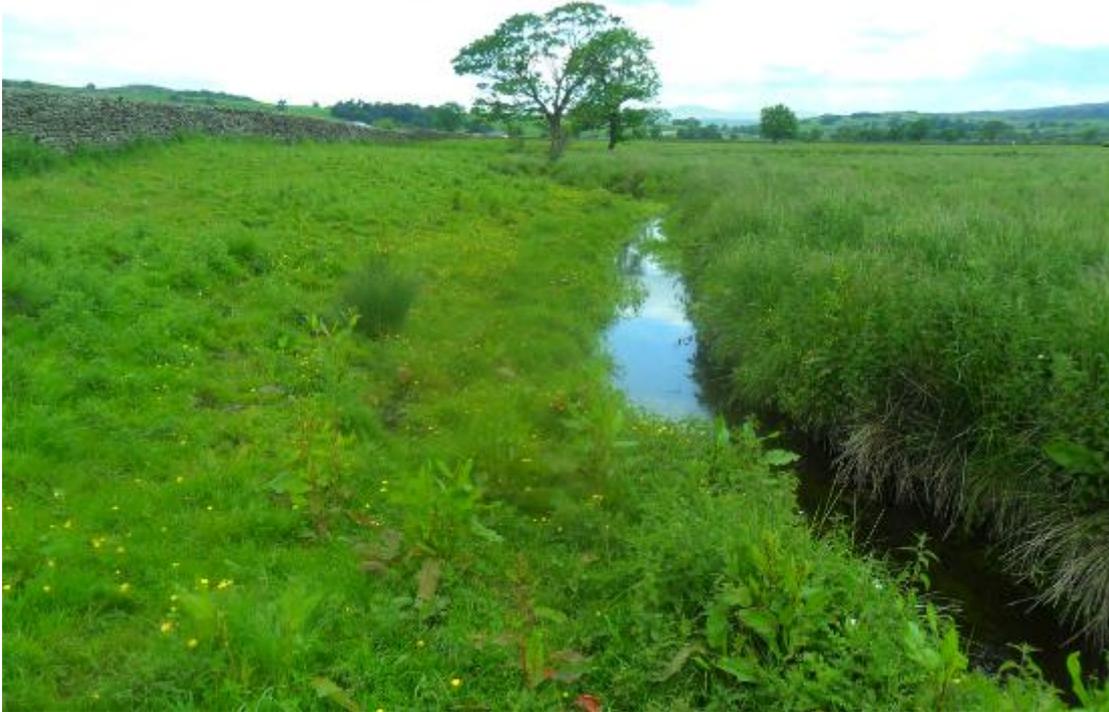
Figure 10. Ponded silted tributary channel before confluence culvert removal.

Around 300 m of the previously ponded Trout Beck (Figure 10) was dredged and the entrance culvert to the main river removed and replaced with a bridge crossing. 12 riffle areas were reinstated (Figure 11). Channel blockage at the dry stone wall upstream was removed and pipe access installed to allow fish passage upstream.

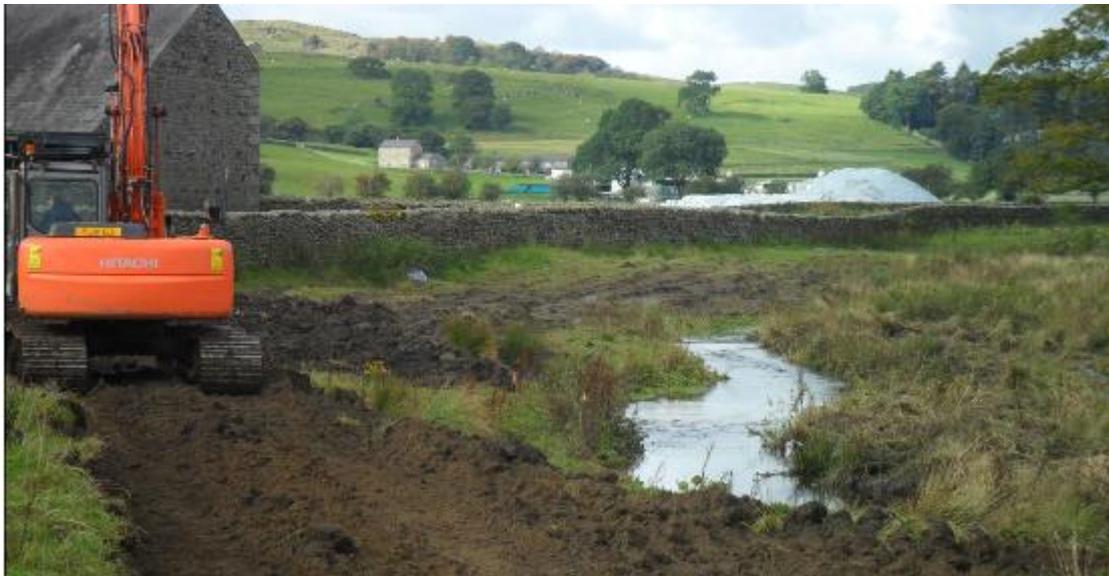
Figure 11. Two riffle areas on the Trout Beck tributary.

The present imposed morphology is functioning to create loose open gravels across the riffle surfaces and there is some potential for gravel mobilisation during high tributary flows moving material into the intervening pools. The lack of coarse sediment input from upstream due principally to the dredged nature of the channel will mean that these features will not be resupplied with material and may alter their profile or coarsen up over time. Without a wider restoration programme for the beck this is inevitable.

The installed level of the riffles is also controlling floodplain groundwater levels lifting these to create a wetland with standing water. Adjustment of the riffle levels will impact on this connectivity degrading this environment.

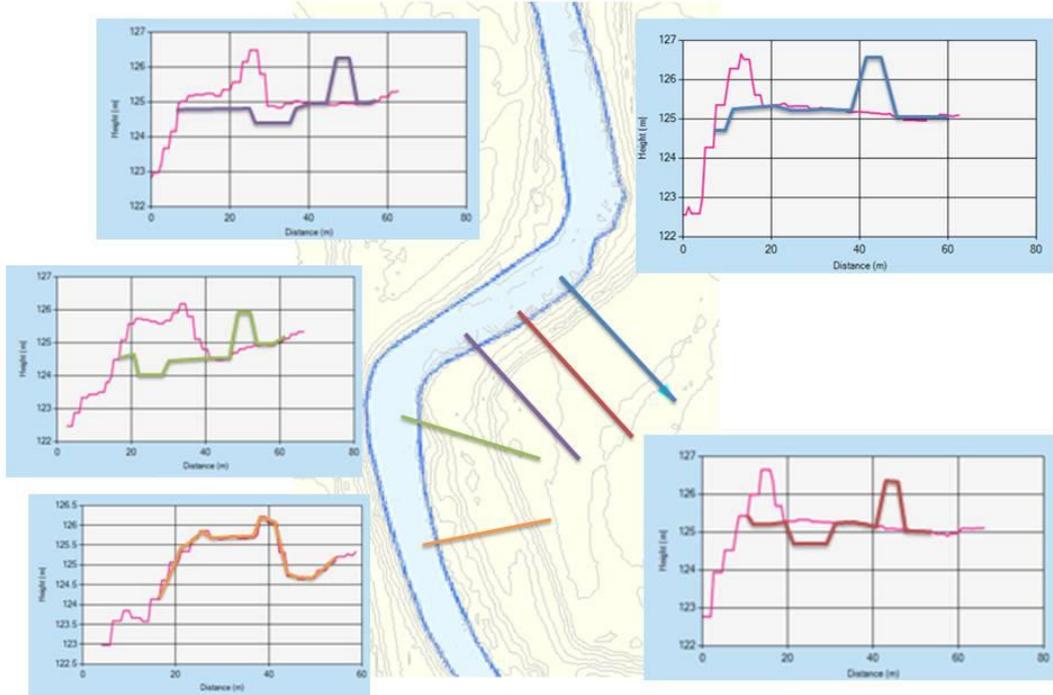
Figure 12. Detail of the flood bank realignment, chute channel and floodplain scrapes.

Around 400 m of adjacent flood bank was realigned 30-50 m away from the channel edge reconnecting this area of floodplain with the river and reducing flood energy levels against the right outer bank (Figures 12). Additional chute channel and scraping further enhanced the connectivity and these are detailed below.

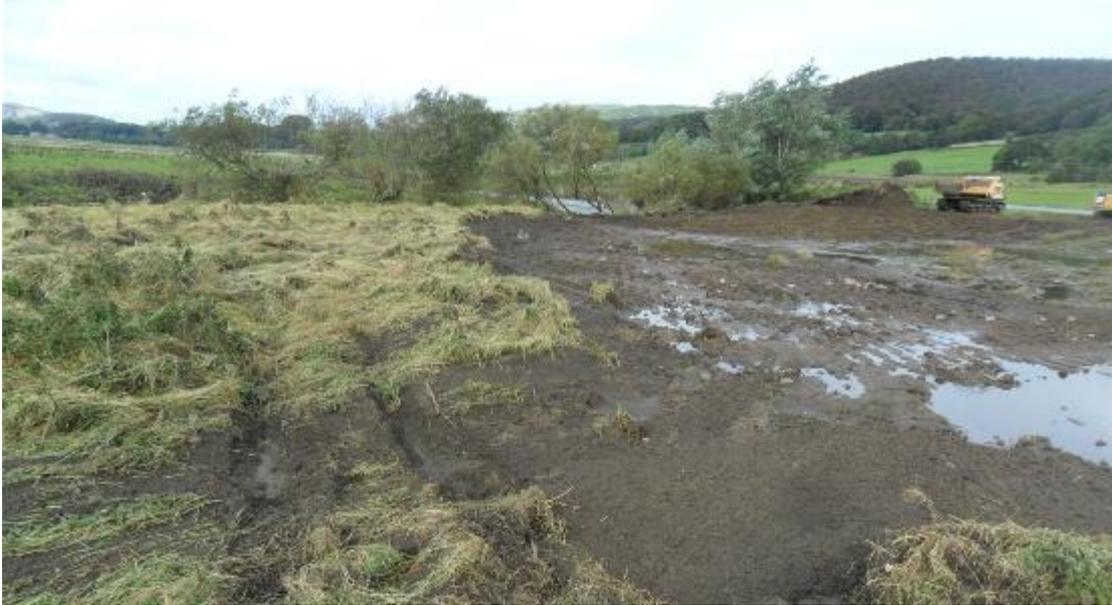
Figure 14. Construction of floodplain chute on the River Ribble.

A wide high level chute was cut across the floodplain surface (Figure 14). This feature was designed to accommodate only high winter flows and to be shallow sloping to allow easy traverse.

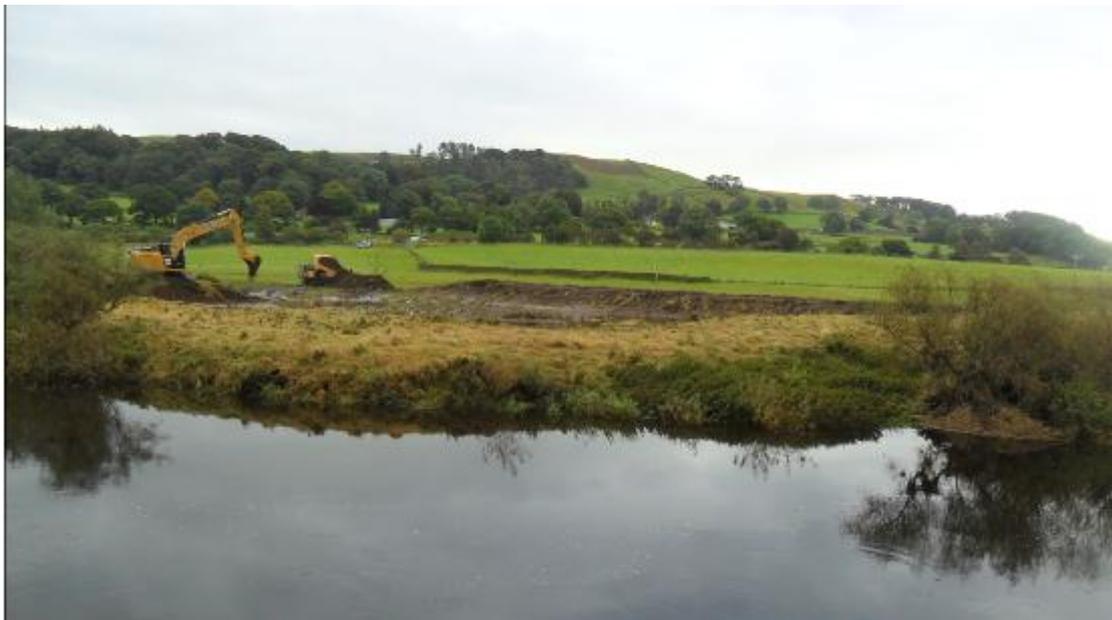
Figure 15. Construction of floodplain scrape on the River Ribble.

Two lowered sections of floodplain were constructed (Figure 15) to accommodate higher flows and to provide better river access as a secondary benefit. New floodplain levels are designed to be inundated frequently during winter reducing the flow volume and erosive energy in the main channel.

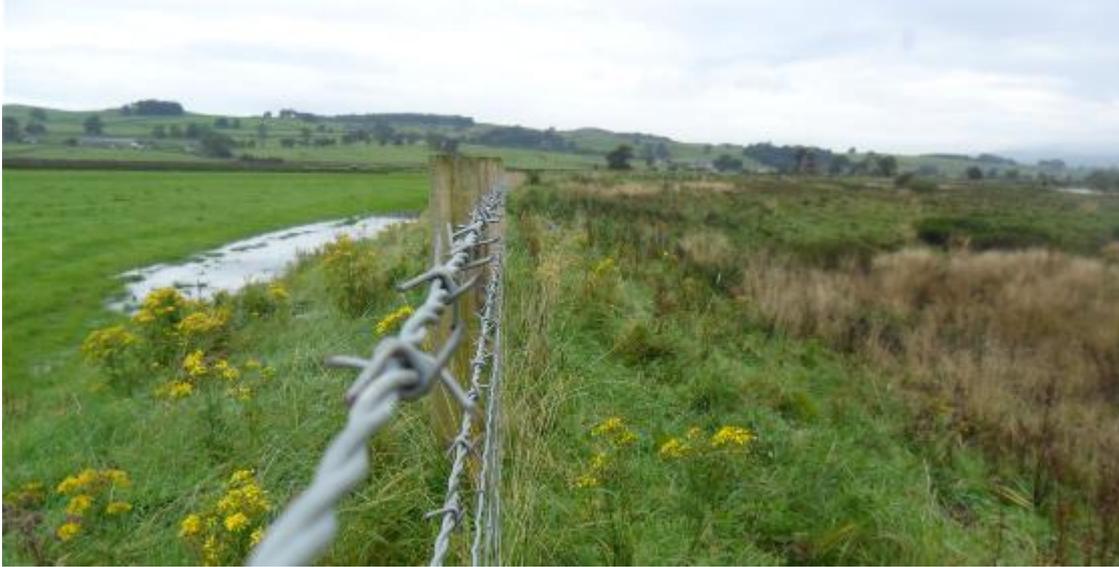
Figure 16. Effect of fencing on vegetation community on the River Ribble.

The new flood bank realignment on the left bank was fenced for later planting. Fencing continued through the next field around 30 m from the river isolating this area for later planting. Figure 16 illustrates the rapid change to the floristic community that can occur following fencing during the Phase I works.

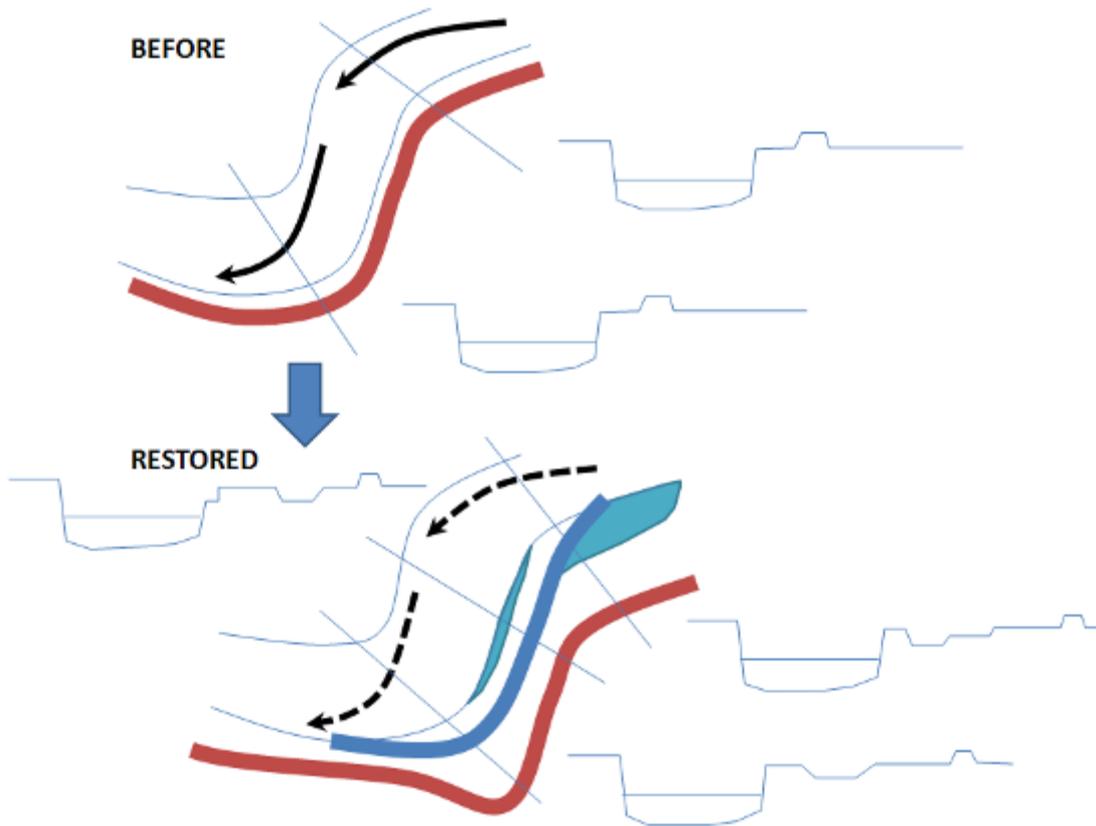
Figure 17. Effect of flood bank realignment and high level chute creation on the River Ribble.

The works delivered during phase II of the Long Preston Deeps Restoration Plan generally seek to lower flow energy in the main channel to reduce gravel mobility by diverting flow away from key erosive sites and providing more area for flood flows. This has been achieved through flood bank realignment, chute channel creation and floodplain lowering (Figures 17 to 19). Additional benefits from these actions include improved floodplain connectivity and floodplain palaeo-feature rejuvenation.

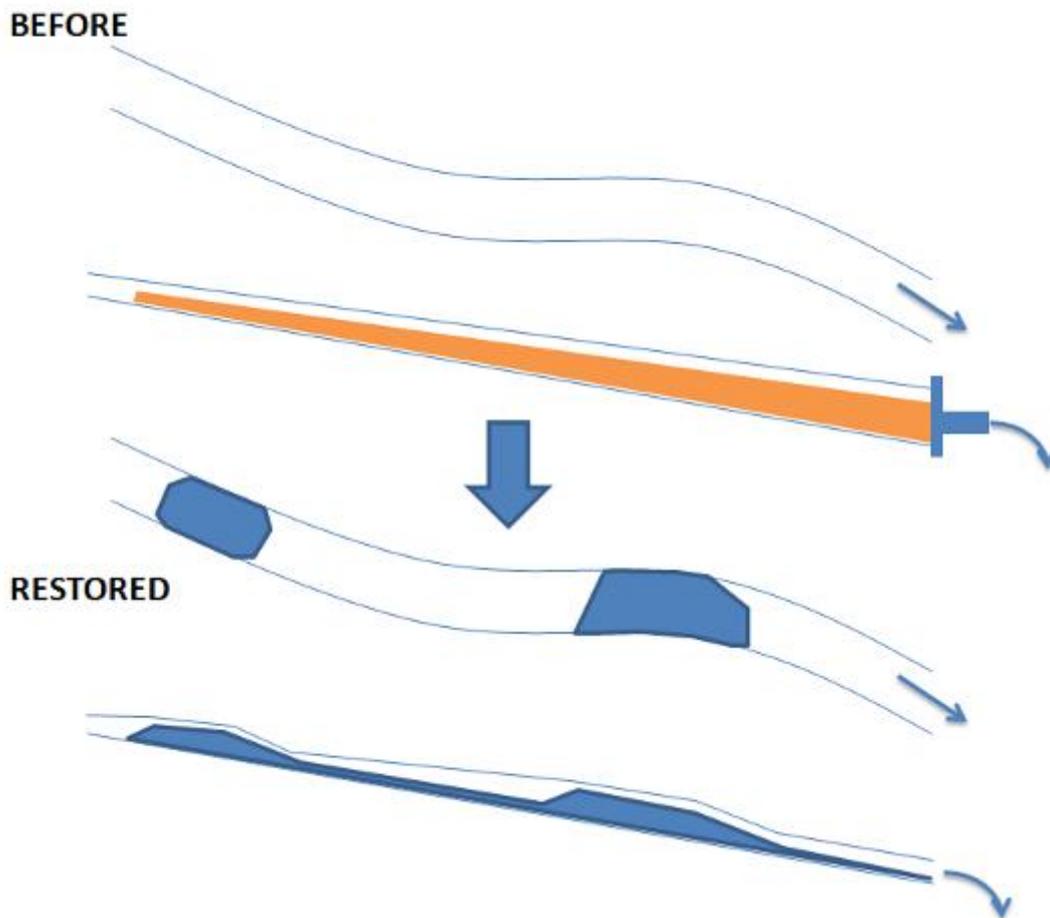
Figure 20. Effect of creating functional riffles on the Trout Beck.

Other local works have restored flow to an open watercourse and have created process conditions suitable for the maintenance of installed riffle units (Figure 20).
