Tyne Rivers Trust

River Don Obstructions – Detailed Design for Site Two

Don Improvement Project, Obstructions Site Two: The Dene, Weir 2

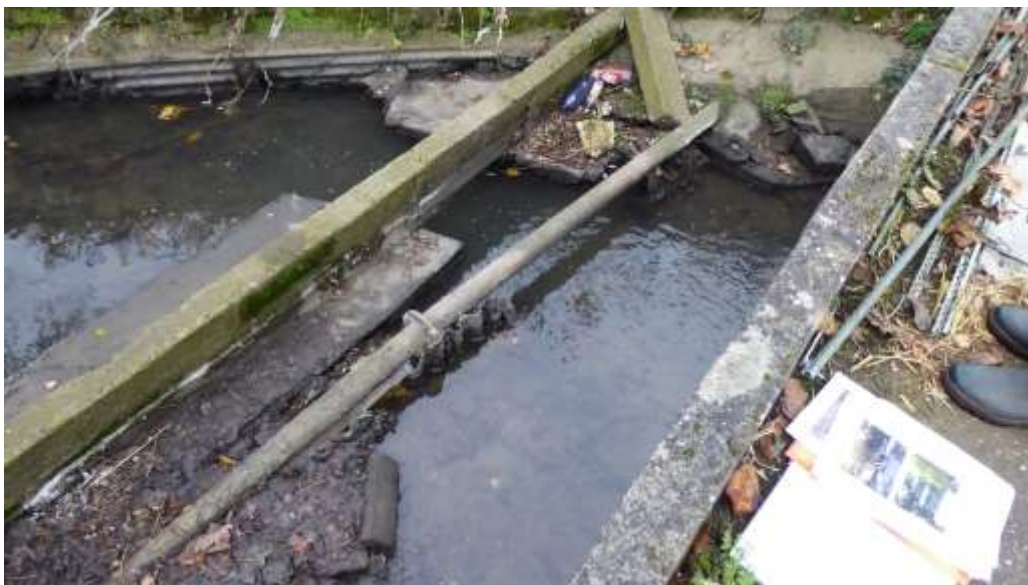
Site two, The Dene, comprises two structures side by side on the riverbed: a weir and a pipe. The pipe is upstream of the concrete weir which has a small gap through which low flows can pass when not blocked by debris. This obstruction was classified as a high priority by the Environment Agency and the Don Obstructions Optioneering Report (January 2018) highlighted weir removal as the preferred option for this site.

Figure 1: An image of Site 2, the second weir at The Dene.

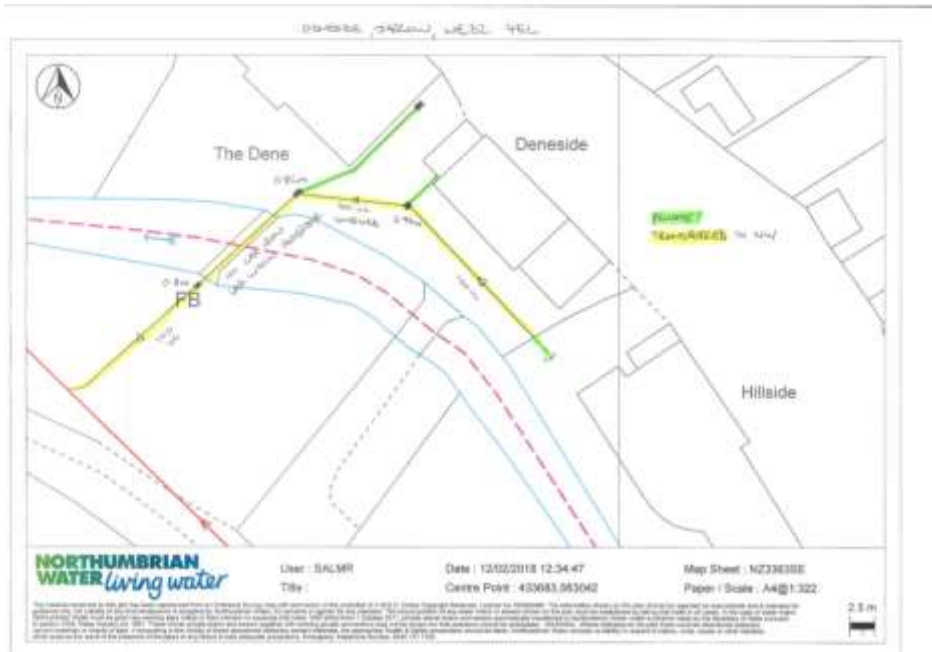
It was thought that the pipe carried sewage from the houses at The Dene across to the main sewage pipe on the left bank of the river. However, since the optioneering report was completed in January 2018, Northumbria Water have completed a pipe survey in the area and have concluded that the pipe does not carry either sewage or clean water to the houses in The Dene (see Figures 2 and 3).

Figure 2: The results of a pipe survey carried out in February by Northumbria Water showing that the sewage from the Dene is carried across the river in a pipe underneath a footbridge (pipe indicated in yellow).

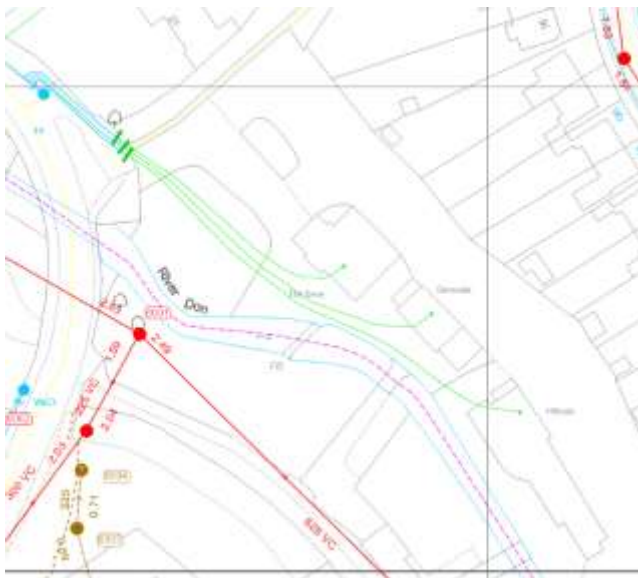
Figure 3: A Northumbria Water map showing the route, along the right bank, of the clean water pipes to The Dene.

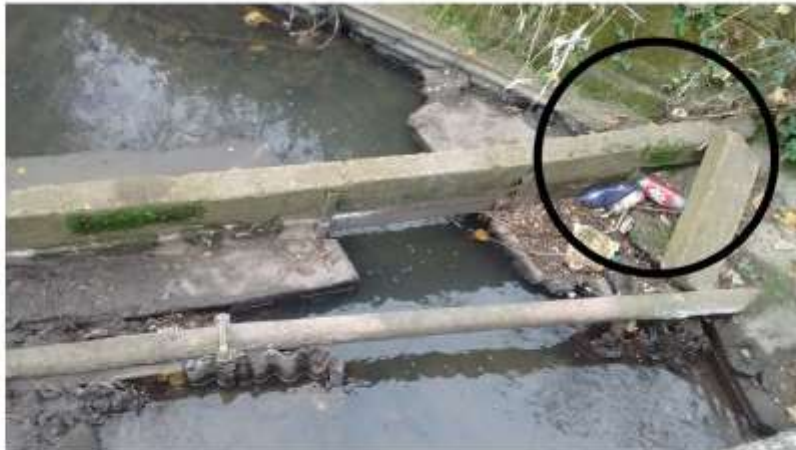
The discovery that the pipe crossing element of this obstruction is disused, makes the preferred solution: to remove the weir, cheaper, easier and more feasible. Further investigations have also revealed that the weir immediately upstream of the disused pipe, is not integral to the walls, but was a later addition (Figure 4).

Figure 4: This image shows the two structures comprising site 2, the black circle highlights where the weir has been joined to the bank walls at one side.

The fact that the weir has been added after the bank walls were constructed means that removing it is unlikely to cause damage to the bank walls, which are in reasonable condition at this location. The pipe and the weir can therefore both be carefully dismantled with the consent of the land owner and the obstruction removed.

- Establishment of site compound.
- Placing of straw bales downstream of the working area.
- All work will be carried out in the wet.
- Operatives with waders and life jackets will carefully break up the concrete weir.
- The arising material will be loaded into a digger bucket and removed from the river bed.
- Care will be taken to cut the steel pipe with cutting saw and removed.
- All waste material will be removed and recycled in the correct manor.
- Removal of the straw bales.
- Ground reinstated and site demobilised.
