River Wensum Restoration Strategy

Lenwade Mill to Wooden Footbridge, Lenwade – Reach 10a

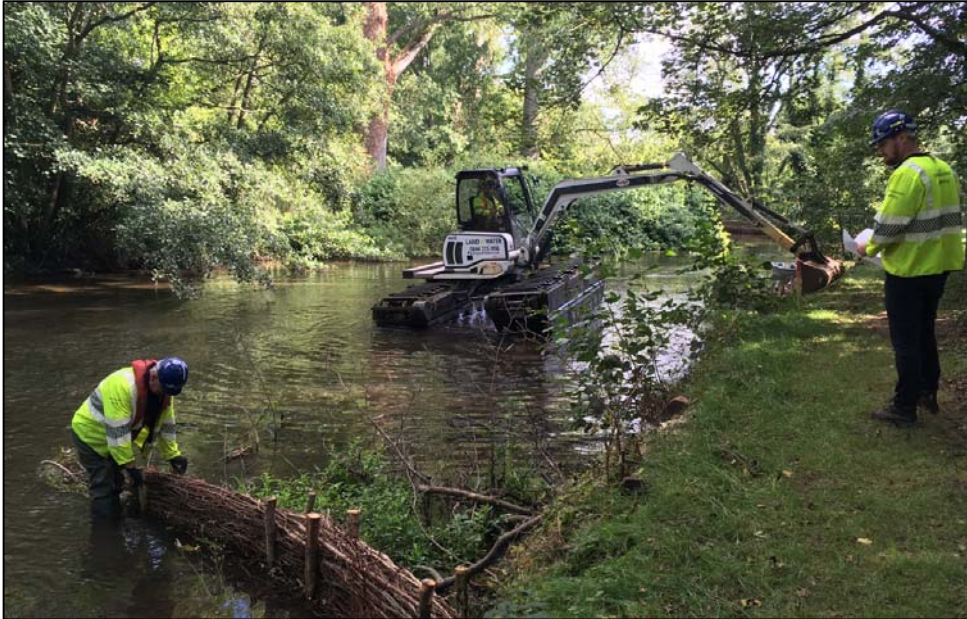
Amphibious excavator re-profiling bank profile.

Access for large plant and machinery has been restricted because of the adjacent floodplain lakes and trees. As a result the majority of the works has been completed by hand. An amphibious excavator has been used downstream of Porters Lane Road Bridge to re-profile the river bed / bank and assist installing woody material features.

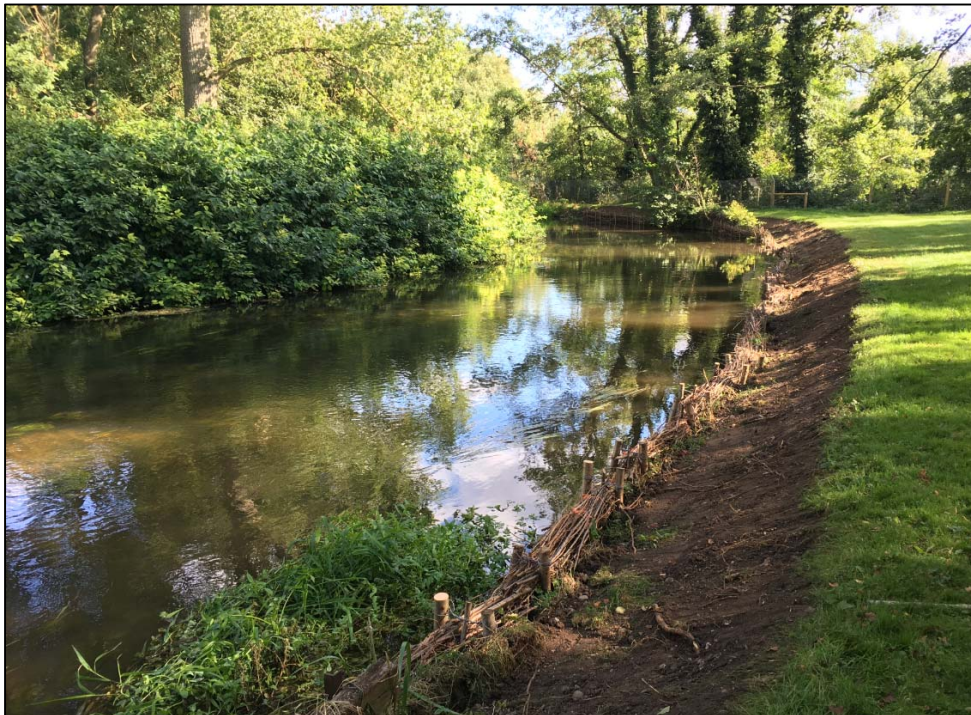
Steep banks suffering erosion has been re-profiled to encourage marginal vegetation to establish.

On areas of river bank showing signs of erosion, which are mainly located on the outside bends, we have pinned brushwood faggots approximately 0.5m from the bank. Using an amphibious excavator the river bank has been re-profiled to provide a gentler more natural bank angle encouraging wetland marginal vegetation to establish. Transplanting existing bank side vegetation and pinning Geojute 500 (a biodegradable low carbon geotextile) on recently seeded provided protection from high flows experienced immediately after the works were completed.
