Upper River Witham: Great Ponton

(including the Grange Farm channel re-alignment to create a naturalised river channel)

Location:	Great Ponton, Lincolnshire (south of Grantham)
Upstream Grid Refs:	Phase 1: SK930305; Phase 2: SK930290; Phase 3: SK926280
Length:	Phase 1: c450m; Phase 2: c2.5km; Phase 3 (channel re-alignment): 620m
Completion Date:	Phase 1: February 2013; Phase 2: July 2014; Phase 3 (channel re-alignment): August 2015
Cost:	Phase 1: c11K; Phase 2: c£30K; Phase 3 (channel re-alignment): c£80K
Partners:	These schemes were implemented by the Environment Agency in partnership with the Wild Trout Trust and Grantham Angling Association Fly Fishing Section (GAAFFS). They were made possible by the co-operation and agreement of the adjacent landowners (Stephen Jackson, Stoke Rochford Estate, Buckminster Estate)

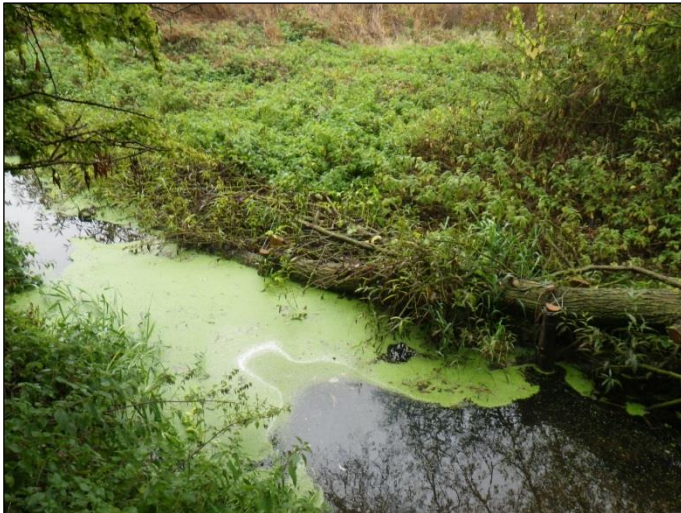
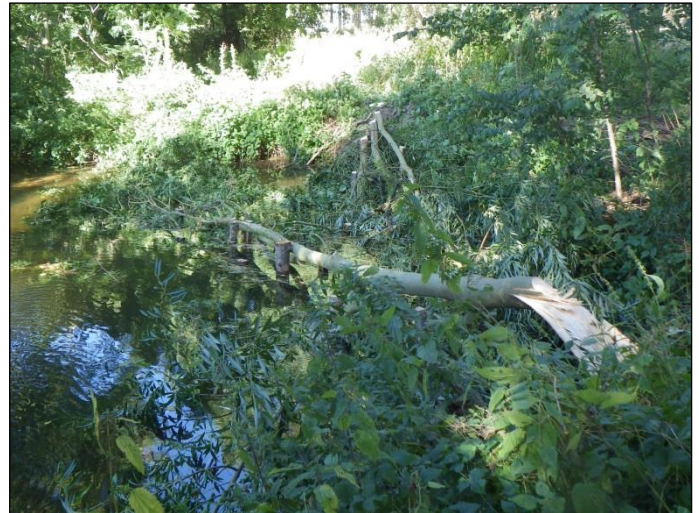
Fig 1 and 2. Examples of hinged and pinned bankside trees narrowing the channel

Several sections of the upstream (Phase 2) reach were heavily shaded by riverside trees. An important element of the scheme was to increase light levels to encourage the growth of emergent vegetation on the fine sediment that is accumulating at the channel margins - the growth of vegetation consolidates the silt as well as providing a trap for more fine sediments mobilised during high flows. Riverside trees were either coppiced to open up the channel and generate woody material which was used to create channel narrowing structures (see below), or hinged and pinned into the channel to create live flow deflectors. Some existing instream deadwood was also secured.

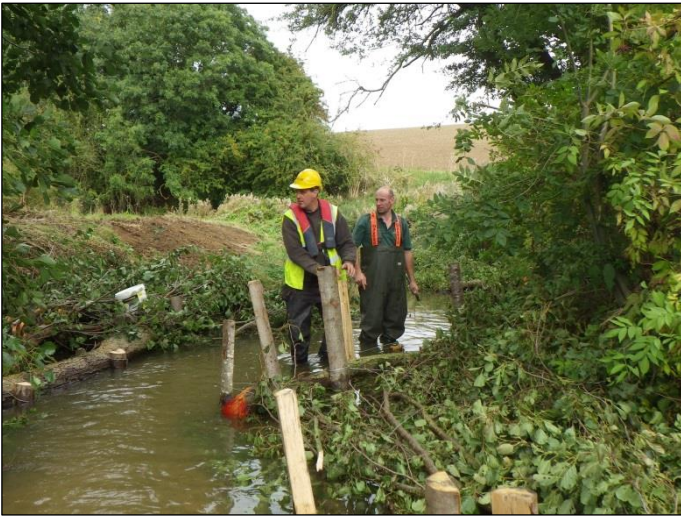
Fig 3. Log-faced brushwood mattress under construction

Log/faggot-faced mattresses: as above, but fully enclosed with either secured logs (generated from the riverside tree management) or faggots;

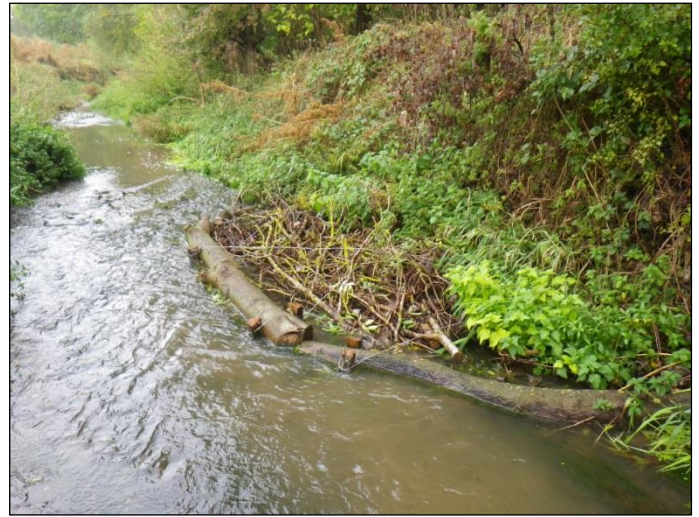
Fig 4. Completed log-faced brushwood mattress

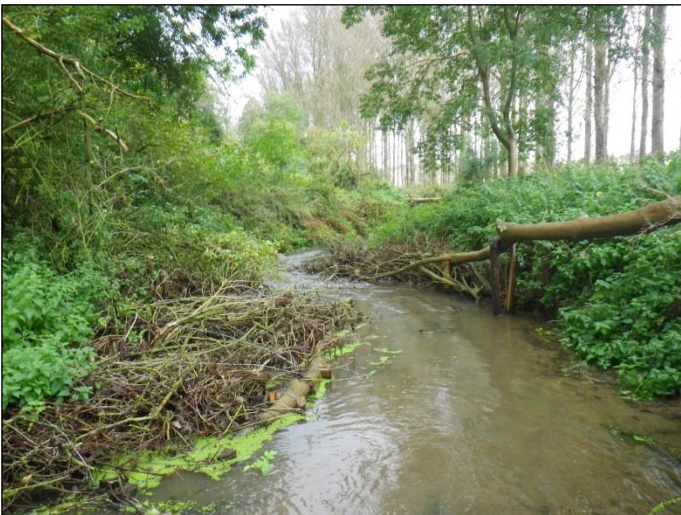
Fig 5. Log-fronted brushwood mattress (left bank)

Log-fronted mattresses: brushwood mattresses partially enclosed by secured logs leaving the downstream end open to create a “backwater” which provides a valuable fish/fry refuge;

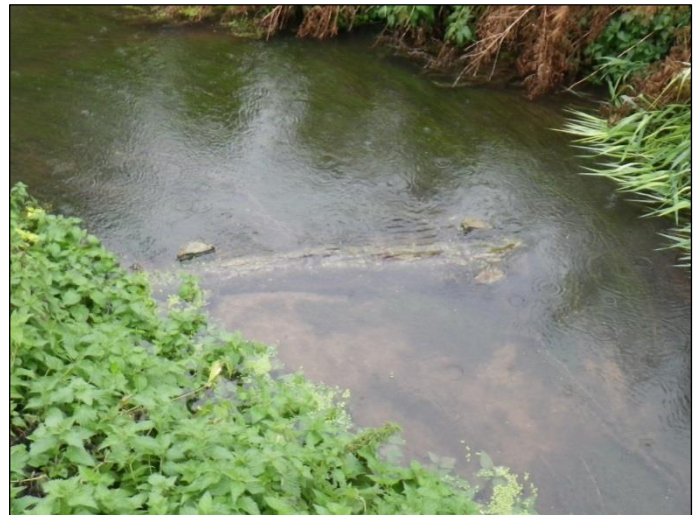
Fig 6. Log vane

Logs derived from riverside tree management were used to construct flow deflectors and vanes. Flow deflectors are partially exposed above the water level, but slope down at a very shallow angle towards the centre of the channel, and are designed to deflect the flow during typical flow conditions, effectively narrowing the channel. Vanes, however, are permanently submerged. Deflectors and vanes create localised flow variation, helping trap and retain gravels; improve flows over/through gravel beds to keep them free from fine sediment; and improve the bed structure through scouring. Both types of structure, either in pairs or singles, are normally angled upstream to direct the flow towards the centre of the channel and minimise the potential for bank erosion.

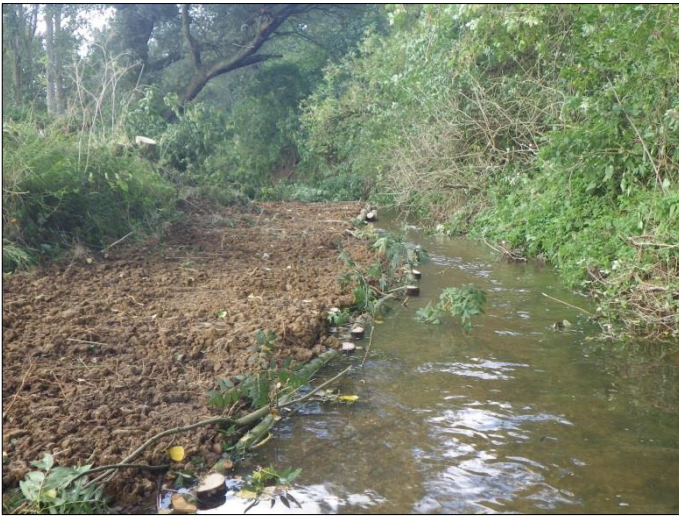
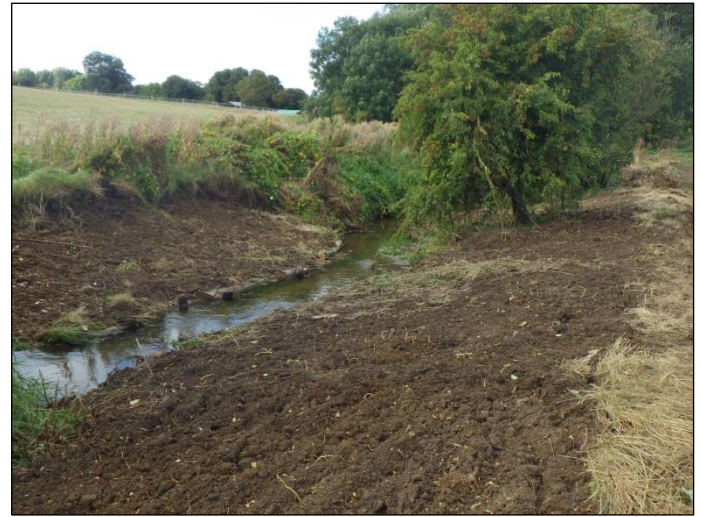
Fig 7. Sections of 2 stage channel created by reprofiling the bank against a new (a) faggot and (b) log bank toe.

This technique was used where the banks were high, eroded and/or where the river was over widened. A new bank toe was formed using secured logs or faggots to create a new bank toe and a narrower channel. The adjacent bank was then reprofiled to create a more gently sloping riverbank. This resulted in a bay/low berm behind the new toe and the creation of 2-stage channel, which was narrow during typical flows, but provides increased channel capacity as the water level rises.

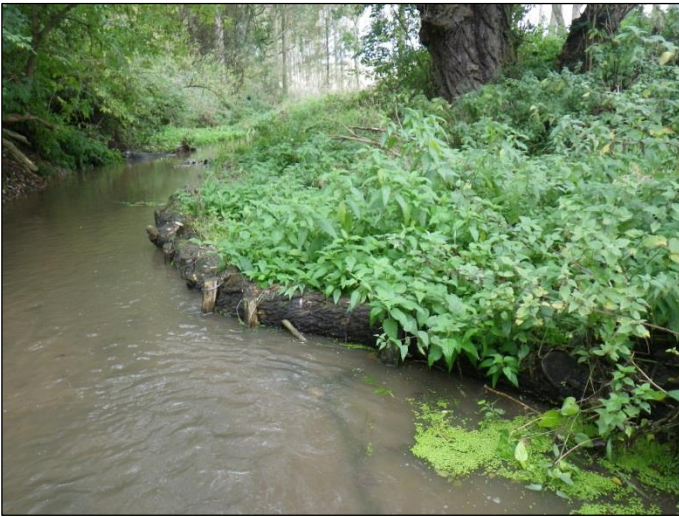
Fig 8. New berm stabilised by vegetation.

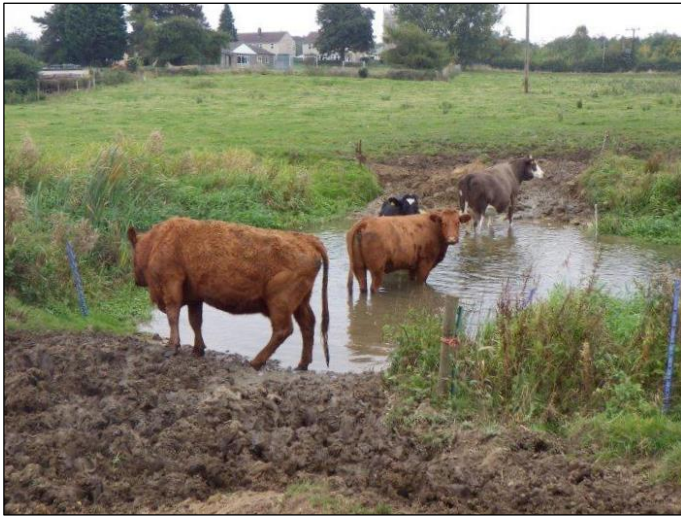
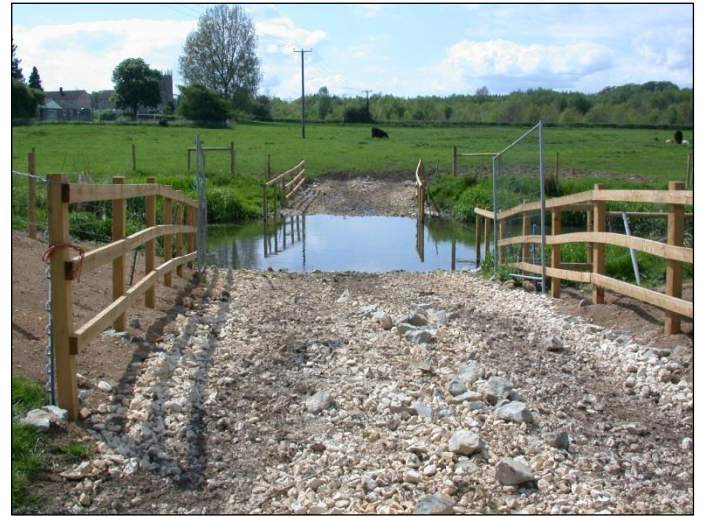
Figs 9. The ford downstream of Dallygate Lane (a) before and (b) as the refurbishment was nearing completion

Between Dallygate Lane and Great Ponton Mill the river is crossed by a ford which also functions as a cattle drinker for both banks. Prior to refurbishment the ford was in poor condition with bare, severely poached and eroded earth access ramps and nothing to prevent cattle access to the river upstream and downstream. Refurbishment involved reprofiling the access ramps and consolidating the slopes and crossing point with crushed limestone to create a porous hard-standing. Post and rail fencing was erected to control access to the ford and electrified “scare-wires” now cross the river to discourage cattle access to the river channel.

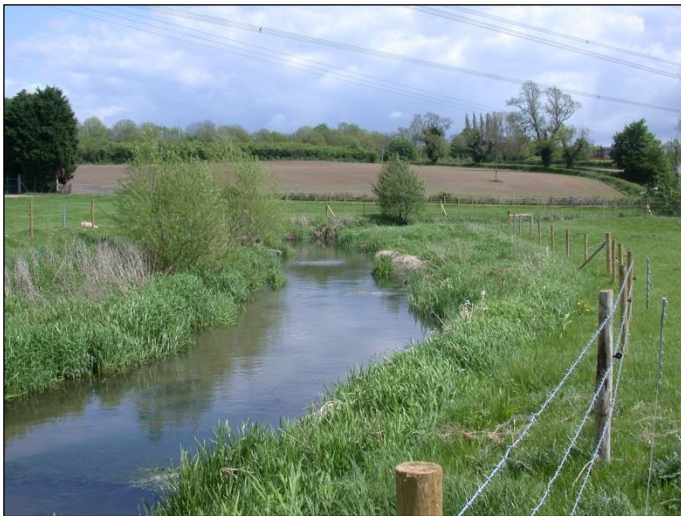
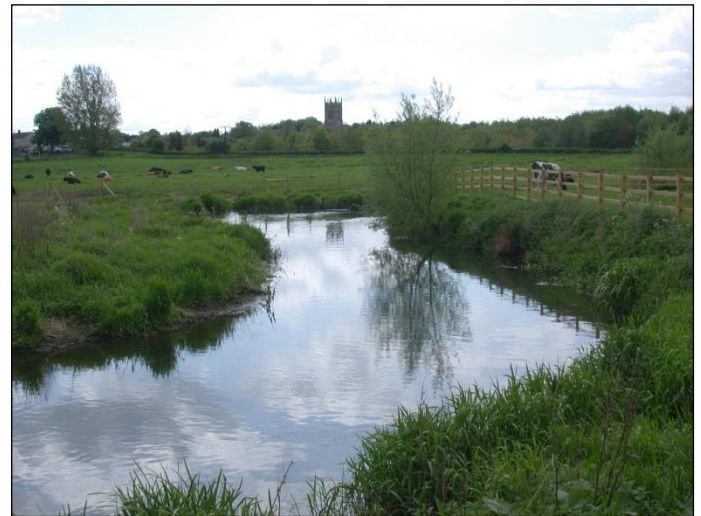
Fig 10. Wide, wet, vegetated berms protected by (a) post and wire and (b) post and rail fencing

Accumulation of sediments along the banks has naturally narrowed the channel upstream of the mill and bypass channel and, as a result wide, vegetated, wet berms are developing along both banks. To prevent cattle from overgrazing and poaching these important wetland margins the banks have been fenced with post and 3 lines of barbed wire and a section of post and rail fencing in the paddock closest to the farm buildings. Post and wire fencing was also erected along the right bank either side of the refurbished ford. No additional fencing was installed during Phase 2 of the scheme.

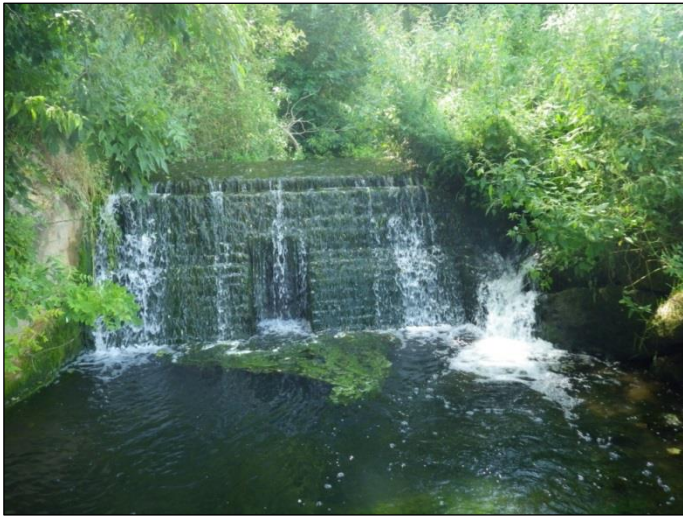
Grange Farm Weir was constructed in the mid-19th century. Its purpose was to impound a section of straightened river channel to provide a head of water to power a, now redundant, hydraulic-ram water supply to Grange Farm. The Grange Farm project involved the bypassing of this weir by restoring the river to a more natural planform.

Fig 11. Grange Farm Weir

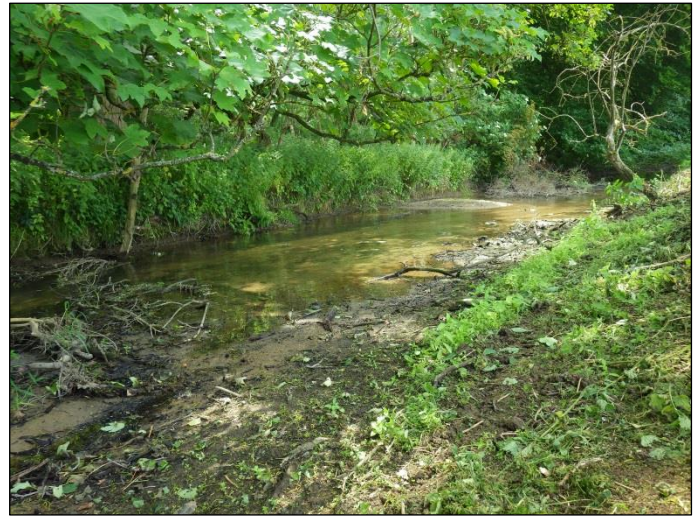
Prior to the restoration work the straightened channel, impounded by the weir, was ecologically degraded, morphologically uniform and suffering from heavy sedimentation, with fine silt bed deposits in excess of 1m thick. The degraded condition of the impounded reach contrasted sharply with the unmodified, meandering and morphologically diverse gravel bed of the reach immediately upstream.

Fig 12. The course of the river prior to realignment

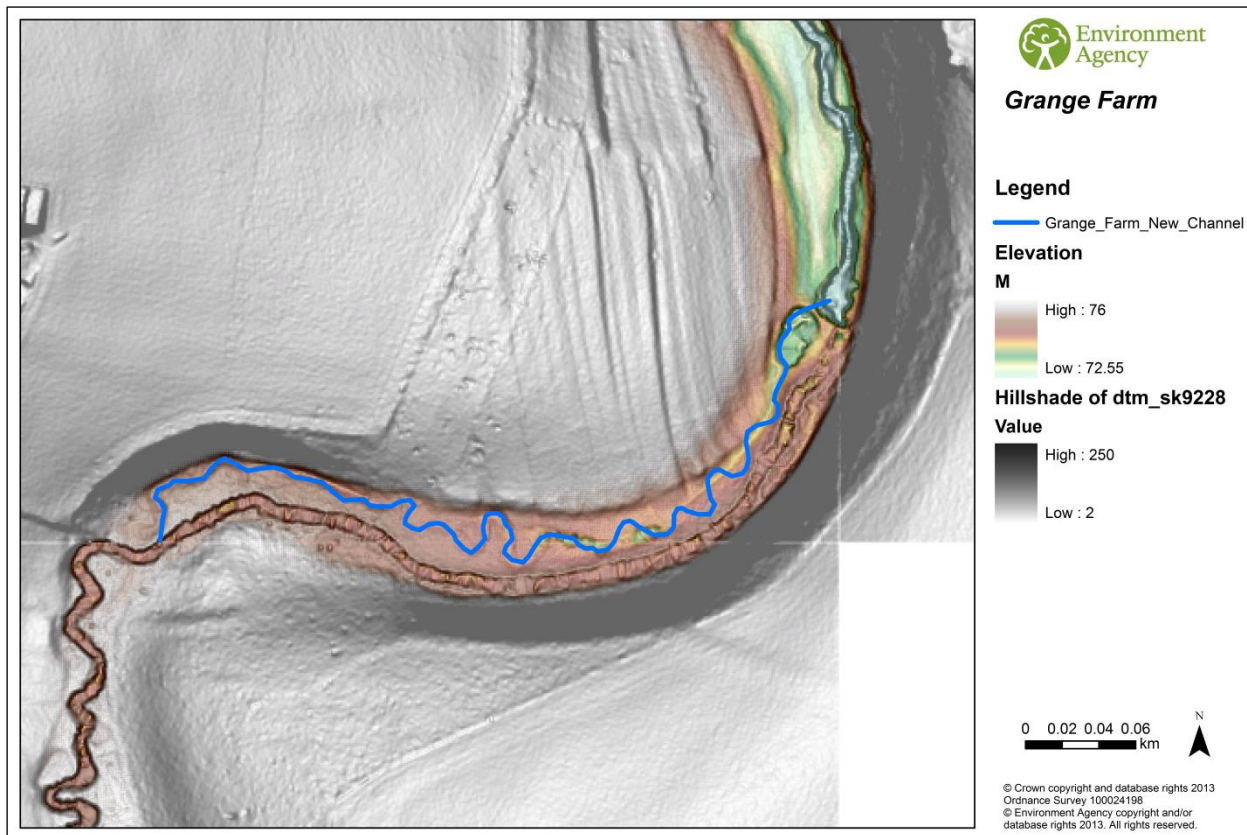
Fig 13. Topographical image generated from LiDAR data showing the designed alignment of the restored channel

Landscape evidence also informed the design. Site walkovers and LiDAR survey data identified clear evidence of the former course of the river and this information was used to design the shape of new, meandering river channel. The new channel design also incorporated an extended pool-riffle sequence. This is the natural form that would be expected of the river here and it provides the basic frame of the new channel.

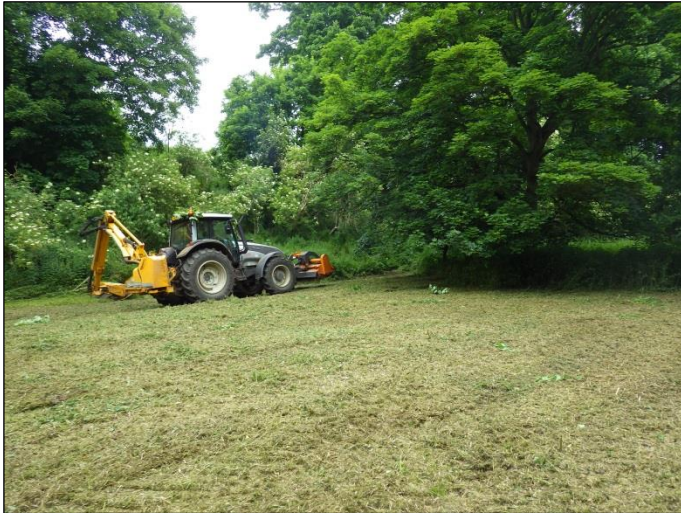
Fig 14. Initial mowing of the working area

The fields were mown prior to the works and the new planform of the river and the locations and levels of the riffles and berms were set out on the ground. The excavation of the new channel took 9 weeks, with excavated material being stockpiled either side of the new course and along the length of the straightened channel above the weir. With the new channel still dry, gravel was introduced to create a series of 26 riffles, before the connection was made at the upstream end and water was introduced into the new channel for the first time. Finally, with the river now running over its new course and leaving the weir in situ, excavated soils were used to infill the former channel and excess material was reprofiled higher up the floodplain.

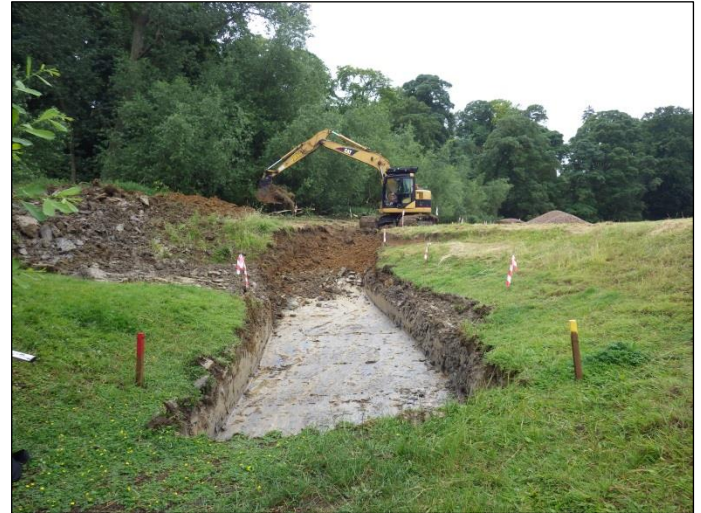
Fig 15. Start of the channel excavation following pegging out of the planform on the ground

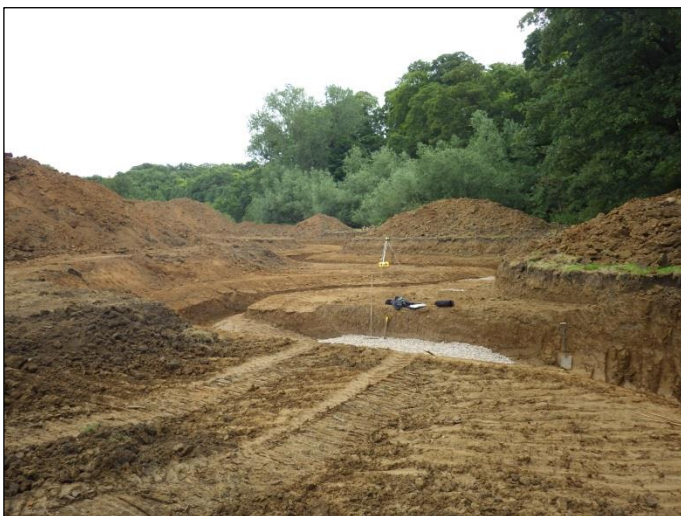
Fig 16. The meanders and berms are taking shape

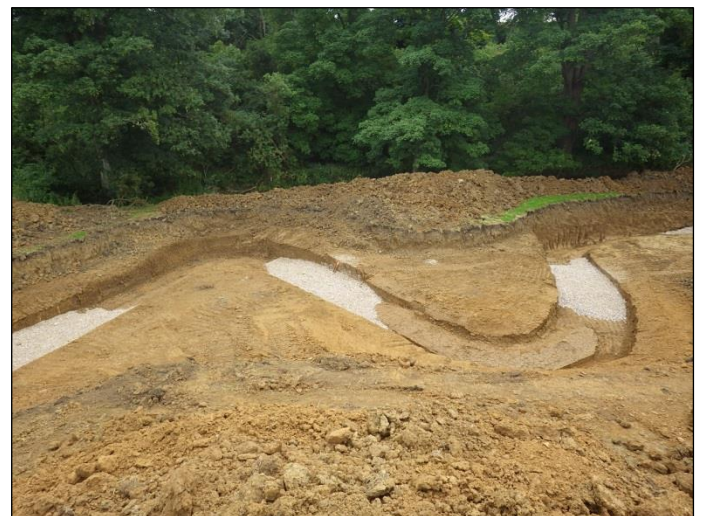
Fig 17. Gravel was introduced at predetermined locations while the channel was still dry to form the pool- riffle sequence

The new riffles are carefully located to control the flow over the now shallower bed gradient – the length of the channel has been increased by 150m (c30%) as a result of the works - and the riverside berms create a 2-stage channel that increase connectivity between the river and its floodplain.

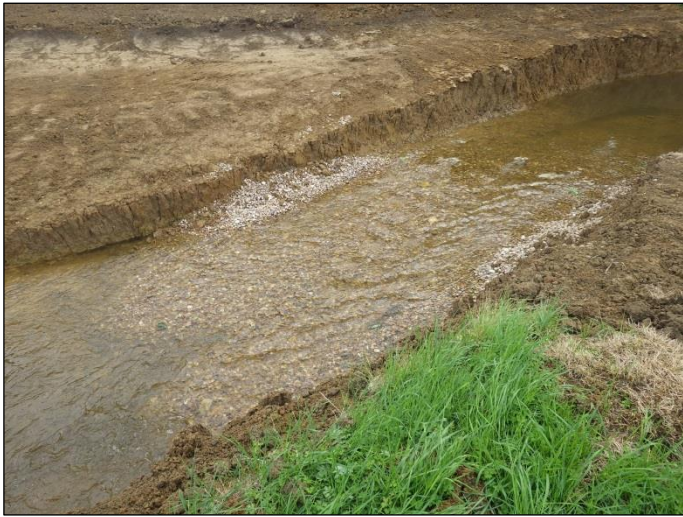
Fig 18. One of the new riffles

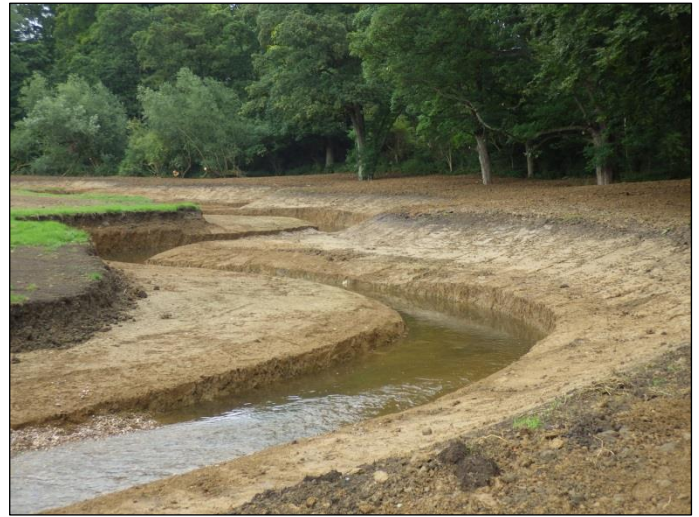
Fig 19. The meandering channel and berms (2-stage channel)

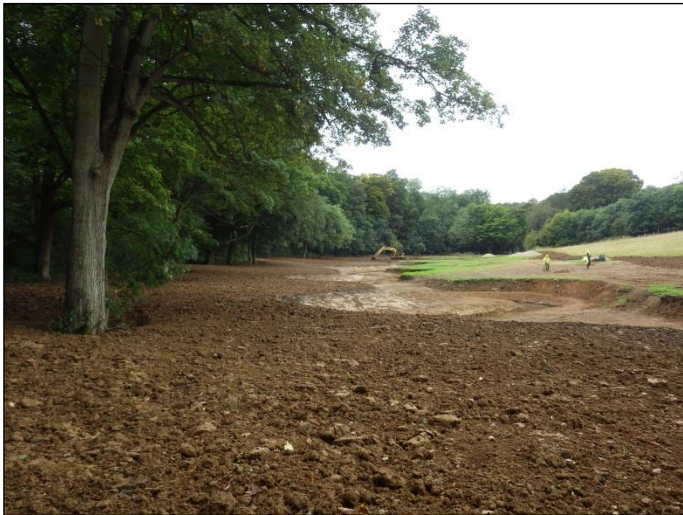
Fig 20. Reprofiling the excavated soils

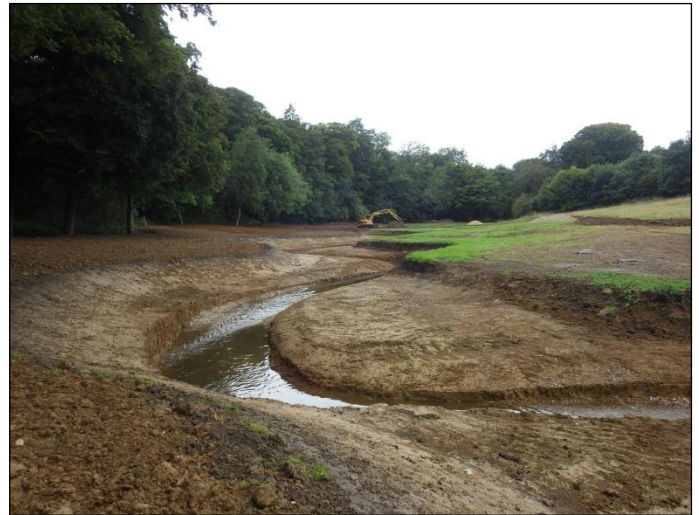
Fig 21. The completed scheme

The completed scheme delivers multiple environmental and ecological benefits, including re-establishment of fish passage (a Water Framework Directive priority), increased geomorphological continuity, and a diverse and healthy aquatic environment for fish and other aquatic life, in particular white-clawed crayfish.
