River Witham - River Restoration Case Study

| Catchment & Waterbody: | Upper Witham. Manthorpe | |
| Location: | Manthorpe, Grantham | |
| Upstream Grid Ref: | SK9222737685 | Completion Date: November 2021 |

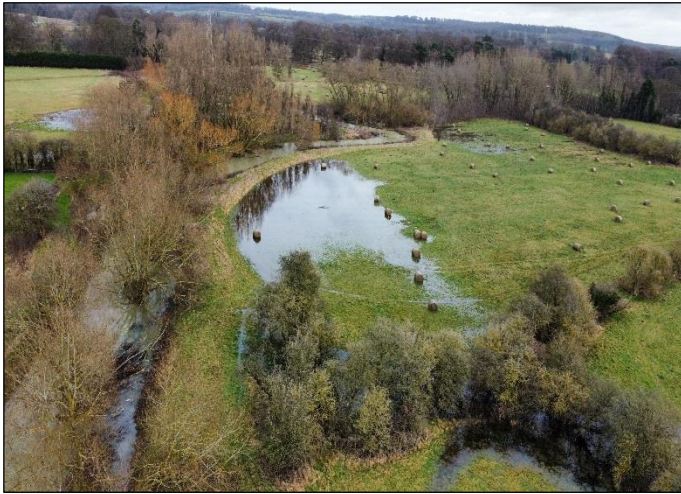
Fig 1. Before (Feb 2021). High water event and heavy rain had caused the Witham to come out of bank further downstream overtopping defences – at Manthorpe flood water didn't occupy the floodplain but instead the defences prevented surface water draining into the Witham

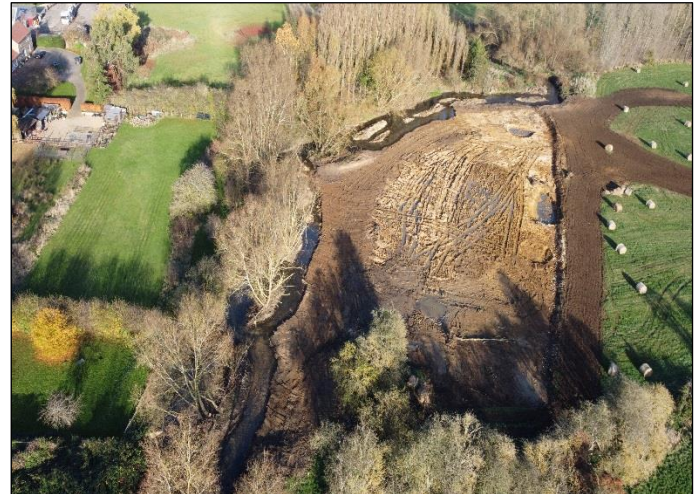
Fig 2. Post works – (Nov 2021). Flood embankments removed from floodplain and part of floodplain lowered by 30cm with ponds and scrapes added to increase habitat types. The floodplain is terraced with a lower more frequently inundated landscape close to the river and then gently rises up towards the valley sides which will inundate less frequently but in higher flood event magnitudes..

4200 m3 of earth was removed from the floodplain during the lowering and removal of embankments. Reconnecting the floodplain has created 19,500m3 of space for water which now reconnects to the lower floodplain frequently after intense rainfall events at a 1 in 2 event magnitude. Brown trout have already been observed spawning on the new limestone gravels. Crayfish monitoring was carried out pre works and showed a very low baseline population with only 6 individuals caught, repeat monitoring of this will be carried out along with repeat bird surveys of the site.

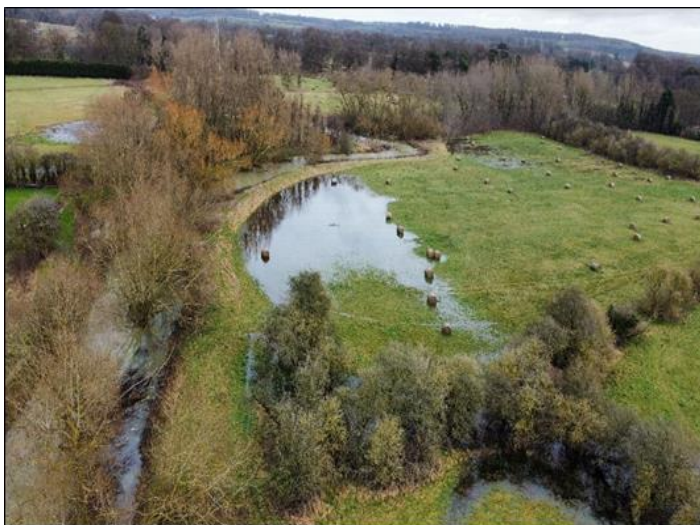
Fig 3. The presence of the historic floodbanks are counter productive for land drainage and improvement. The floodbanks might protect floodplain from inundation from river but trap surface water run off behind the banks reducing drainage of land. The Witham is a ground water fed river which naturally has a high water table and despite considerable effort to drain this landscape through deepening of river and flood banks has not achieved aims of improving agricultural yields and has left the river unable to recover ecologically without significant intervention,

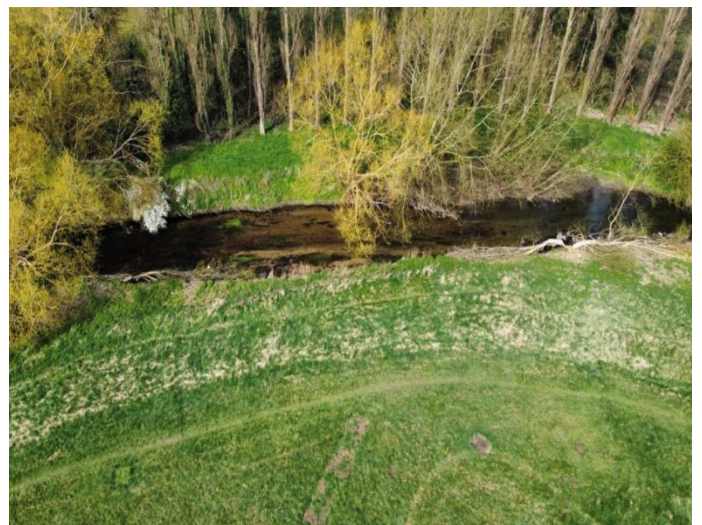
.Fig 4 – Pre restoration works aerial shot showing embankment in situ and hinged trees in channel.

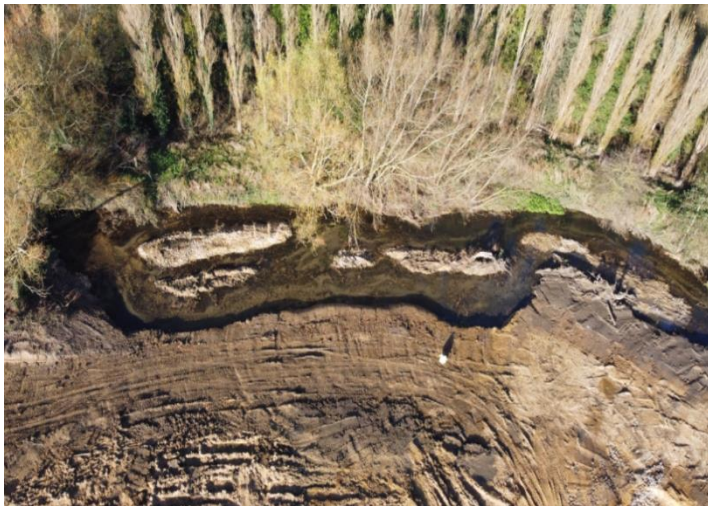
Fig 5. Post works showing channel widening, gravel riffle, island and point bars installed and multiple threaded channels installed with woody material secured in the river and on floodplain..

- Addition of riffles and gravel supply in the form of point bars and islands and splitting of channel into multiple threads creating a more natural form and allowing the river space to adjust to changes in flow but also allow natural processes like silt deposition, channel evolution, less intensive management, woody material to be retained in channel and on flood plain. The gravel raises the bed helping to connect the river into the floodplain reducing the amount of spoil generated to lower floodplain as well as providing rich habitats for riverine wildlife.

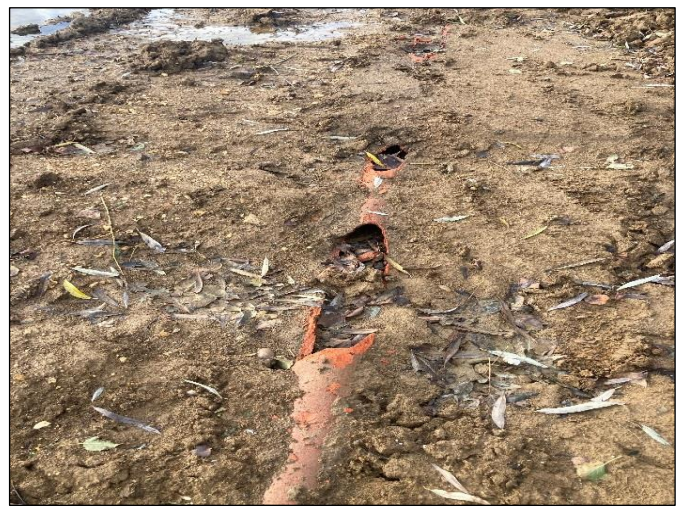
Fig 6. Modern historic land drains uncovered during floodplain lowering to try to drain and improve unsuitable heavy clay soils for agriculture.

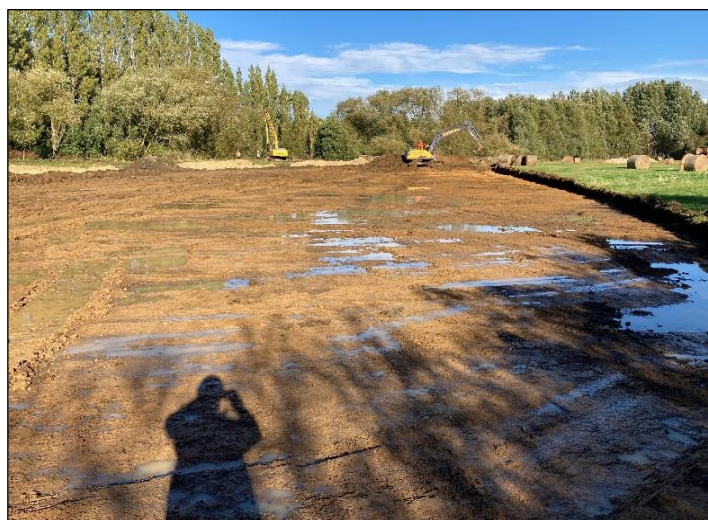
Fig 7. Two stage floodplain with a lowered inset floodplain that will inundate more frequently and then the un lowered floodplain with grass still present to right of image. In places the floodplain was predominantly clay and scrapes were installed over the impermeable geology.

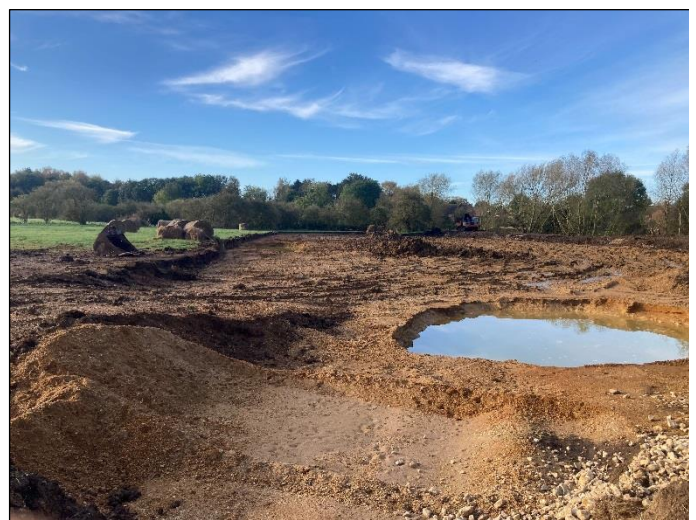
Fig 8. Floodplain ponds and scrapes added to create habitat diversity. Floodplain and top of valley where spoil was spread has been reseeded with native wildflower mixes to maximise benefits for pollinators and biodiversity.

- Creation of floodplain ponds and terrestrial habitat features like habitat piles, stone piles for hibernacular, and woody material on the floodplain to encourage further hydraulic roughness in high flow events

- Spreading of spoil over the top of the valley sides outside of the floodplain, this was then reseeded with appropriate wildflower grassland mix and provides pollinator benefits.

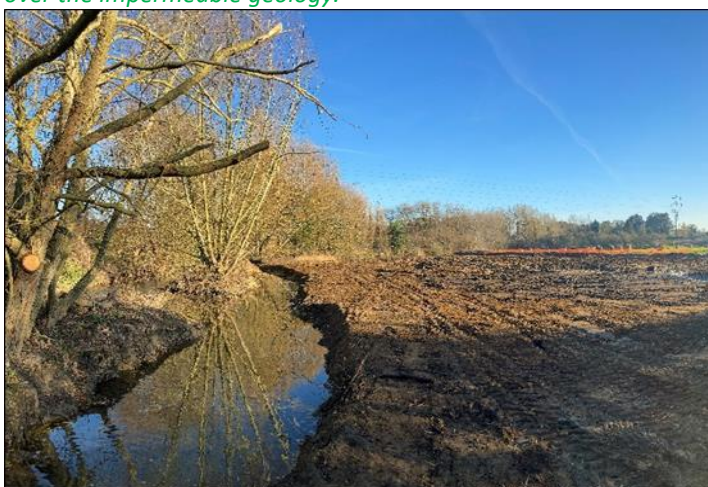
Fig 9. The newly restored multiple threaded channel. Low spots and ponds placed directly upstream of existing willow pollards. These trees if left unmaintained could then allow the river to evolve and change its shape providing new niches and habitats for life to colonise.

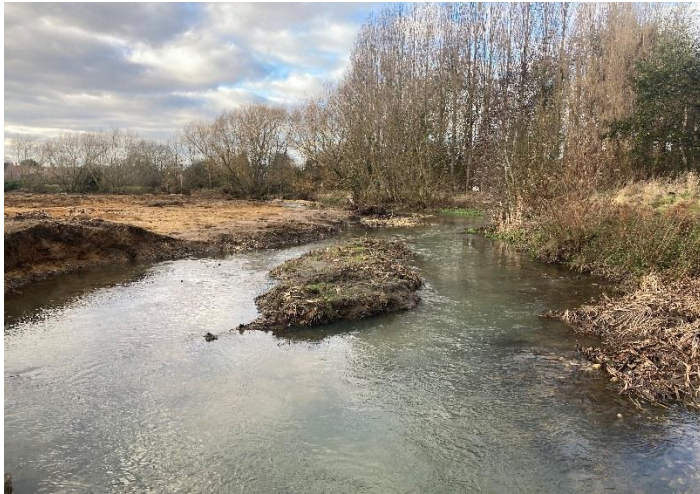
Fig 11 The shows difference in height of historic embankment and of the newly lowered inset floodplain to illustrate what a well-connected floodplain should look like. ,

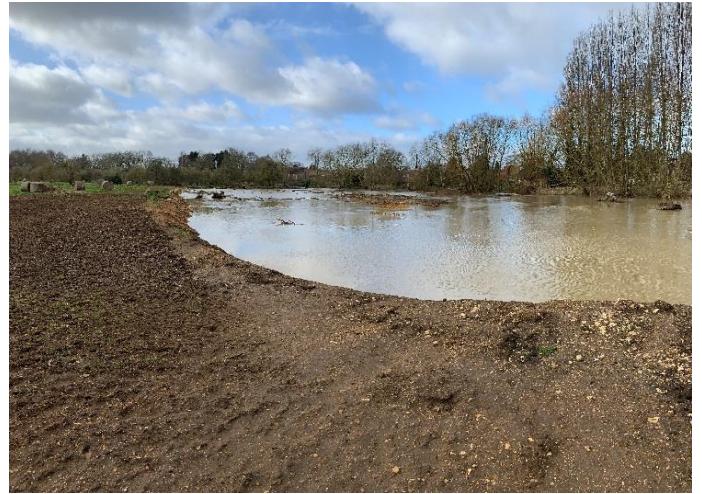
Fig 12 showing floodplain inundating and storing flood water after storm Franklin and Eunice.

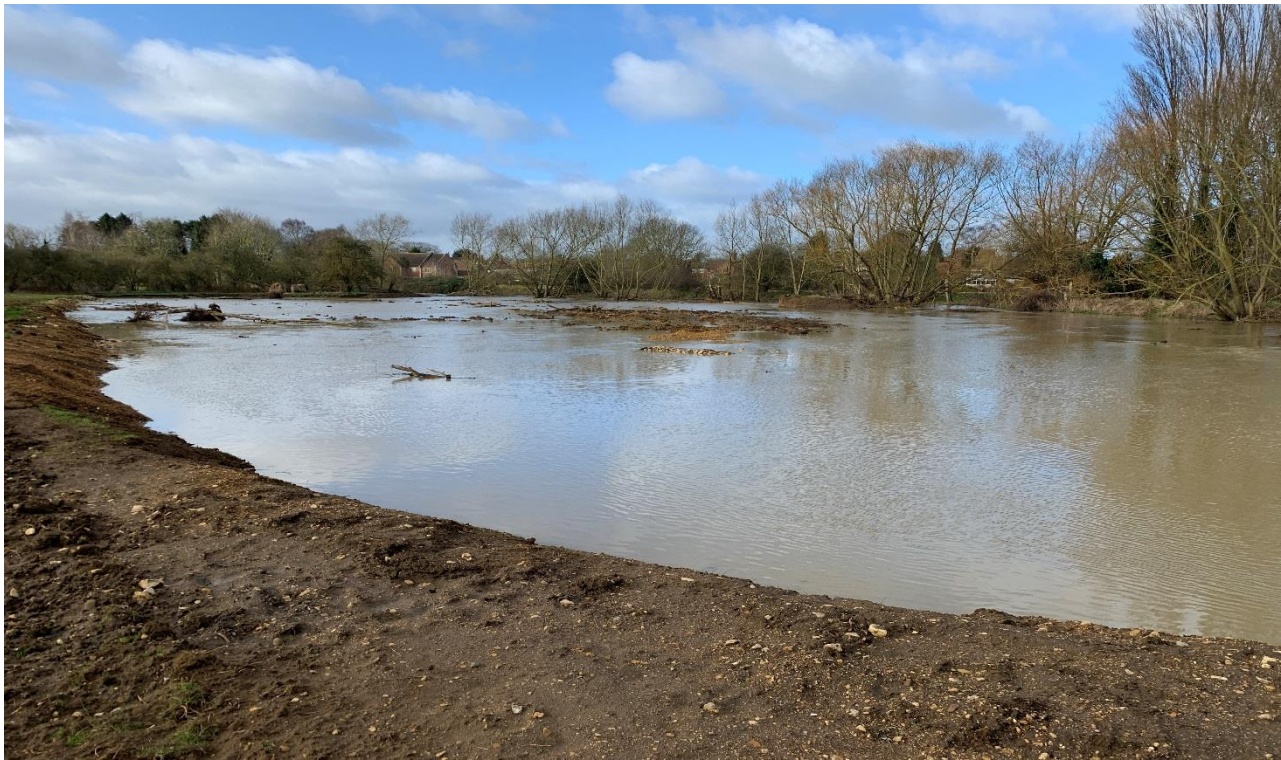
Fig 13 River occupying floodplain note the absence of distinct flow pathways across the floodplain, the added roughness of woody and uneven floodplain slows the flow of water downstream and encourages fine sediment deposition whilst providing fish and invertebrates calm water to shelter from the higher flows in the channel.
