Elton Backchannel

Location: Elton, Peterborough

Completion date: May 2018

Summary of activities

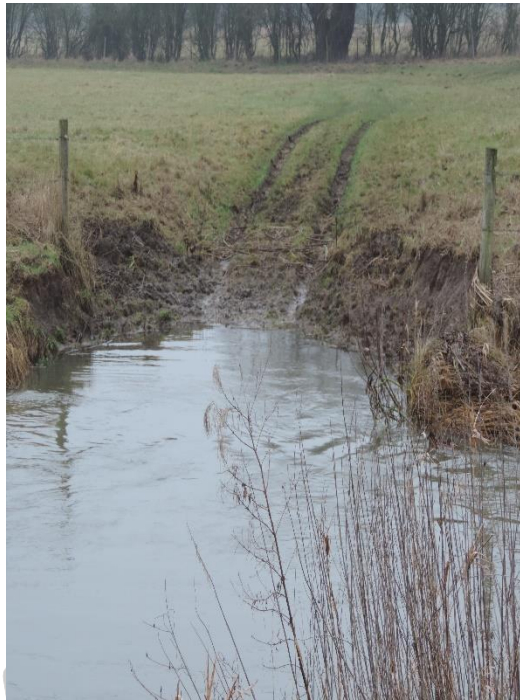
Figure 2 Elton ford prior to this project

Remedial work was completed on the ford to reduce fine sediment and nutrient inputs as a result of cattle crossing and congregating on the ford. The eroded ramps sides and the ford ramps were stabilised by re-profiling them to reduce the angle of the batter by having a base layer of 100-150mm of granite laid down with a top layer of 4-20mm of crushed granite being 'tracked in' after. This provides the cattle with a comfortable base to walk on when they are moved across the channel and the ramps were grass seeded after. The granite was placed no further than the face of the bank. The 'wet' bed of the ford was not be re-stoned to minimise further mobilisation of fine sediment.

A 360 tracked excavator with a suitable reach, operated by a qualified driver was used to carry out this work. "Clean" stone was specified to minimise the introduction of fine sediment to the water course. Stone was delivered by lorry to the ford. Prior to placement the stone was thoroughly re-washed using river water poured from the excavator bucket leaving any residual fine sediment on the bank. Figures 2 and 3 show a before and after comparison of the remedial work on the ford. The new ford is now suitable for cattle to cross with the newly lined ramps and the re-profiled banks.

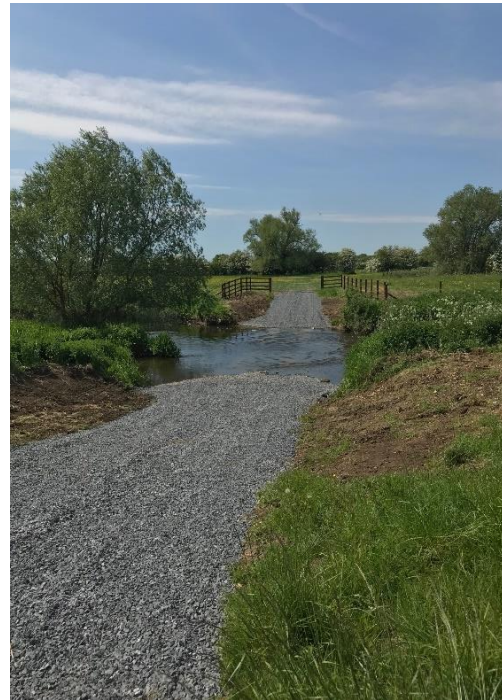
Figure 3 Elton ford after the works had been completed

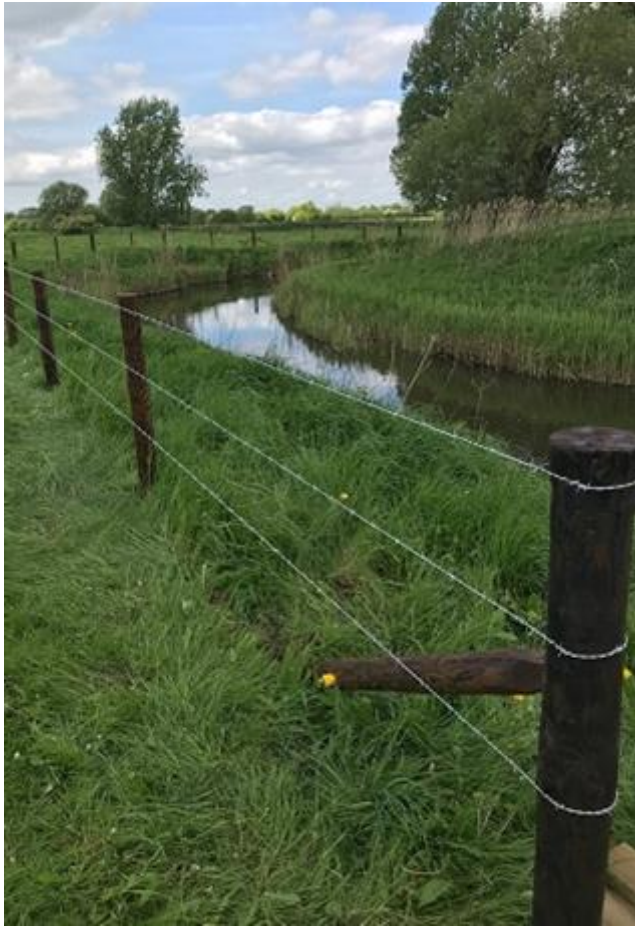
Figure 4 New fencing installed at Elton

The post and barbed wire fencing was previously in poor condition on the right bank and in places had collapsed. A new fence line was erected 1m back from the original line, the fencing was upgraded to 3 strands of barbed wire to minimise cattle damage and reduce the likelihood cattle would attempt to breach it. Angler access points were upgraded from a “pipe” crossing to a simple treadless post and rail stiles. Heavy duty post and rail fencing at the top of the banks either side of the ramps that lead down to

the ford were erected and access gates were installed to prevent cattle access. Overall, over 600 metres of fencing was erected.

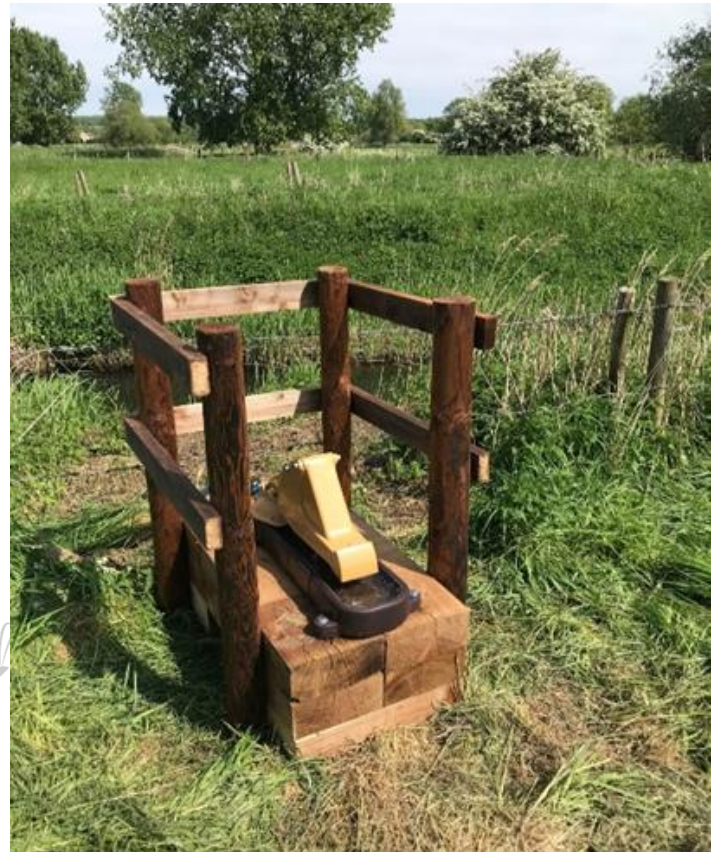
Figure 5 One of three pasture pumps installed at Elton

Due to the fencing of the ford and new fence line running along the length of the river a new water supply was required on the left-hand bank. Three pasture pumps were installed for the cattle to drink from as this was deemed the most efficient method of providing water for the cattle. These devices are a very low maintenance way of providing water for cattle as the cattle operate them by pushing the pump with their nose as they drink from the small trough.
