RESTORING MEANDERS TO STRAIGHTENED RIVERS

1.6 Opening up a culverted stream

RIVER RAVENSBOURNE

LOCATION - Norman Park, Bromley TQ 412 674

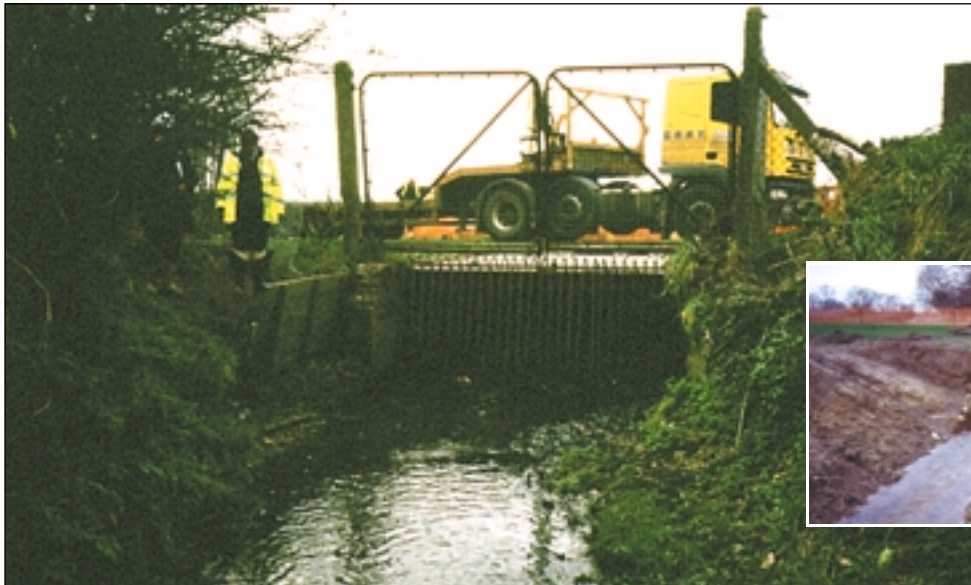
View of headscreen prior to removal

Justification for the design was threefold: reduction in costly maintenance for a culvert, the removal of a trash screen that also required regular clearing and was a health and safety issue, and an increase in flood storage.

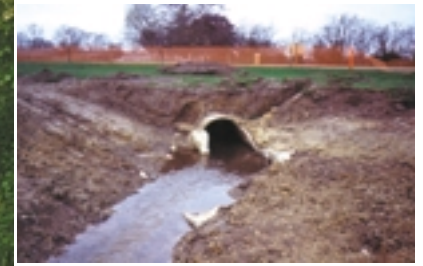
'Daylighting' of the Ravensbourne

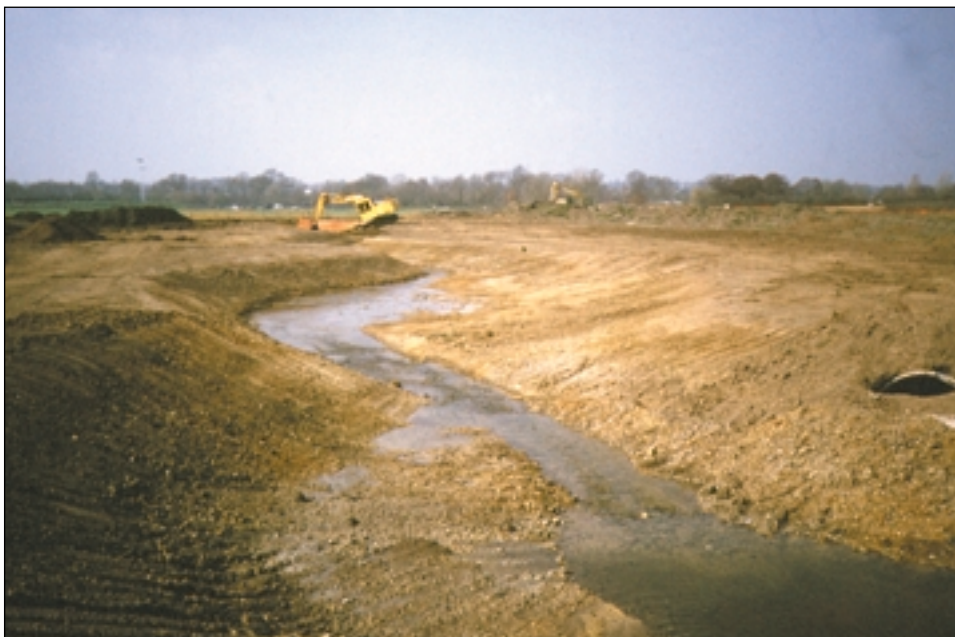
Looking downstream at the shallow bank slopes. The severed culvert still visible

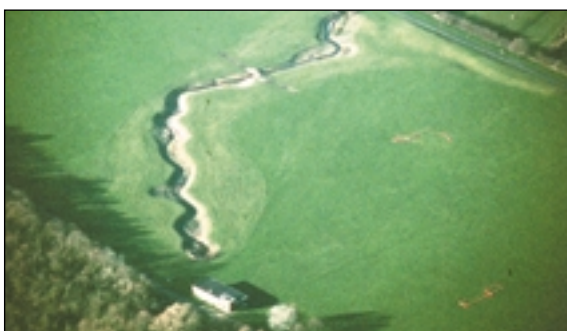
The new sinuous course and extent of wildflower seeding

The new course is 12.5% longer than the culvert, sinuous, with varying bed and top-of-bank widths. A shallow (1:8 batter) 'beach' area, as a result of an exposed gravel lens, and new meanders (1:5 inside batters) form the focal points for access to the stream.

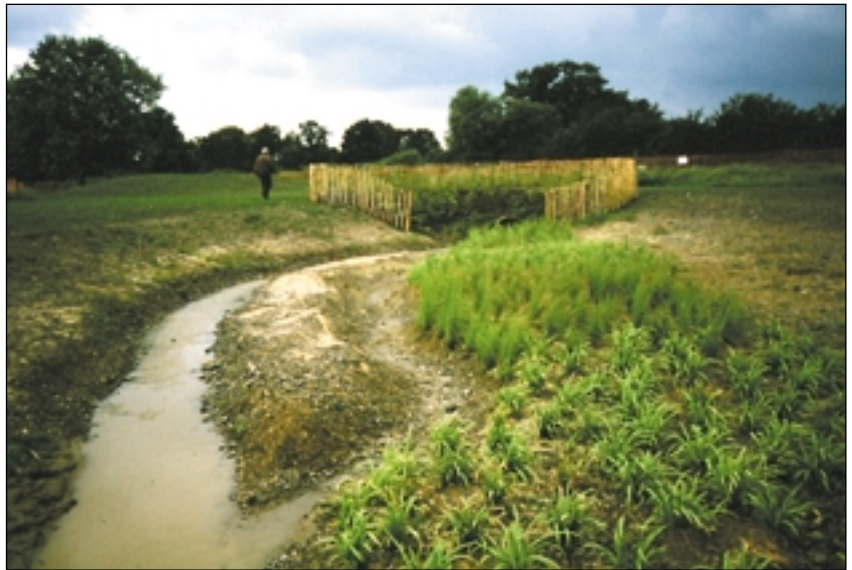
Planting up the 'wet berm' area and shielding the culvert entrance with shrub planting

Topsoil was not replaced on the riverbanks in order to attain a low fertility substrate suitable for the natural colonisation of wildflowers and plants from upstream. A 'buffer zone' between the amenity grassland and the top of the bank was seeded with a low-density wildflower mix from an approved source. This creates a visually pleasing edge to the playing fields and provides a suitable seed source for the banks. On the river's edge native provenance marginal plants were specified from a carefully sourced local nursery. School children were involved in some of the marginal planting. Wildflower plugs were also planted. The culvert entry and exit were both screened using a variety of native shrub species.
