# Wetlands

# Restoration of drained mires in the Šumava National Park

# Restoration of the mined peat bog Soumarský Most

# Revitalising effects of near-natural bypass at a migration barrier on the Blanice River

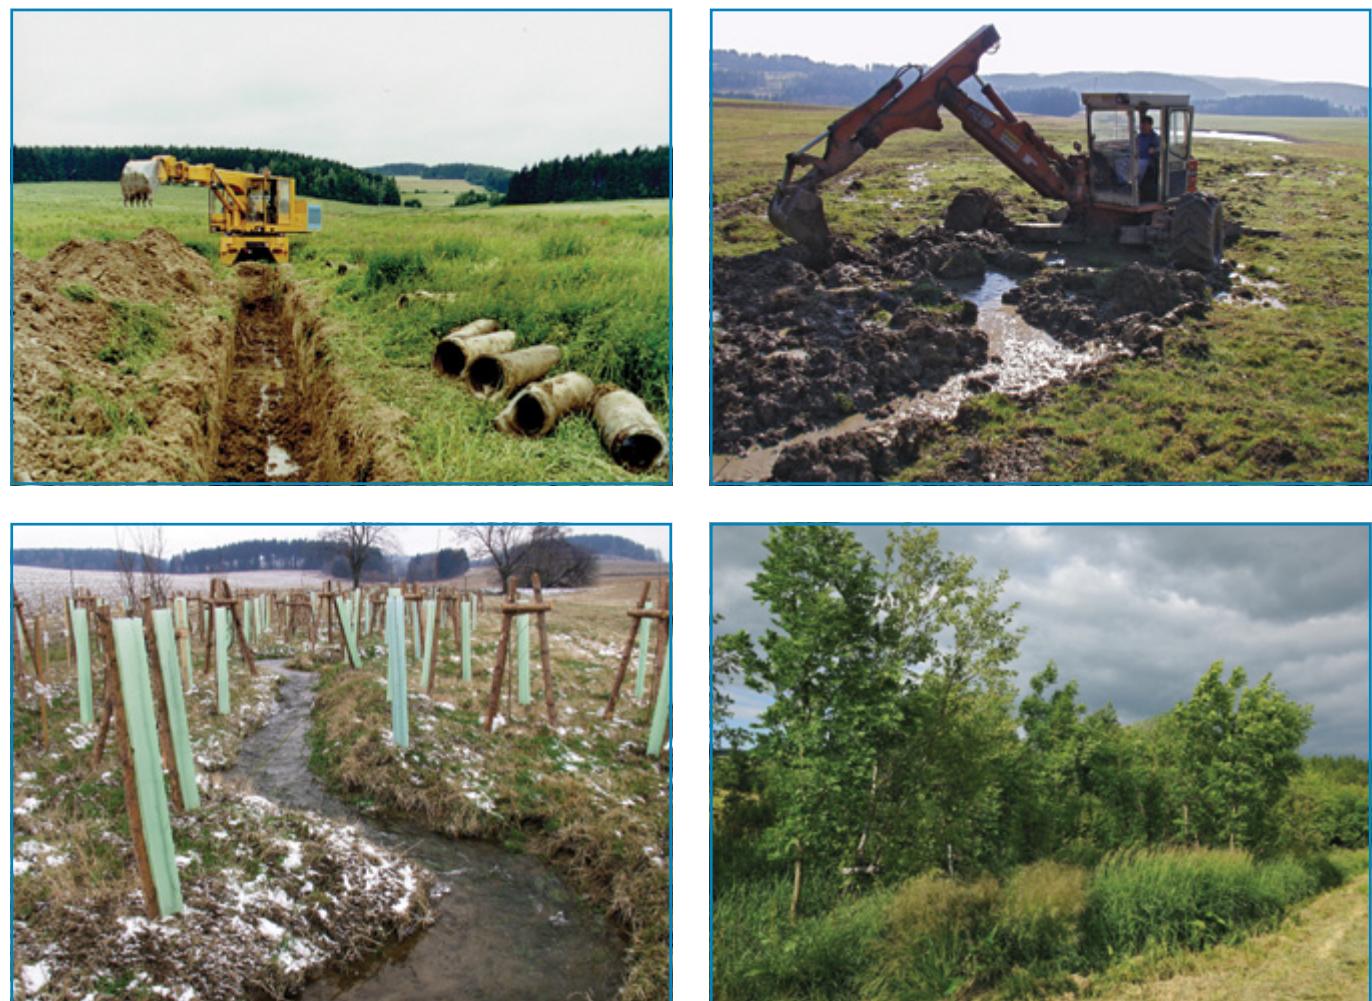
**Fig. 2.** Restoration (1999, 2000) of two formerly channelised streams in the middle of arable fields, Dolní Moravice, N Moravia. After removing the concrete tubes and filling the grooves, a shallow, varied streambed and several retention reservoirs were created with an excavator. Subsequently autochthonous trees were planted in the space between the reservoirs to create a local biocorridor. This operation was initiated, designed and realised by Ekoservis Jeseníky, Světlá hora and financed from Landscape management programmes. (L. Bureš)

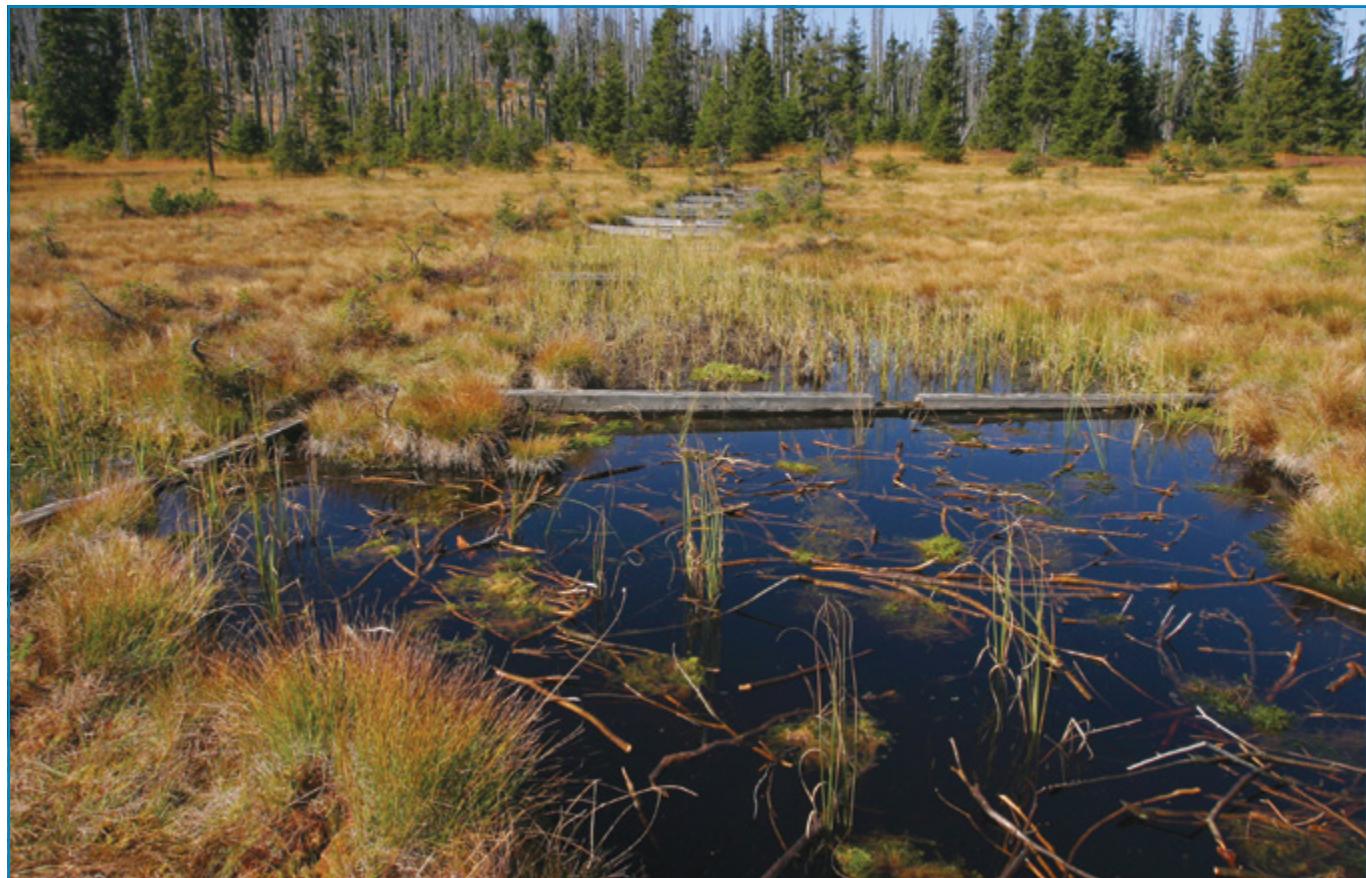
Fig. 1. Blocked ditches on an open raised bog four years after restoration, Březnické slatě.

Many mires in the Šumava National Park have been modified by various human activities like forestry, agriculture and peat extraction in the past (Schreiber 1924). Various interventions in the hydrology, mainly surface drainage, are generally the most harmful impacts on mires in the area. A current mire survey revealed that almost 70% of mires have been influenced at least once by drainage. However, disturbance intensity varies largely across the area depending on e.g. human population density and land use. Drainage ditches from the turn of 19<sup>th</sup> and 20<sup>th</sup> centuries are rather shallow and usually less damaging for mires. By contrast, deep channels made from the 1960s to the 1980 are less frequent but represent a much more serious problem (Fig. 1).

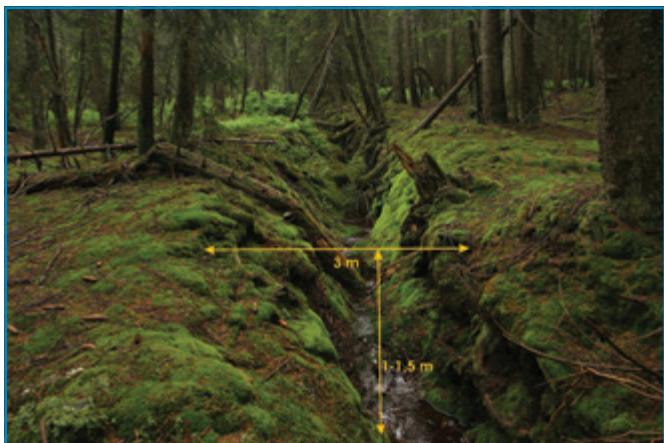
Fig. 2. Heavily drained spruce mire before restoration, Ztracená slat'.

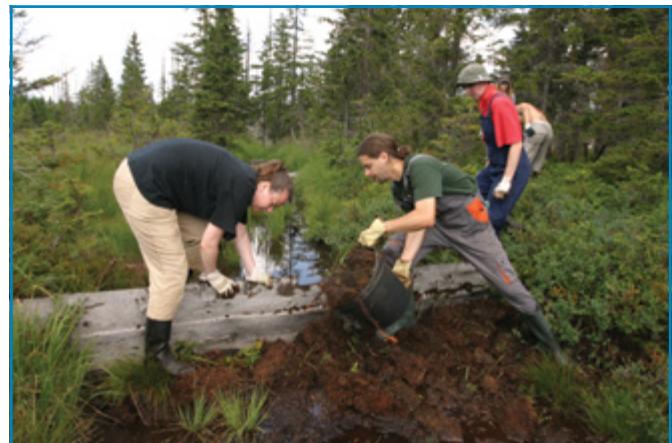
Fig. 3. Volunteers helping with mire restoration at Vrchové slaté (2010).

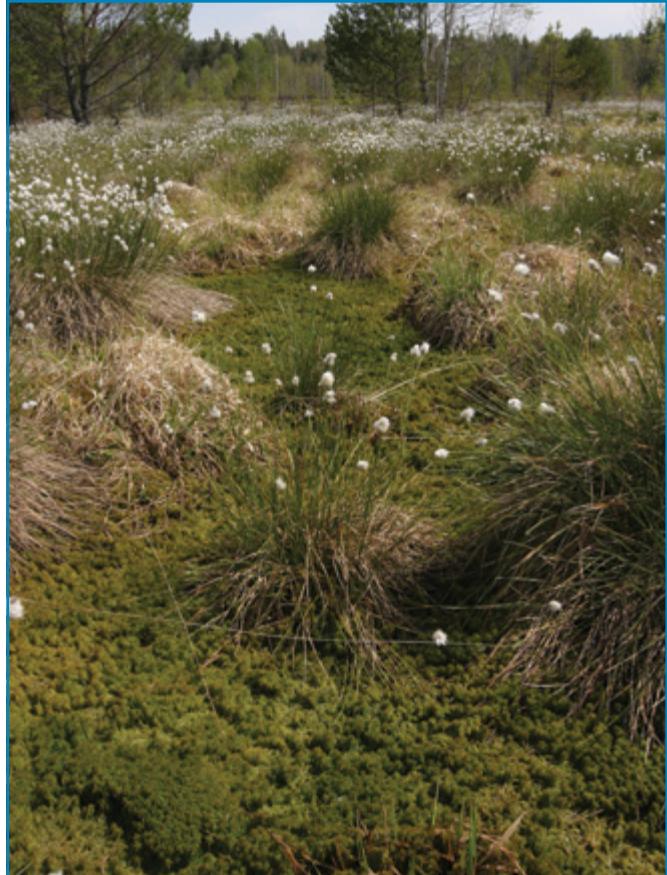
Fig. 1. Redeveloped *Sphagnum* carpet between *Eriophorum vaginatum* tussocks on former bare peat (2011).

After peat mining had ceased, the peat bog consisted of large areas of abandoned bare peat strongly drained by system of open ditches (Fig. 1). Several large ditches (both central and peripheral) were connected with a large number of small lateral ditches and in many places even piped (Fig. 2). The residual peat layer was up to 3 m thick, but the prevailing peat layer thickness was only 0.5 m and average peat thickness about 0.8 m. The bare peat surface was characterised by a harsh microclimate – especially high temperature extremes near the peat surface and a strong fluctuation of the water table and peat moisture, causing extreme desiccation in some places. Colonising plants and spontaneous revegetation were strongly limited by these conditions. The mean annual temperature in the area is 6.2 °C, the total annual precipitation is ca. 760 mm (Svobodová et al. 2002), but the whole valley is under strong influence of temperature inversion and a high amount of horizontal precipitation from frequent fogs.

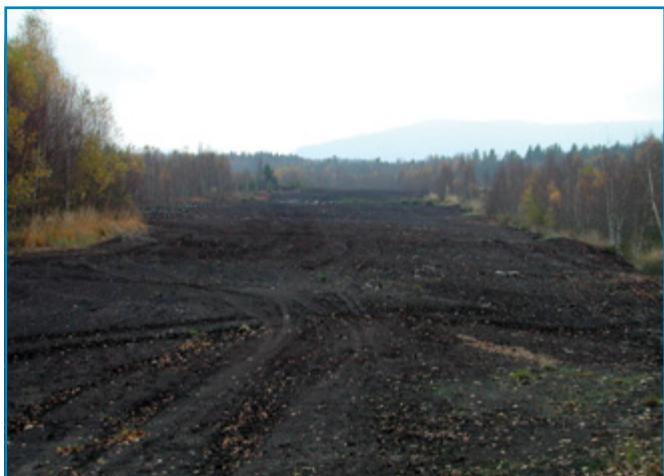
**Fig. 2.** Bare peat immediately after peat milling was finished in 2001.

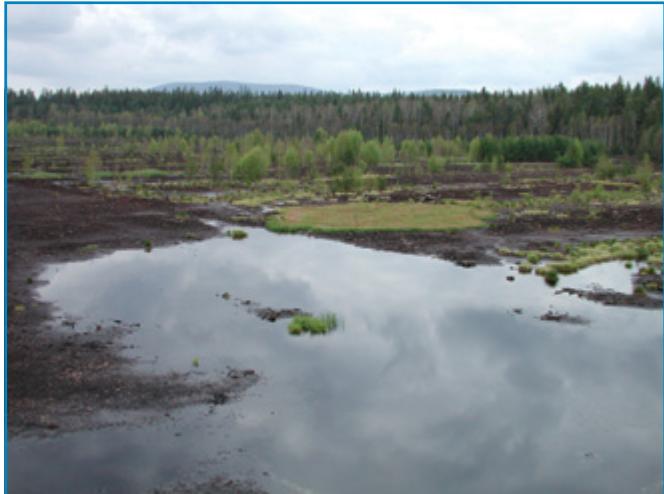
**Fig. 4.** Shallow waterlogged basins at the end of the restoration (2004), bare peat partly covered with vegetation can be seen in the background.

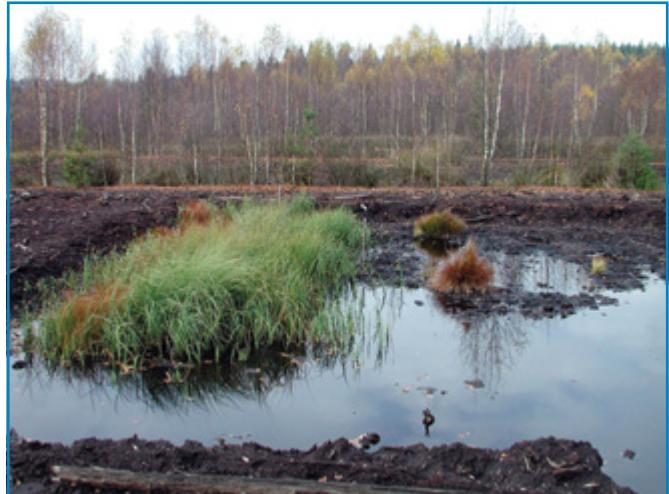
**Fig. 6.** Example of experimental planting plots with *Carex rostrata* and *Eriophorum angustifolium* (2001).

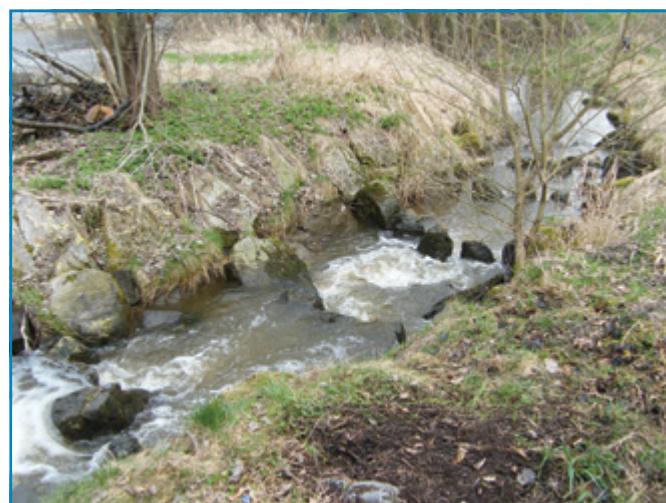
Fig. 1. Upper torrent segment of the bypass. (V. Šámal)

In 2002, a 35 m long bypass was built at the weir to allow upstream migration. It runs from the upper weir through natural terrain around the body of the weir and joins the river 20 metres downstream of the weir. The average gradient is 5%. Fig. 3 shows the placement of this near-natural bypass. At a medium flow rate (Q180), up to 250  $\text{l.s}^{-1}$  flows through the bypass. The 2.5 m wide upper part of the bypass is a torrent fish pass with an inlet device placed upstream of the weir. The construction includes 9 stone sills for the necessary backwater, in which 7 to 16 cm wide gaps between the stones (boulders) enable fish to swim through either at the bottom or below the water surface. Gravel and smaller stones on the bottom decrease the flow in the lower water layers. The sills differ no more than 15 cm in height and their depth ranges from 0.3 to 0.5 m (Fig. 1).

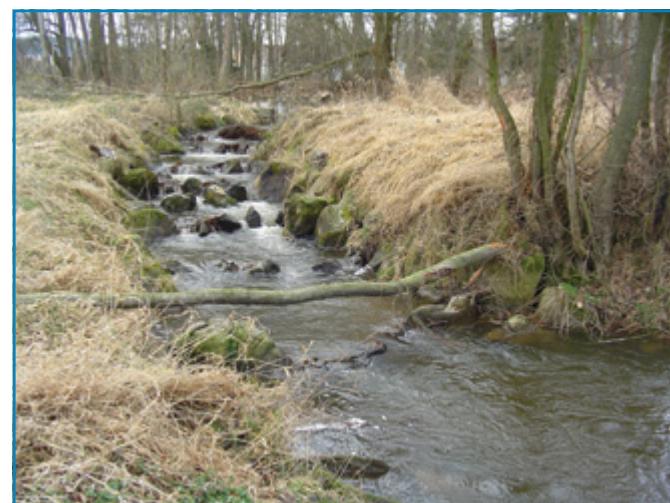
Fig. 2. Torrent and lower, fluvial part of the bypass. (P. Dvořák)

The lower part of the bypass is formed by the oxbow (which was first cleaned) with slowly flowing water (Fig. 2). The width of the low-

er part ranges from 3 to 5 m and the gradient is only 2%, but a few stone sills form up to 1 m deep pools. In places over sand and gravel banks shoals have been formed by high-water flows.

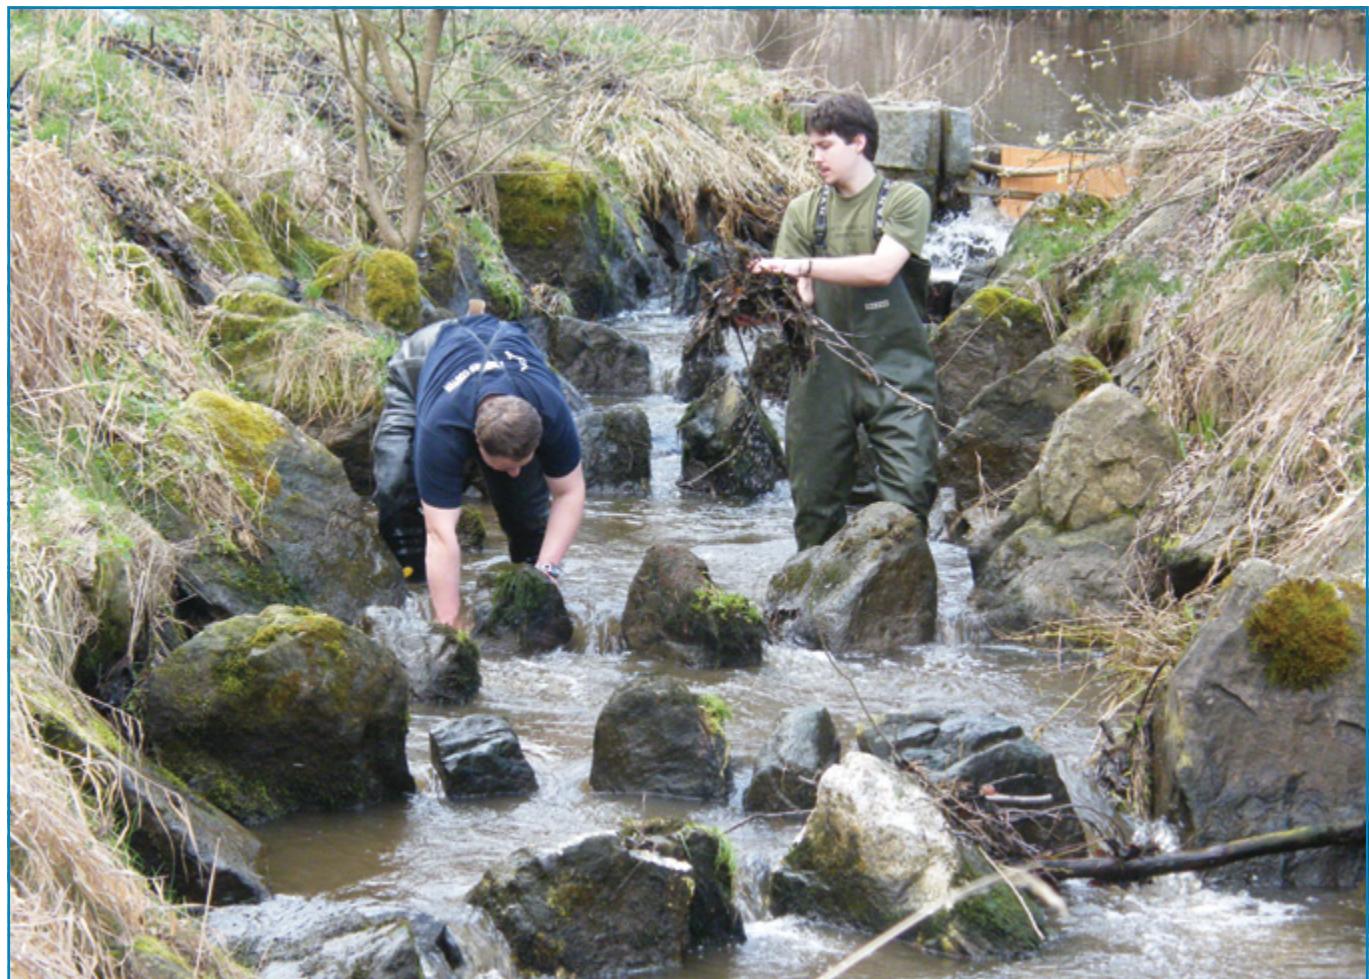
**Fig. 4.** The bypass under construction. Depositing of boulders on the banks and into the sill across the stream. (V. Šámal)

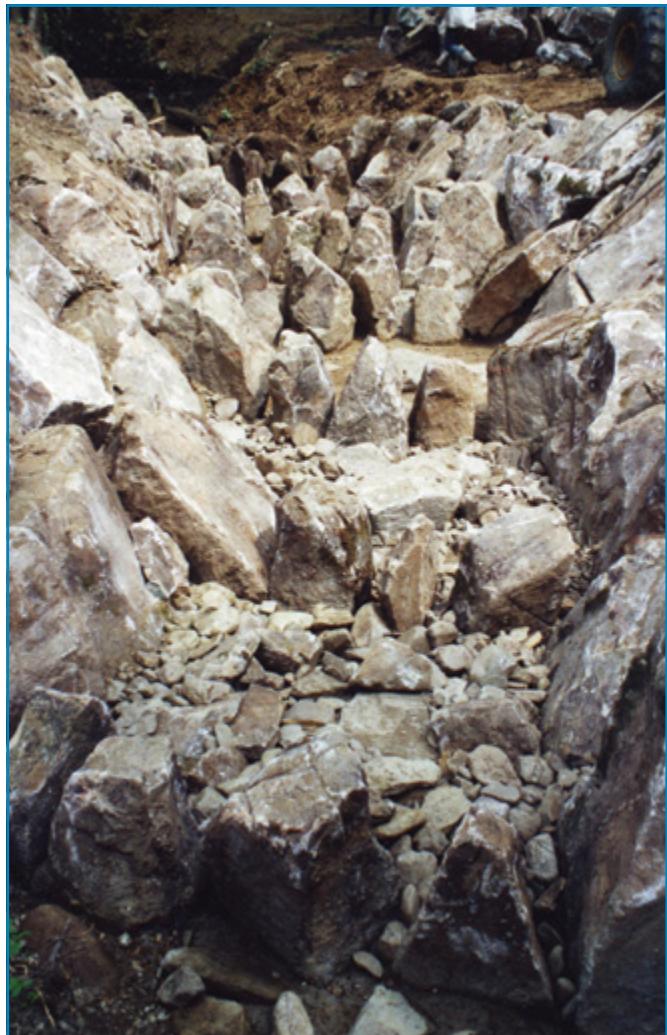
Fig. 5. Bypass under construction. Depositing of coarse gravel on the stream bottom between the stone sills. (V. Šámal)
