Wyndham Park, Grantham, Lincolnshire

Catchment & Waterbody:	Upper Witham. Confluence of Cringle Brook to confluence of River Brant	
Location:	Wyndham Park, Grantham	
Upstream Grid Ref:	SK 91603 36462	Completion Date: late July 2017
Length of river enhanced:	100m	
Partners:	South Kesteven District Council, Lincolnshire Rivers Trust, Wyndham Park Forum, Grantham RiverCare, Sustrans	
Budget:	c£65K	
Related Plans & Strategies:	Grantham Urban River and Wetlands Plan Upper Witham River Corridor Habitat Plan Wyndham Park Grantham: The People's Park (Heritage Lottery Fund project)

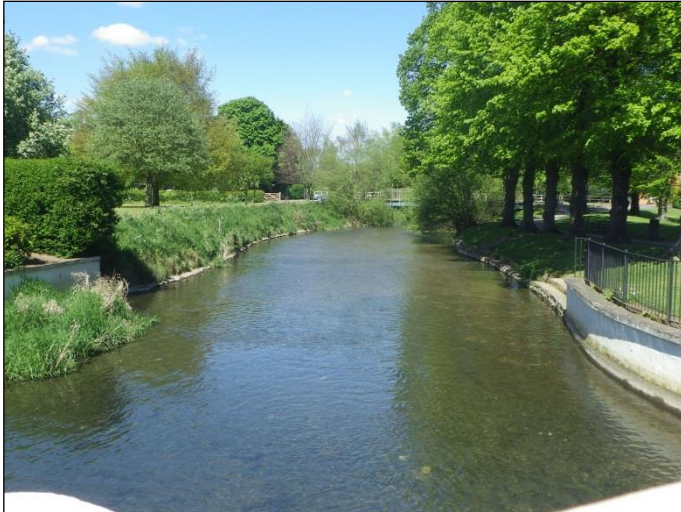
Located in Wyndham Park in urban Grantham this short section of the River Witham between White Bridge and Belton Lane footbridge is publicly accessible and highly visible. The channel was overwide with a shallow bed gradient and predominantly concrete banks (Fig 1). There was very little marginal and aquatic vegetation and the bed was covered with a thick layer of immobile fine sand and silt. There was also localised bank erosion (Fig 2).

Fig 1. Before (May 2017). Looking downstream from White Bridge showing the original wide channel and concrete banks

The overall objectives of the Wyndham scheme were to improve the flow, reduce sedimentation and create habitats for river life, including native brown trout and white-clawed crayfish, as well as insect pollinators. A narrower, more sinuous, 2-stage channel would increase the flow and reduce the accumulation of fine sediment on the river bed.

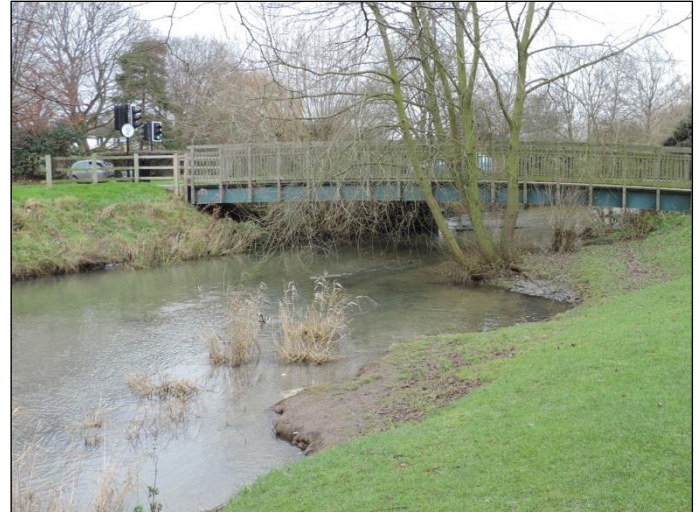
Fig 2. Before (December 2014). Upstream of the Belton Lane footbridge the river bank was heavily-eroded (also see Fig 7).

Fig 7. The eroded bank has been restored behind a faggot and gravel enclosure and planted-up with native plants. The willows behind have been coppiced or pollarded.

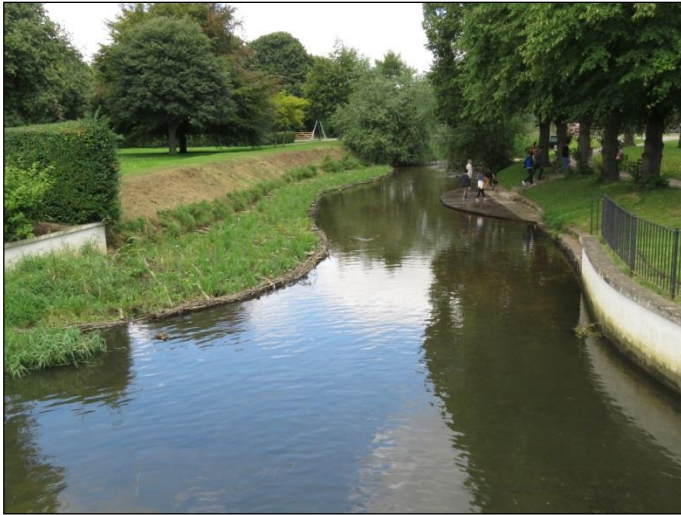
Fig 3. The newly restored channel. The planted berm on the left bank narrows the river and softens the hard bank, while park visitors enjoy the new access decking.

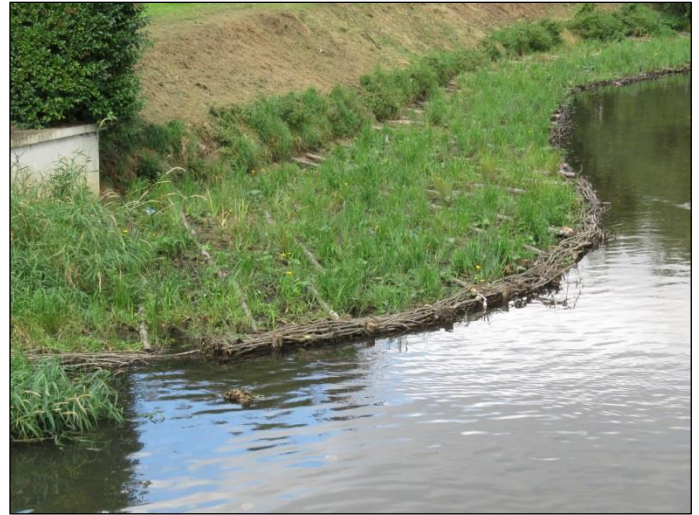
Fig 4. The soft berm, edged with faggots, infilled with sediment excavated from the river and topped with pre-planted coir.

- Soft berms (Figs 4 & 7) - low bankside shelves fronted with faggots (tightly bound bundles of sticks) were constructed to narrow the channel, conceal much of the concrete edging and provide erosion protection. The enclosures, which will be submerged to maintain flood resilience when the river level rises, were filled with fine sediment from the river bed, and topped with coir planted with colourful locally native wetland plants to support pollinator species. The resulting 2-stage channel reduces siltation by increasing the speed of flow.

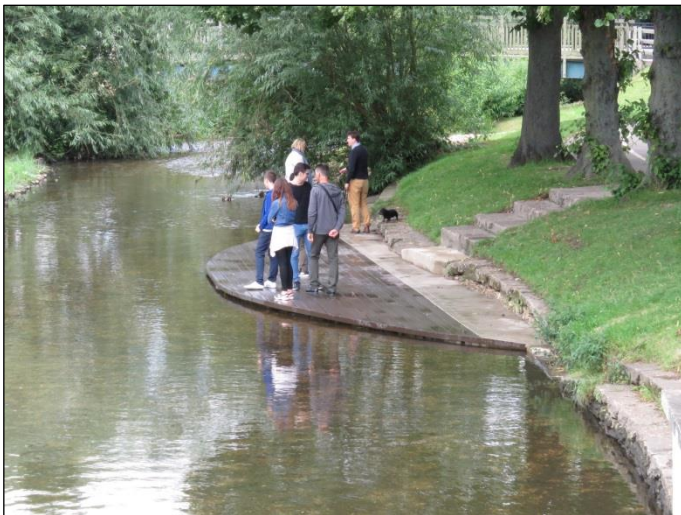
Fig 5. Visitors to Wyndham Park can now get closer to the river by using the accessible decking, which also narrows the channel.

- Access berm (Fig 5) - located at the foot of the existing steps down to the river, surfaced with recycled plastic boards and fronted with stone, the decking has the same channel narrowing and silt mobilisation function as the soft berms. It also allows park users to get closer to the river and provides a safe platform for river studies.

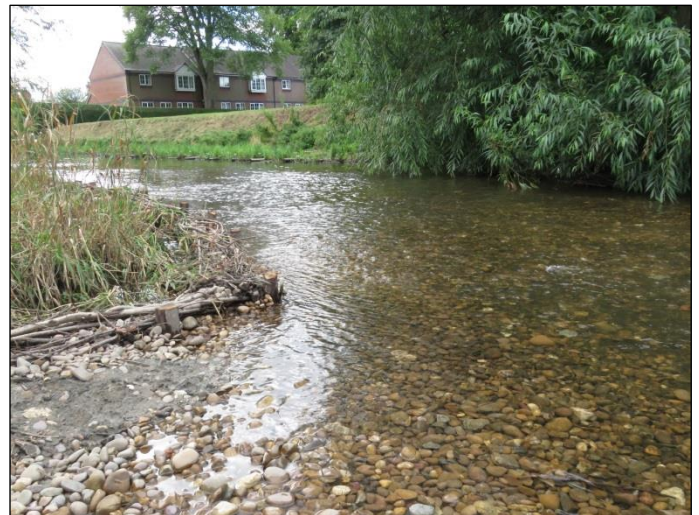
Fig 6. Fine sediment excavated from the bed has been replaced with fresh, clean gravel.

- River bed restoration (Fig 6) - Large quantities of fine sand and silt were excavated from the river bed and used to back-fill the soft berm enclosures. The bed level was then restored by replacing the sediment with fresh, clean gravel to provide habitat for native white-clawed crayfish, fish and other aquatic life.

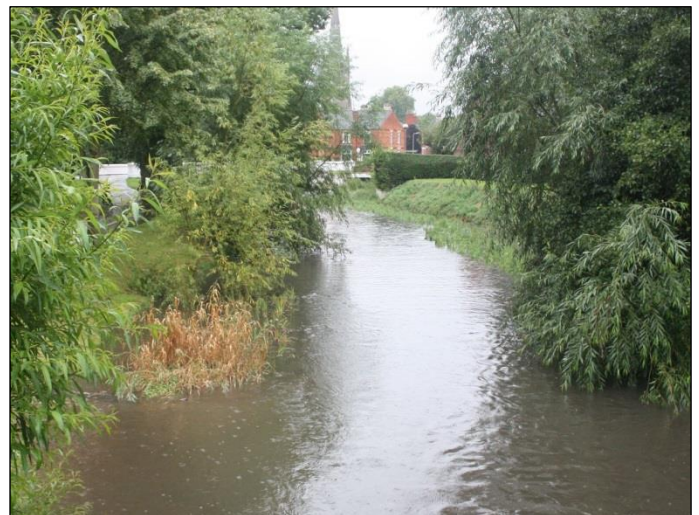
In August 2017 the flood resilience of the project was immediately demonstrated when heavy overnight rain caused the river to rise and temporarily flood the berms (Fig 8). Soon after completion chub were observed on the fresh gravel bed and in winter 2017/18 brown trout redds (spawning scrapes) were located. The access berm was an immediate success and provided the venue for river studies at the World Rivers Day event in September 2017.

Fig 8. Shortly after completion (8th Aug 2017) the low berms were temporarily flooded following heavy rain.
