Nassington Backchannel

Location: Nassington, Peterborough

Completion date: October 2020

Summary of activities

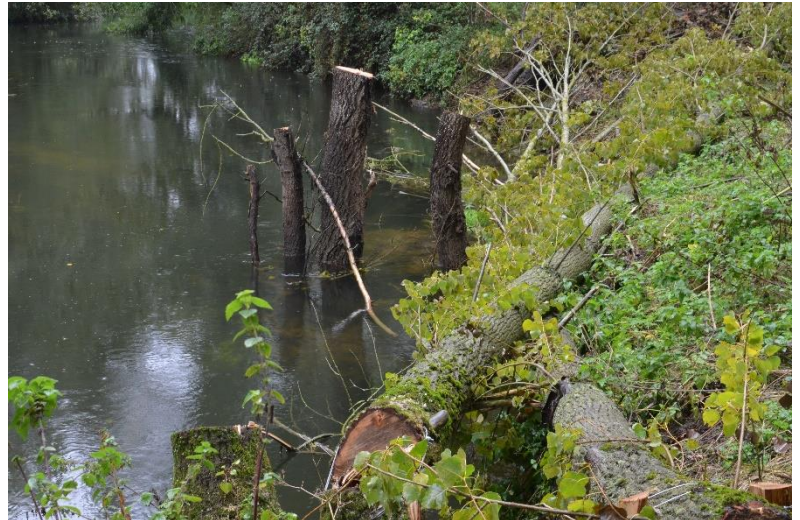
Figure 2 – Secured limbs on the bankface extending on to the channel

The trunks of trees were partially cut at the base, leaving a narrow bark and sapwood hinge, and then bent horizontally (pointing downstream) along the bank to create a tangle of twigs and branches extending to no more than 10-15% of the channel width. Cut limbs were held between pairs of hardwood stakes, and then secured with short loops of plain fencing wire attached to the stakes with staples. The loops of wire were independent from each other, so if one fails, the whole structure will not. Wire loops were twisted tight and the stakes driven down further to securely hold

down the limbs in place. Post tops and surplus wire were trimmed to length. For added security, particularly if the hinge was to fail, in addition to the wire bindings, the limbs were drilled through and secured using lengths of steel cable shackled to double hardwood stakes driven deep in the riverbank using a mechanical (compressed air) post driver. Also, on the basis of advance maintenance, where trees have already collapsed, they were pulled against the bank and secured in situ, to ensure that they do not wash away in high flows and create a blockage downstream.

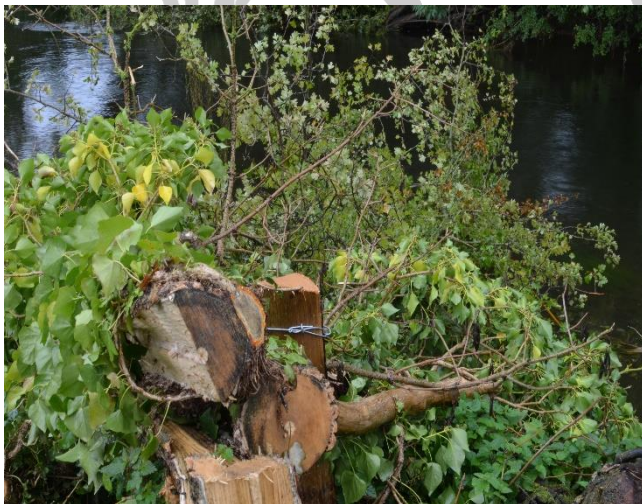
Figures 3 & 4 – Smaller hinged and pinned trees extending in to the channel

19 small trees as well as 2 large trees were selectively “hinged and pinned” to increase woody habitat and provide a refuge for juvenile fish and invertebrates. The limbs that were closest to the water and extended furthest across the channel at the time were selected to ensure that conveyance will be improved as a result of the works. Larger overhanging limbs/trunks were also selected on the basis that they were the most likely to collapse into the river with the potential to cause a blockage. As such hinging these larger 2 trees/limbs is effectively advance maintenance – removing the need for emergency action and ensuring that beneficial in-stream woody habitat is retained.

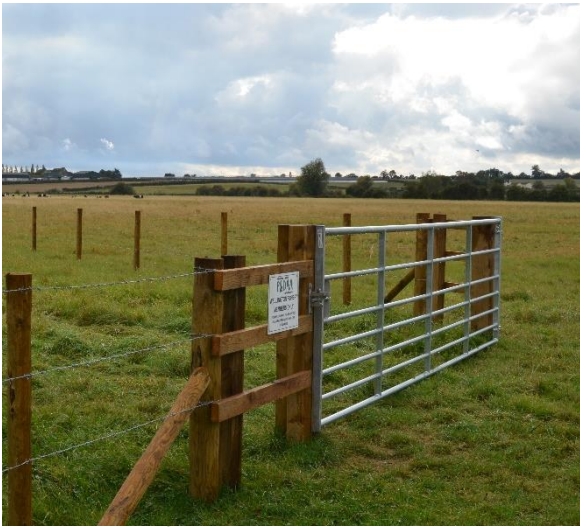
Figure 5 - Access gate on the new fence line

The left-hand bank from the weir at the upstream end of the back channel to the central point of the back channel had a dilapidated existing fence line, in places erosion had left the fence line suspended over the watercourse. The original fencing was replaced with post and 3 string barbed wire fencing, set 10m from the original fence line. The open fencing pattern ensures that flood water flows under the fence, minimising the likelihood that the fence will collect debris that had been washed down river when in flood. Up to three, 13ft 7 bar aluminium field gates will be included in the fence line to allow access if required. The fields are not currently grazed however in the event they are grazed in the future these access gates would allow periodic grazing at the right time of year.

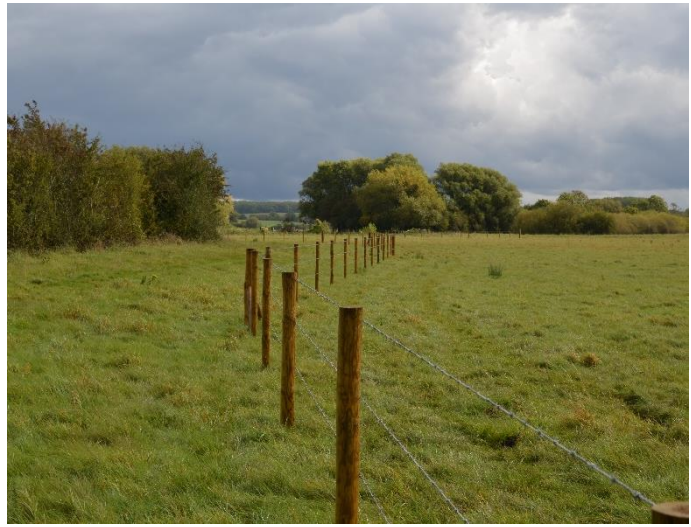
Figure 6 - New fence line at Nassington backchannel

With the new fence line creating much more space between the bank edge and the fence, the local angling club now have much better access to be able to fish on this section of the backchannel. Previously it had been tricky with the original fence line leaving very little room to fish, as well as not having access points on it.
