River Habitat Enhancement Case Studies

Upper River Witham: Easton

Version 2 (22.04.15)

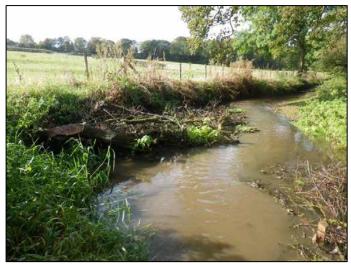
Fig 1. Hinged and pinned live sycamore. (Phase 2)

Several sections, particularly the reaches below Easton Lane (Phase 2) and downstream of the A1 (Phase 3), were heavily shaded by riverside trees. An important element of the enhancement works was to increase light levels to encourage the growth of emergent vegetation on the fine sediment that is accumulating at the channel margins - the growth of vegetation consolidates the silt as well as providing a trap for fine sediments mobilised during high flows. Riverside trees were either coppiced to open up the channel and generate woody material which was used to create channel narrowing structures (see below); hinged and pinned into the channel to create live flow deflectors; or felled secured in-stream (using wire bindings or by wedging between multi-stemmed riverside trees) to deflect the flow and provide additional deadwood habitat. Some existing instream deadwood was also secured. In addition to narrowing the channel and increasing flow variation the branches and twigs provide important refuges for juvenile fish and invertebrates.

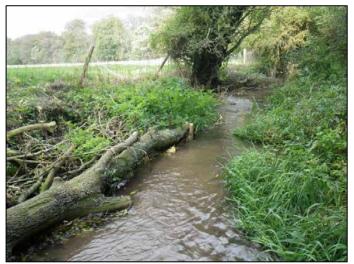
Fig 3. Riverside tree felled into the channel and secured with wire bindings. (Phase 2)

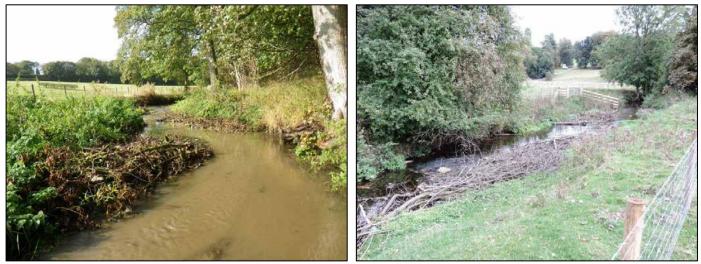
Fig 5. A series of offset brushwood mattress creating a narrow, Fig 6. Brushwood mattress. (Phase 1) sinuous channel. (Phase 2)

Small branches firmly secured with posts and wire bindings to create a mattress.

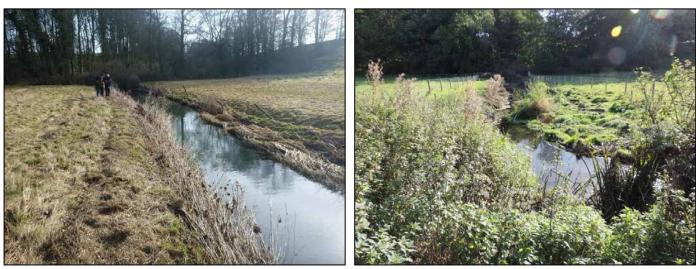
Fig 7. Channel narrowing using infilled brushwood mattresses, (a) before and (b) after. The right bank was reprofiled to create a 2-stage channel and excavated material was used to cover the adjacent brushwood mattresses and seeded. (Phase 1)

As above, but adjacent to sections of reprofiled eroded bank the brushwood mattress were infilled with excavated soils.

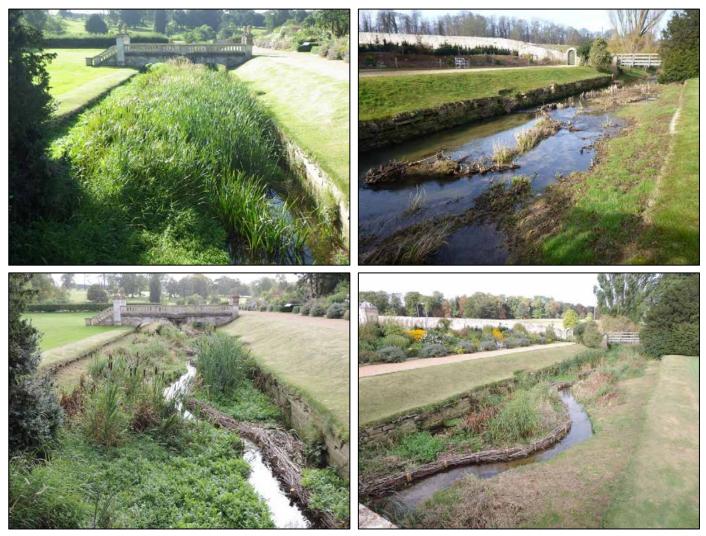
Fig 8. Narrowing using faggots infilled with brash and silt in the Walled Garden section (above before, below after). (Phase 1)

Several variations of the log and faggot-faced enclosure were installed. Some were left open, whilst others were infilled variously with brushwood, earth, turves and silt. In some instances logs or faggots was used to create a new bank toe and the adjacent eroding bank was reprofiled in to the enclosure to create a 2-stage channel. Of the earthfilled enclosures constructed during Phase 1 all but one was grass seeded and some were also planted with clumps of native wetland plants translocated from the Walled Garden section of the river.

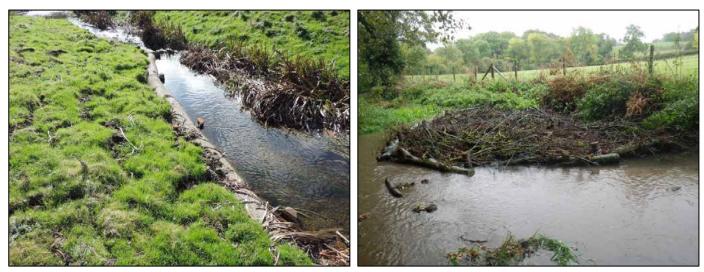
Fig 9. Log-faced enclosure infilled with earth and turfs. (Phase1) Fig 10. Log-faced brushwood mattress. (Phase2)

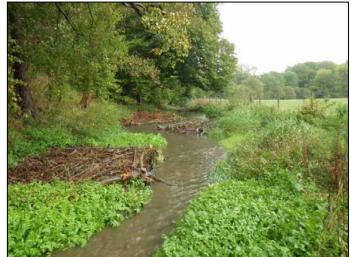
Fig 12. A series of log-fronted brushwood mattresses creating a narrower, more sinuous channel. (Phase2)

Brushwood mattresses partially enclosed by secured logs leaving the downstream end open to create a "backwater" which provides a valuable fish/fry refuge.

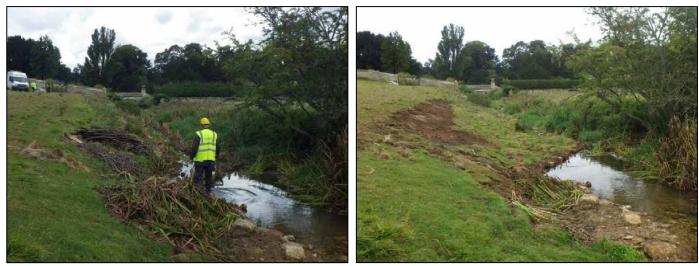
Fig 13. (a) The 2-stagechannel creation in progress and (b) the completed works, which include turf-filled faggot-faced enclosures, prior to fencing being erected at the top of the reprofiled slopes. (Phase 1)

During Phase 1, immediately upstream of the Walled Garden, a number of the channel narrowing techniques described above were combined to narrow the river and create a long section of 2-stage channel. Once completed the section was fenced to prevent further bank erosion by grazing sheep. 2-stage channels contain typical flows within a narrow primary channel, but as flows increase and the water levels rise the flood flows are carried in the wider second stage channel, emulating the operation of a natural floodplain.

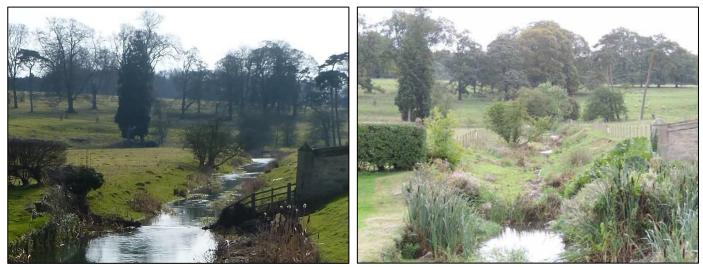
Fig 14. (a) before and (b) after, showing the extent of channel narrowing upstream of the Walled Garden. (Phase 1)

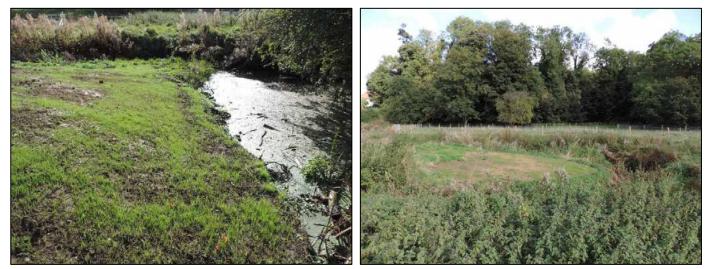
Fig 15. The two reprofiled meander bends. (Phase 1)

Towards the bottom of the middle (Phase 1) reach there is a short series of very sharp, deeply-incised meanders. Here the gradient of the steeply sloping banks on the inside of two meanders bends was reduced to reconnect the river with its floodplain and prevent further incising. Excavated soils were spread thinly at the top of the bank and seeded.

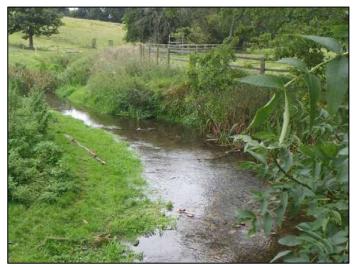
Fig 16. Offset log flow deflectors. (Phase1)

Logs derived from riverside tree management were used to construct flow deflectors and vanes in Phase 1 and 2 of the enhancement work. Flow deflectors are partially exposed above the water level, but slope down at a very shallow angle towards the centre of the channel, and are designed to deflect the flow during typical flow conditions, effectively narrowing the channel. Vanes, however, are permanently submerged. Deflectors and vanes create localised flow variation, helping trap and retain gravels; improve flows over/through gravel beds to keep them free from fine sediment; and improve the bed structure through scouring. Both types of structure, either in pairs or singles, are normally angled upstream to direct the flow towards the centre of the channel and minimise the potential for bank erosion. In addition to vanes and deflectors keyed into the bank, paired "micro-vanes" were also installed mid-channel to create more complex flow variation and bed scour.

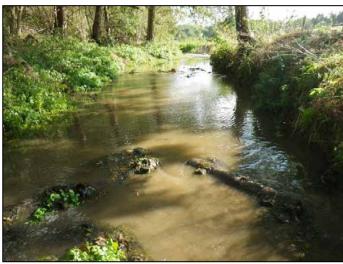
Fig 18. Examples of paired micro-vanes. (Phase 2)

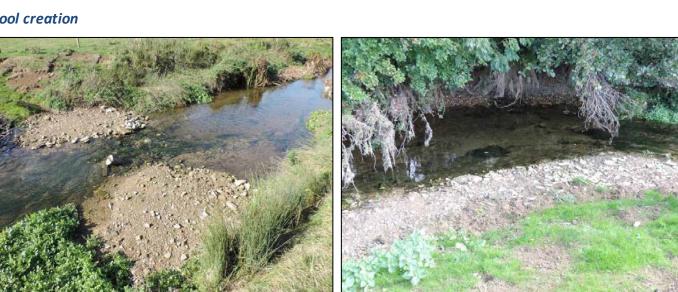
Fig 19. New pools showing the locations of excavated material which narrows the channel and encourages scour. (Phase 1)

During Phase 1 several pools were excavated in the stream bed and the excavated material was deposited either immediately upstream or adjacent to the excavation. The channel narrowing created by the deposited bed material will create scour and should ensure that the pools do not suffer from siltation in the future.

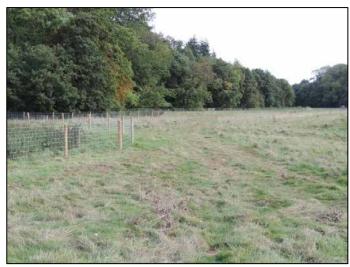
Fig 20. A newly-erected section of stock fencing. (Phase 1)

The riverside pastures and parkland, apart from the section through Easton Walled Garden, are all sheep grazed. Prior to the works most of the banks were unfenced allowing the sheep unrestricted access to the river channel which resulted in some sections of steep, eroded bank. Extensive runs of new fencing (post and wire netting with a barbed top wire) were erected during Phase 1. Sections of fencing that were in poor condition were also replaced. At the suggestion of the gamekeeper the stock netting has been reversed, so that the larger mesh is at the bottom, to allow better access for pheasants (see Fig 20). Hand gates have been installed at both ends of long fencing runs to provide access for the riverbank to be grazed when conditions are suitable.

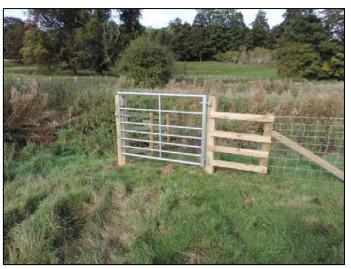
Fig 21. A hand gate installed at the end of a long run of fencing. Note the reversed stock netting with the larger mesh at the bottom to allow better access for pheasants. (Phase 1)

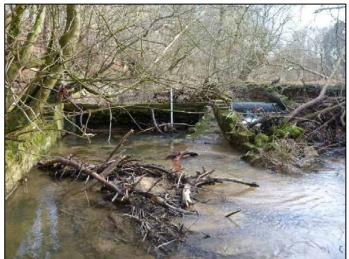
Fig 22. Upstream view of the weir (February 2013).

The main element of Phase 3 was the removal of part of a redundant weir, approximately 650m downstream of the A1, to restore the bed gradient to create a more natural flow and sediment regime and allow fish passage. The project was originally identified in 2009 when the weir was in poor condition, but still creating a significant impoundment. However, subsequently an adjacent bypass culvert had been unblocked, reducing the upstream impoundment and leading to some limited natural regrading of the river bed upstream. When unimpeded the culvert was the preferential flow pathway, although it was prone to blocking with debris, so a permanent solution was required. The removal of the old weir crest to below the base of the adjacent culvert in late 2014 provided this solution and permanently restored the flow to the river channel.

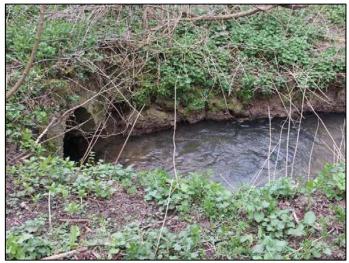
Fig 23. The weir bypass culvert in April 2014 before the removal of the weir crest. The culvert is redundant now that the weir crest has been removed.

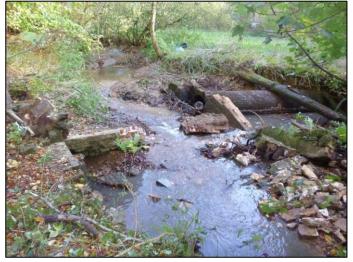
Fig 24. View upstream immediately flowing the removal of the Fig 25. Subsequent high flows through the breached structure central section of the weir which restored the flow to the main river channel (October 2014).

(February 2015.).

The removal of the weir produced a localised steepening of the channel bed (known as a knickpoint), which, if left unmanaged, could migrate upstream and promote bank instability. To address this issue, several hinged trees and brushwood mattress structures were installed into the channel between the weir site and the A1 culvert to slow the flow.

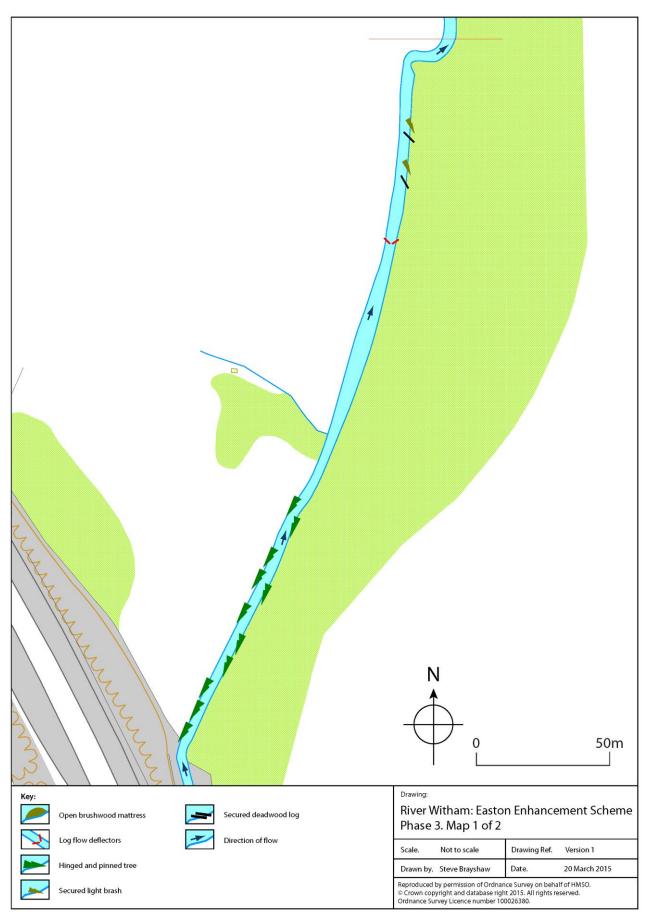
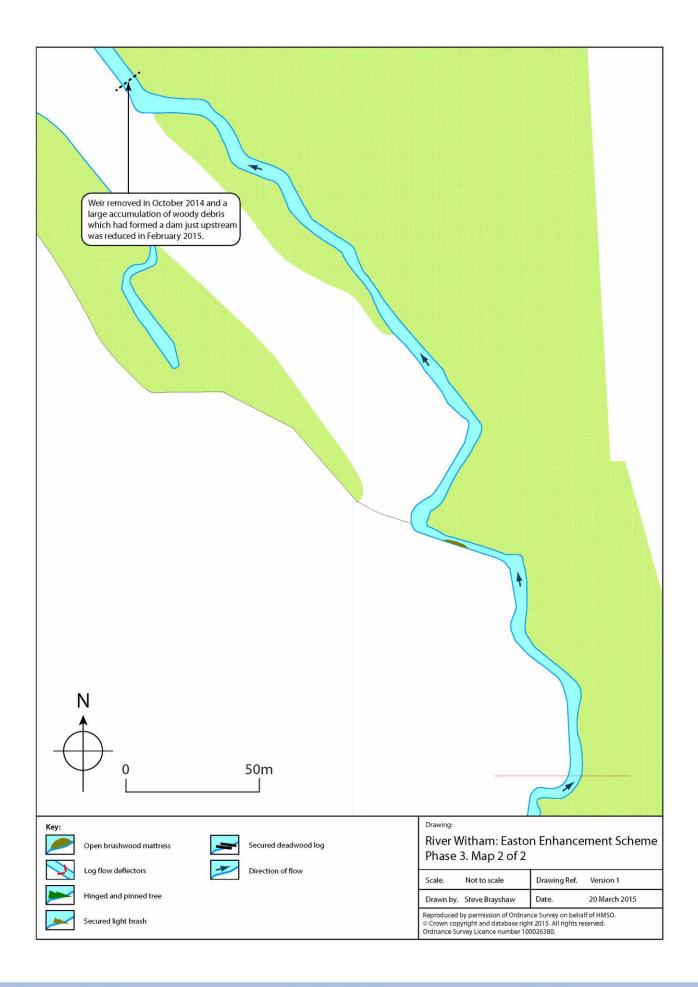
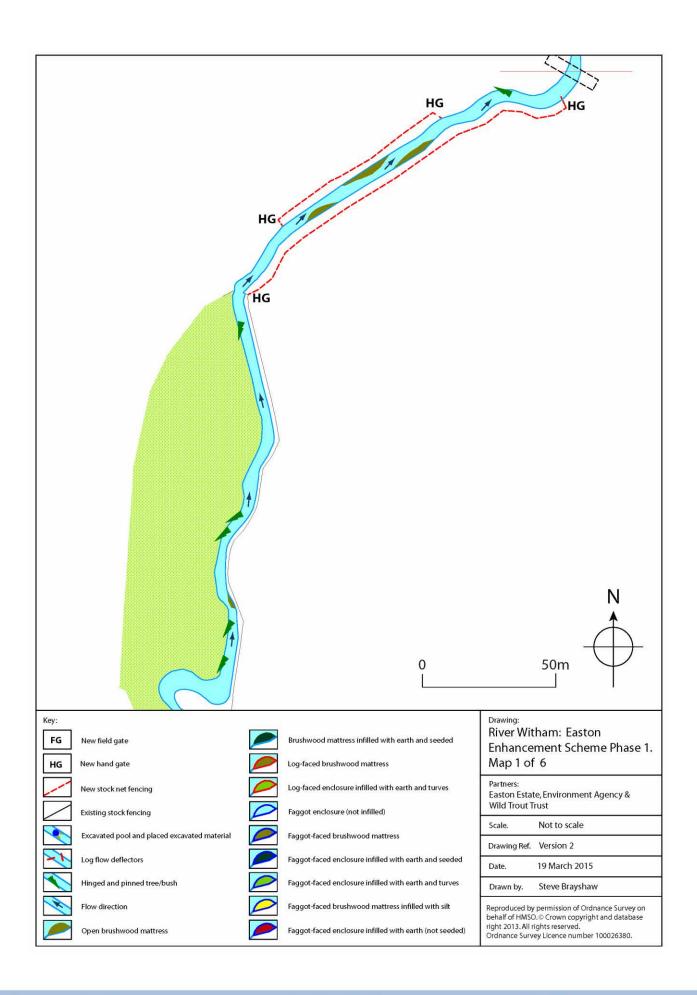
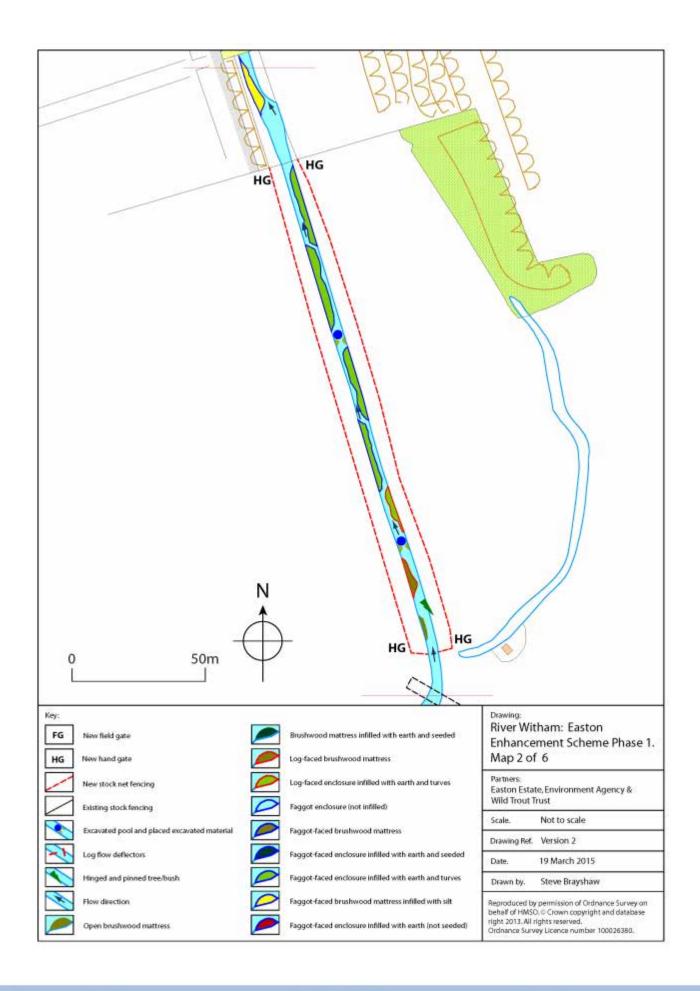
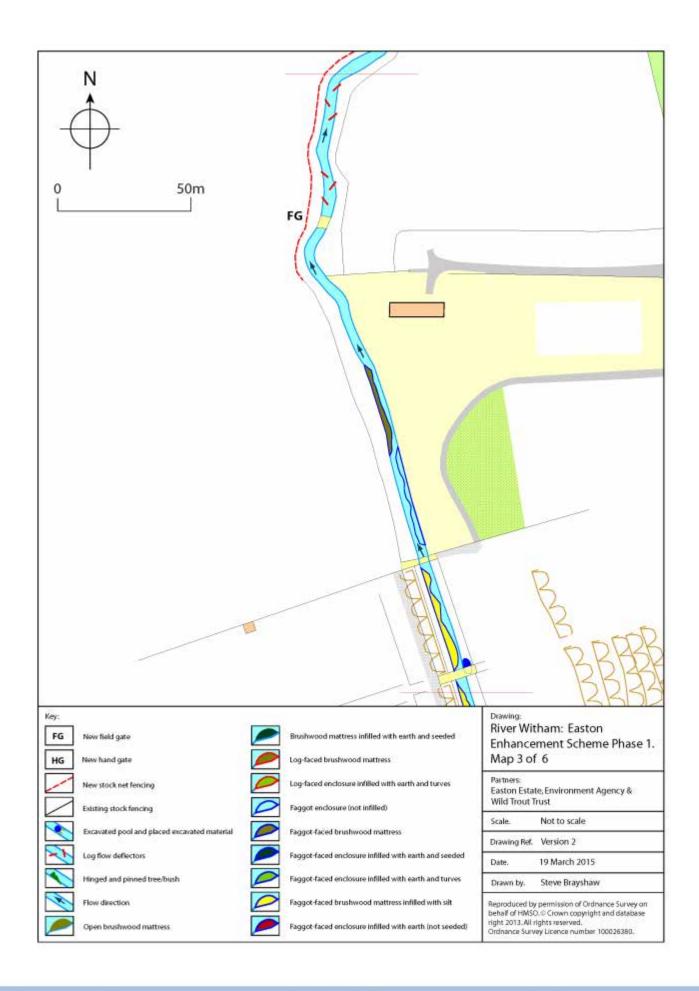
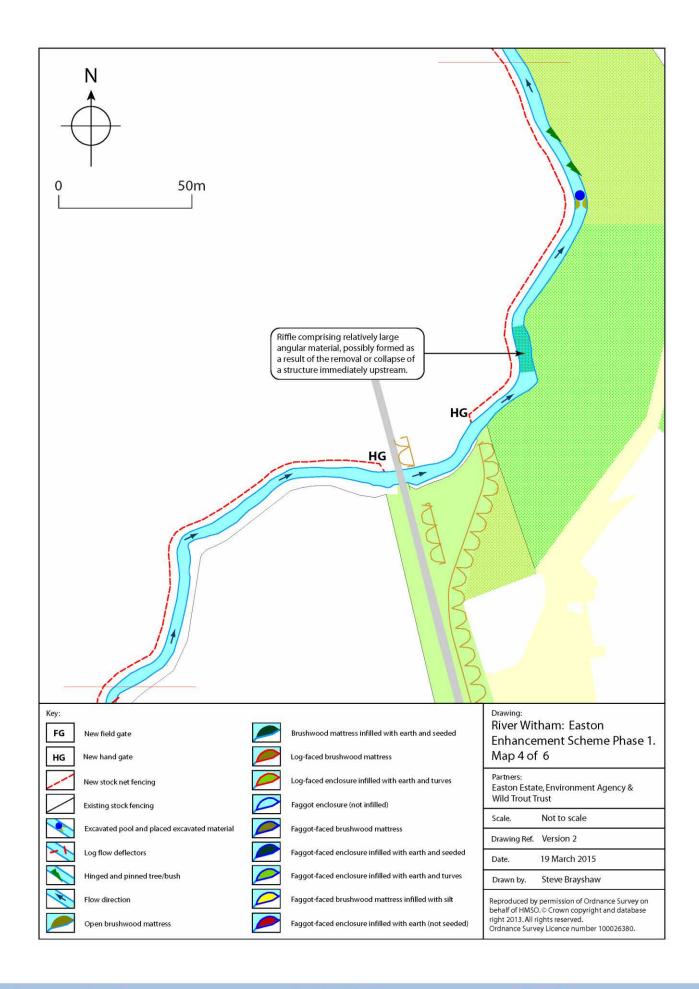
ANNEX 1: The Completed Enhancement Scheme (mapping commences at the upstream extent)

The scheme was completed in 3 phases. The first phase commenced in September 2013 and the third and final phase was completed in February 2015. Phase 1 was through Easton Park and the Walled Garden, Phase 2 was downstream of Easton Lane and Phase 3 started immediately downstream of the A1. The drawings in Annex 1 show the locations of all the elements of the completed phases and the techniques used are described below.
