Fotheringhay Backwater Project

Location: Fotheringhay, Northamptonshire Upstream Grid Ref: TL 06313 92450 Downstream Grid Ref: TL 06505 92363 Length: 300m Completion date: May 2022 Cost: £64,200 Partners: National Lottery Heritage Fund, Environment Agency, Nene Valley Catchment Partnership, Nenescape LP, Landowners

Summary of activities

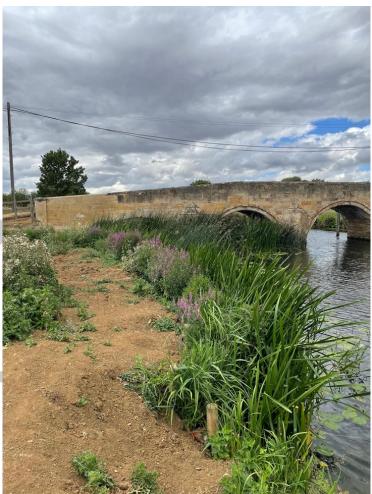
The faces of the eroded banks were stabilised using ash faggot bundles and backfilled with the

vegetation and sediment removed during de-siltation works. Faggots were installed between pairs of untreated cleft hardwood stakes driven into the riverbed / banks at c1-2m centres. They were tightly packed between lines of stakes, and then secured with short loops of plain fencing wire attached to the stakes with staples. The loops of wire are independent from each other, so if one fails, the whole structure will not. Wire loops were twisted tight and the stakes driven further to securely hold down the faggots. Post tops and surplus wire have been trimmed to length. On completion the bank behind the new revetment was filled using the spoil & vegetation removed from the backwater. This was compacted using the excavator bucket and roughly re-profiled to grade in with the current bank level.

There were 3 short sections of bank erosion on the main navigation channel which were repaired and reinforced using faggot revetments. These were then backfilled with the vegetation removed from the backwater to enable faster establishment of marginal plant species.
