Barnwell Inner Backchannel

Location: Barnwell Country Park, Oundle

Completion date: 11th October 2018

Summary of activities

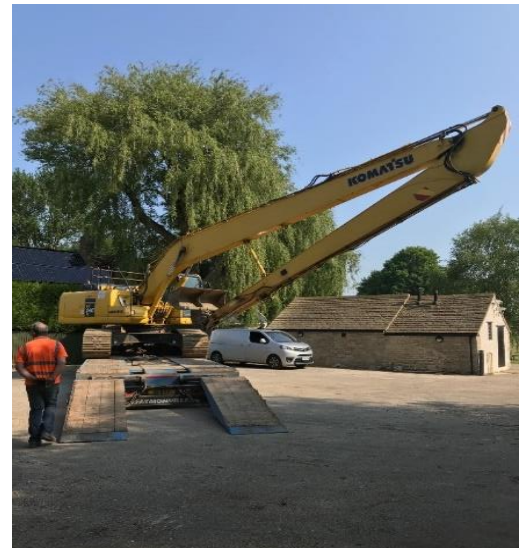
Figure 3 4– 20m long reach excavator for placing the gravel in the channel

160 tonnes of gravel was deposited over three locations along the backchannel. The aim of this was to alter the speed and direction of the water flow creating a range of habitats within the backchannel. The size of the gravel introduced ranged from 4-40mm in size. This is important because gaps are created within the gravel which allows oxygenated water to flow through it, creating good habitat for invertebrates and for fish spawning. The range of gravel size also helps the gravel bed to hold together during flood conditions to minimise movement. Figure 4 shows the excavator which was used to place the gravel into the backchannel.

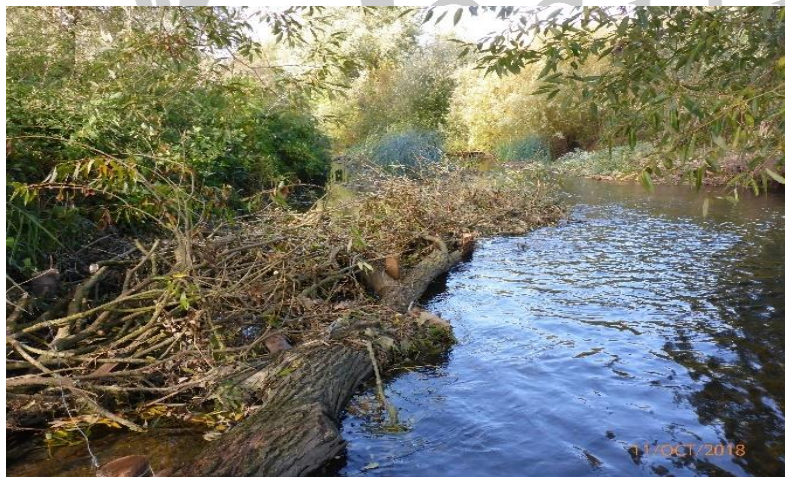
Figure 4 A large hinged and pinned tree

This is where large limbs or whole small trees have a notch cut into the base of the trunk (a hinge) and are dropped on to the bank or into the water in a controlled way before being pinned into the bank using hardwood stakes and heavy-duty wire. This technique was carried out fifteen times across the back channel to increase woody habitat, providing refuge for juvenile fish such as Chub and invertebrates as well as birds and mammals throughout the year. Figure 5 shows one of the fifteen trees that were hinged and pinned across the back channel.

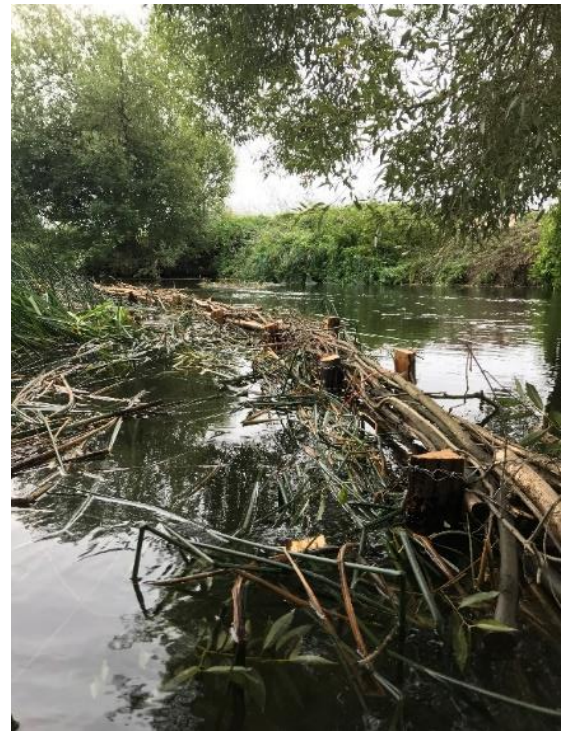
Figure 5 Faggot bundle revetment mid-channel to deflect flow

Two different techniques of revetment have been used to protect the banks from erosion. Firstly, there has been 40m of brushwood bundles installed, using stakes and wire to pin them to the riverbed, in front of an area of eroding bank. This will allow marginal vegetation to establish behind the revetment in order to re-claim the riverbank. This technique can be seen in figure 6.
