Aubourn Rock Ramp Fish Pass, Aubourn, Lincs & Bassingham to Aubourn Woody Habitat Creation

Catchment & Waterbody:	Upper Witham. Confluence of Cringle Brook to confluence of River Brant	Upstream Grid Ref:	SK 90938 60497
Location:	c10km south-west of Lincoln	Length of river enhanced:	3.25km
Partners:	Aubourn Estate & Wild Trout Trust		
Completion Date:	Rock ramp and associated works: May 2016		
	Tree hinging (2017 & 2018): February 2018		
Budget:	Rock ramp and associated works: c£100K		
	Tree hinging (2017 & 2018): c£7.5K		
Related Plans & Strategies:	Upper Witham River Corridor Habitat Plan

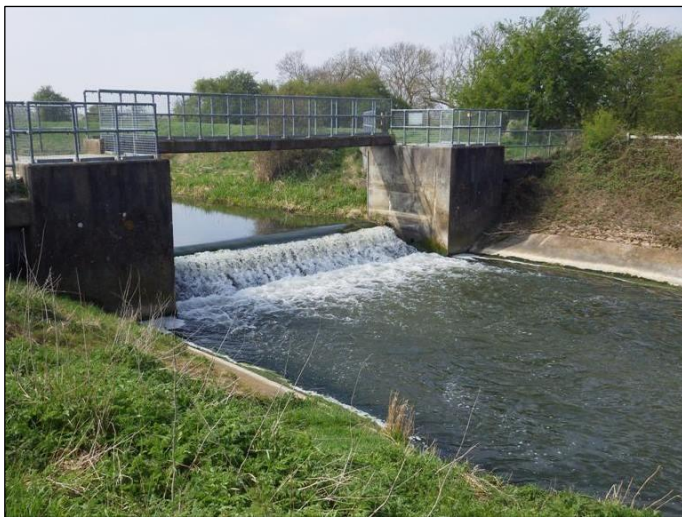
Fig 1. Before – Aubourn Weir showing the drop of around a metre which created a barrier to the passage of fish and eels.

- Rock Ramp - Using large rocks and steel sheet piling to maintain the water levels, a series of stepped pools, rising c1m in c20cm increments, were constructed to create the “rock ramp” which now enables fish and eels to negotiate the former obstruction. See Figs 1 & 2.

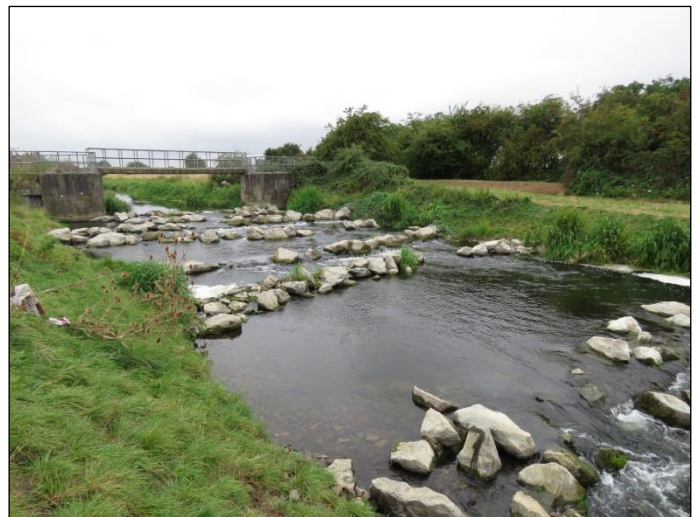
Fig 2. After – the completed Aubourn Rock Ramp. Fish and eels can now pass freely upstream and downstream.

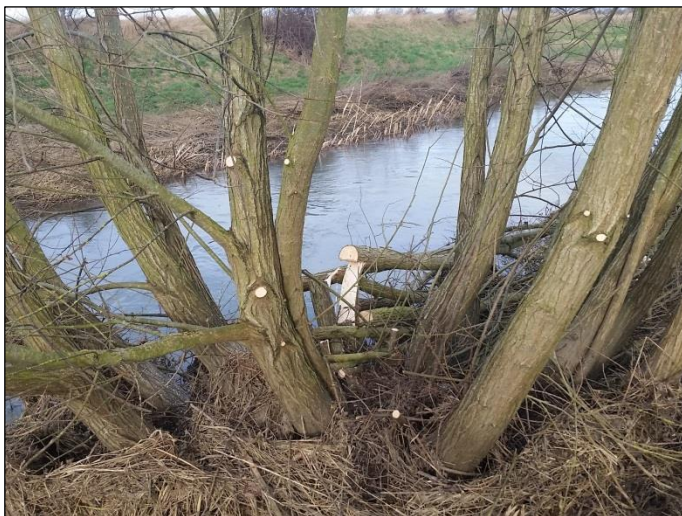
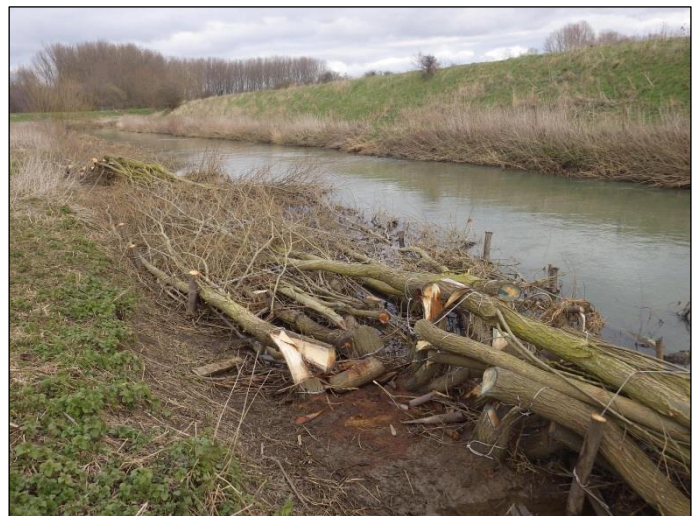
Fig 3 (Before) and Fig 4 (After). Large riverside trees were selectively hinged and secured along the bank and into the water to create valuable instream woody habitat and provide refuges for fish and invertebrates as the river level fluctuates.

- Woody habitat - Riverside trees, in particular those that had collapsed in to the river or were in imminent danger of doing so, were selectively hinged and/or secured into the channel and along the bank throughout the whole of the 3.25km reach. The large woody material creates flow variation and provides refuges for fish and invertebrates as the river level and speed of flow changes. See Figs 3 & 4.
