Dysart Park, Grantham Habitat Improvement Project

When: September 2020

Where: Grantham, Lincolnshire

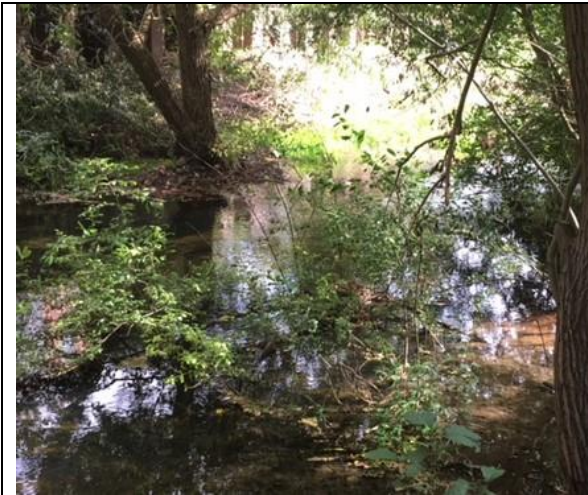
Site before works, Summer 2020. Very shaded and with a silt dominated, over widened channel. **Credit EA**

The project aimed to restore habitat in an over widened, shaded section of river running alongside a public park in the town. This was done by hinging trees to form berms which helped to narrow the channel and

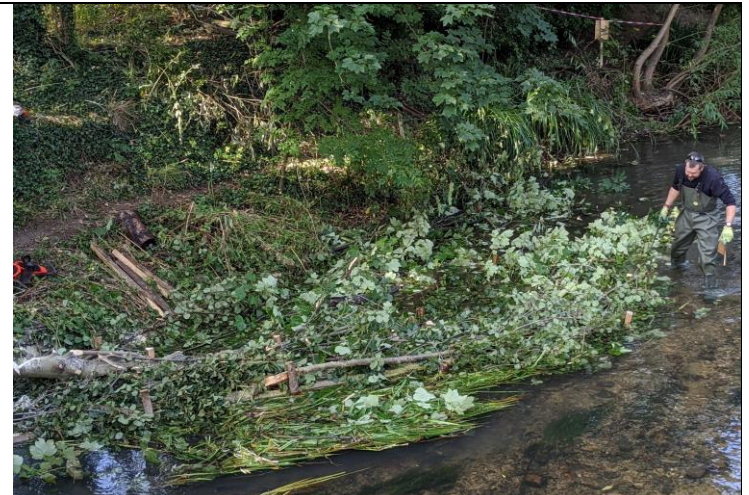
Berm creation using hinged trees, Autumn 2020.
Credit: LRT

provide lighter. As well as benefiting the habitat, this made the river more visible to near-by residents and park users.

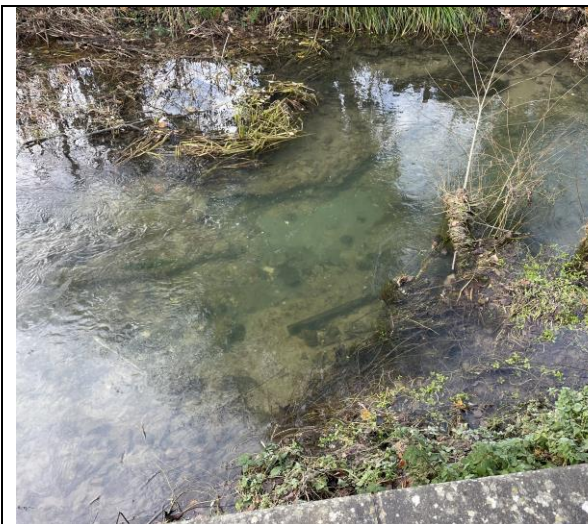
Deep Scour pool between narrowing berms
Winter 2022.
Credit: EA

- Provision of much needed habitat in a very uniform section. The narrowing has allowed scour pools to form and gravels to be exposed and cleaned.
- Reduced EA maintenance requirement.
- Attractive local amenity created which will help with the regeneration of the park.

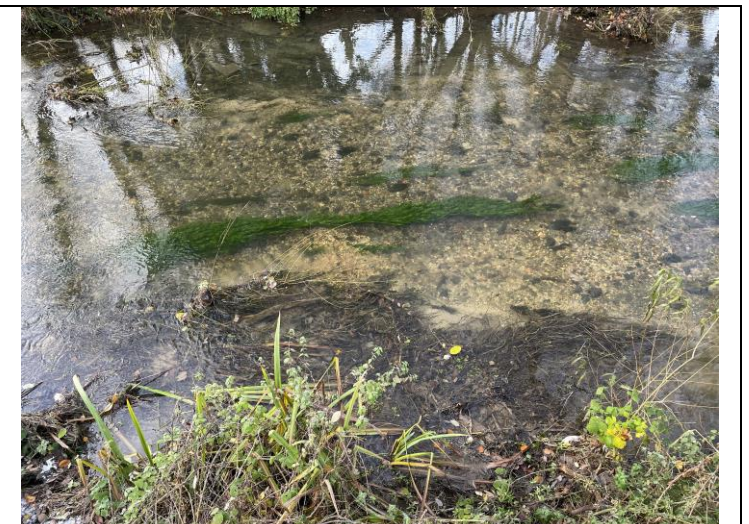
Clean gravels and aquatic vegetation forming next to berm.
Winter 2022.
Credit: EA
