River Witham tree works

Who: Lincs & Northants - Fisheries, Biodiversity and Geomorphology Team

Where: River Witham, Westborough, Lincolnshire

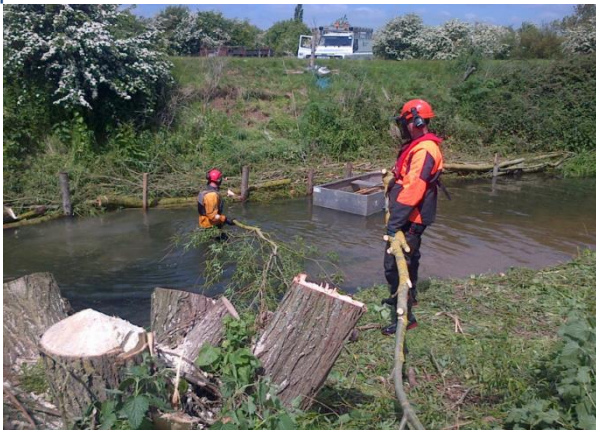
Above - Image taken during the works

Outputs and Outcomes: Phase 1 of the project delivered works along a section of bank 300 metres long, initially 40 meters have been reveted and a number of trees pinned. Phase 2 increased the length of works by a further 1.5km and included bank protection and tree pinning.

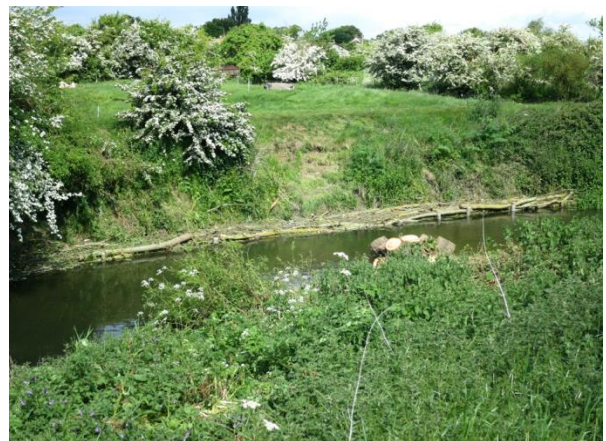
Above - Finished reveted bank

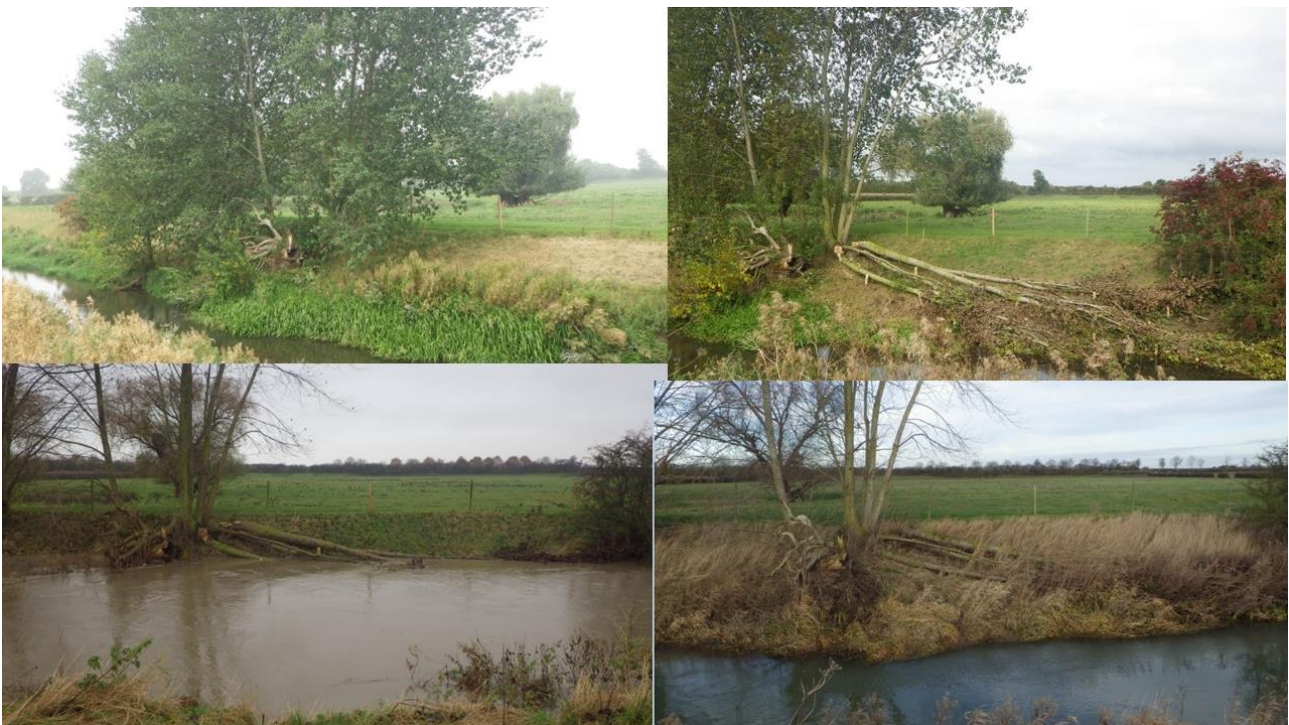
Below - Image showing hinged and pinned material in a range of flow conditions
