Ailsworth Backchannel

Location: Ailsworth, Peterborough

Length: 1.1km

Completion date: September 2019

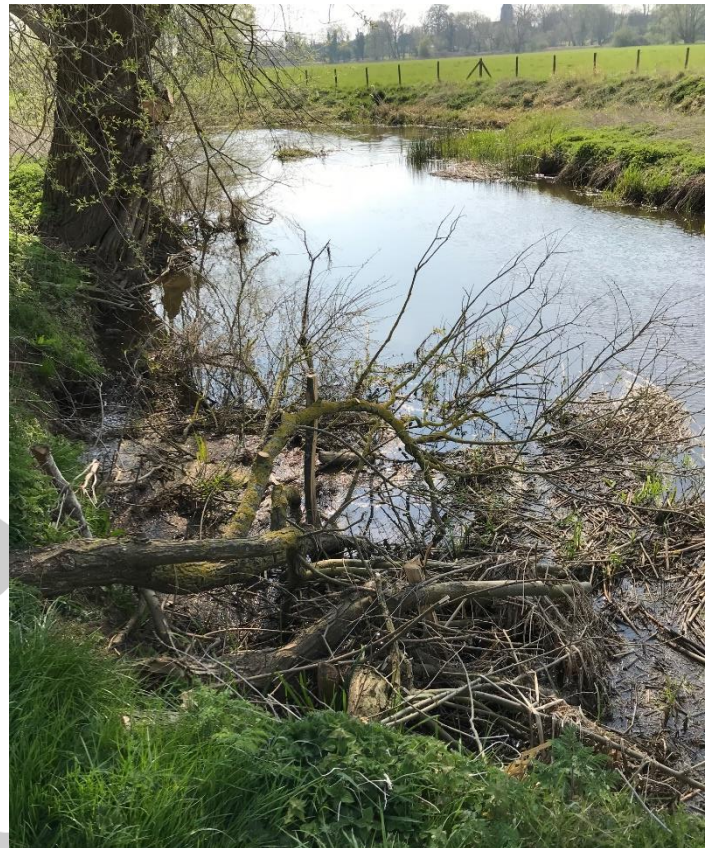
Figure 2 Hinging and pinning of a smaller tree at Ailsworth

10 trees on the low berm along the left bank, and 3 on the right bank, were selectively “hinged and pinned” to increase woody habitat and provide a refuge for juvenile fish and invertebrates. The limbs that were closest to the water and extended furthest across the channel at the time were selected to ensure that conveyance will be improved as a result of the works. Larger overhanging limbs/trunks were

Cut limbs were held between pairs of hardwood stakes, and then secured with short loops of plain fencing wire attached to the stakes with staples. The loops of wire were independent from each other, so if one fails, the whole structure will not. Wire loops were twisted tight and the stakes driven down further to securely hold down the limbs in place. Post tops and surplus wire were trimmed to length. For added security, particularly if the hinge was to fail, in addition to the wire bindings, the limbs were drilled through and secured using lengths of steel cable shackled to double hardwood stakes driven deep in the riverbank using a mechanical (compressed air) post driver. Also, on the basis of advance maintenance, where trees have already collapsed, they were pulled against the bank and secured in situ, to ensure that they do not wash away in high flows and create a blockage downstream.

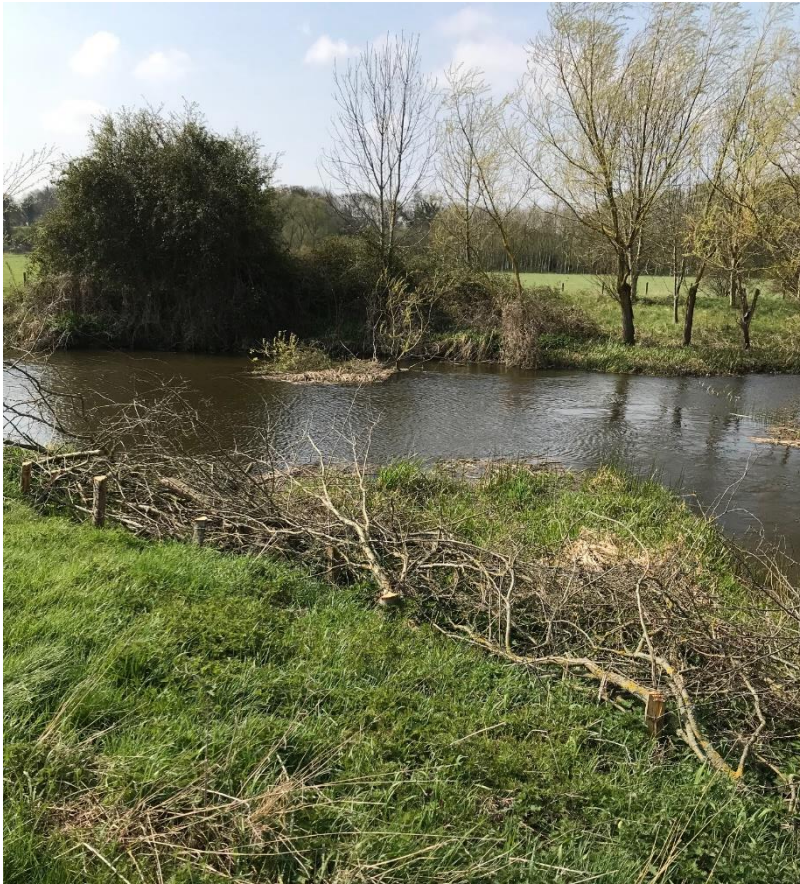
Figure 3 *Brash mattress blocking off the Nursery swim*

A variation to the permit was submitted just prior to the tree works on the request of the Peterborough & District Angling Association (PDAA). This included using the brush material generated on site to create a living ‘mattress’ as seen in figure 3 below, with the purpose of blocking off angling to an area nicknamed ‘The Nursery’ because the Barbel, and other fish species, favouring this area to spawn annually. In the past there have been a number of problems when fishing has been restricted in the swims so the PDAA decided to block it off completely to minimise stress n fish during spawning periods. Unfortunately the current river close season (16th March to June 15th inclusive) do not cover the main spawning period for fish in rivers in modern times.

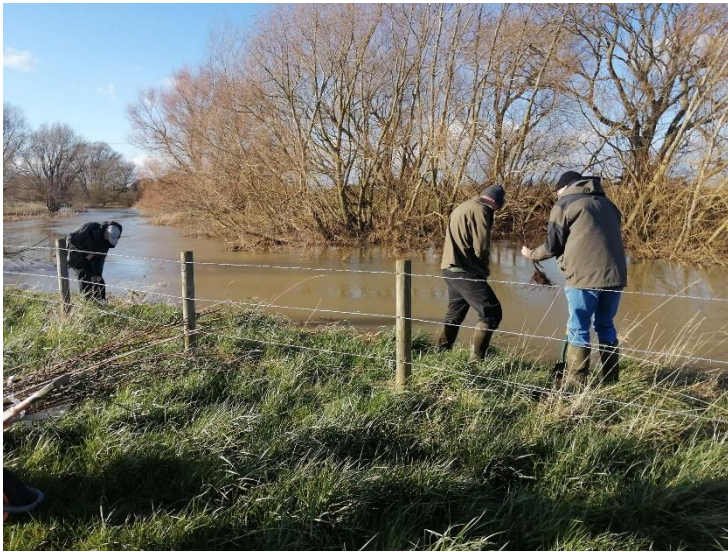
Figure 4 PDAA volunteers planting trees

Originally, there was limited tree stock along much of the right bank, and on the left bank too in the lower part of the reach, so 20 native trees, consisting of Alders, Blackthorn, Dog Rose, Elder, Hazel, Wild Cherry, Rowan and Hawthorns, were planted to, once mature, increase shade. The trees are staked and guarded to protect them from rabbit damage. Although the planting is protected by the riverside existing and new fencing, the trees may be in cribbed if necessary, to ensure that they are fully protected. Trees were planted by PDAA volunteers on the bank crest in pairs leaving sufficient room for machinery to work around them if necessary.

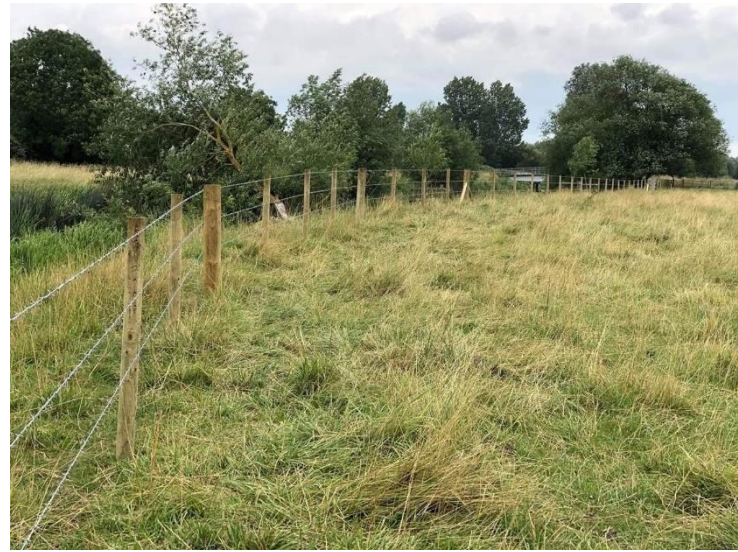
Figure 5 New fence line at Ailsworth backchannel

Much of the right bank had already been fenced as part of an earlier enhancement scheme and where necessary refurbishment took place. Along this section the pre-existing angler access points were upgraded from a “pipe” crossing to a simple treadle post and rail stile, one near each gate. Fencing of the entire right bank was completed by installing c230m of post and 3 lines of barbed wire fencing, with 2 treadles stiles, upstream of the bridge. The open fencing pattern will ensure that flood water flows under the fence, minimising the likelihood that the fence will collect debris that has been washed down river when in flood.
