Water Framework Directive Delivery

River Frome Rehabilitation Plan: Louds Mill 2013

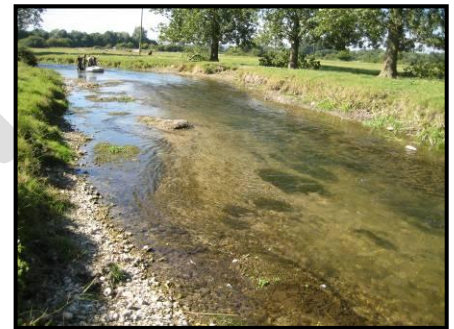
There were no water voles identified on site during surveys. Hemlock Water Dropwort was observed which require removal from site if uncovered through bank reprofiling (they are poisonous to cattle). There were no Himalayan Balsam located in the reach itself but the mill channel adjacent has extensive Himalayan Balsam growing. Poplar trees on the left hand bank would provide most of the woody material required for the project.

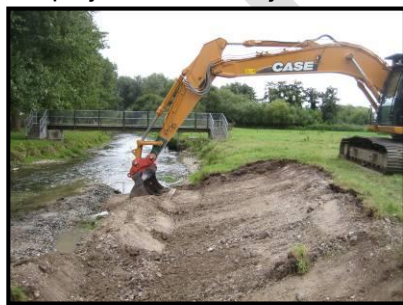
Apart from the project itself the Operations team had to create a temporary crossing point that separated the depot from the field adjacent to the river allowing direct access for their machinery. This required permission

from the Biodiversity team as water voles were known to be present in the Mill Channel banks.
