RIVER NAR RIVER REHABILITATION

March 2011

‘AS BUILT’ SUMMARY OF PROJECT IMPLEMENTATIONS @ West Lexham, Castle Acre & Narborough

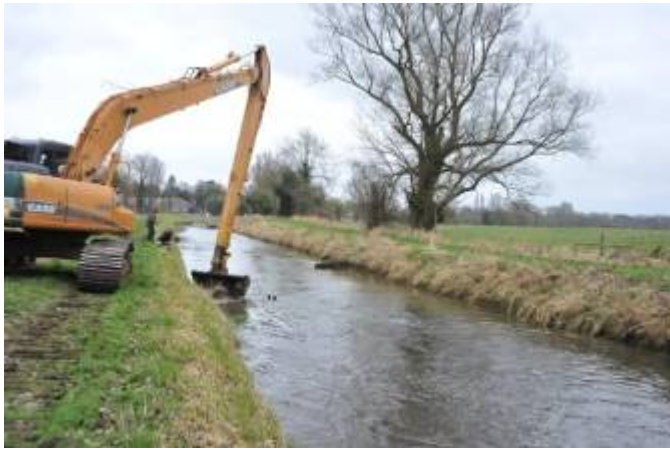
Narborough pool complex 8: Three very indistinct pools and shoulders formed from PURE and very soft peat; upstream shoulders topped by *Phalaris*. Shoulders short due to unsuitable material. Project implementation helped by presence of wooden deflectors that now form the downstream edge of the shoulders and held the very soft peat in place before reed topping added. Expect to stay in place but pools will never be distinct.

Nar Narborough – ‘Pool’ complex 8 – soft peat shoulders; indistinct deepening - not discrete pools
