Long Preston Deeps SSSI Restoration: Phase II Works Description

Final

October 2012

Environment Agency

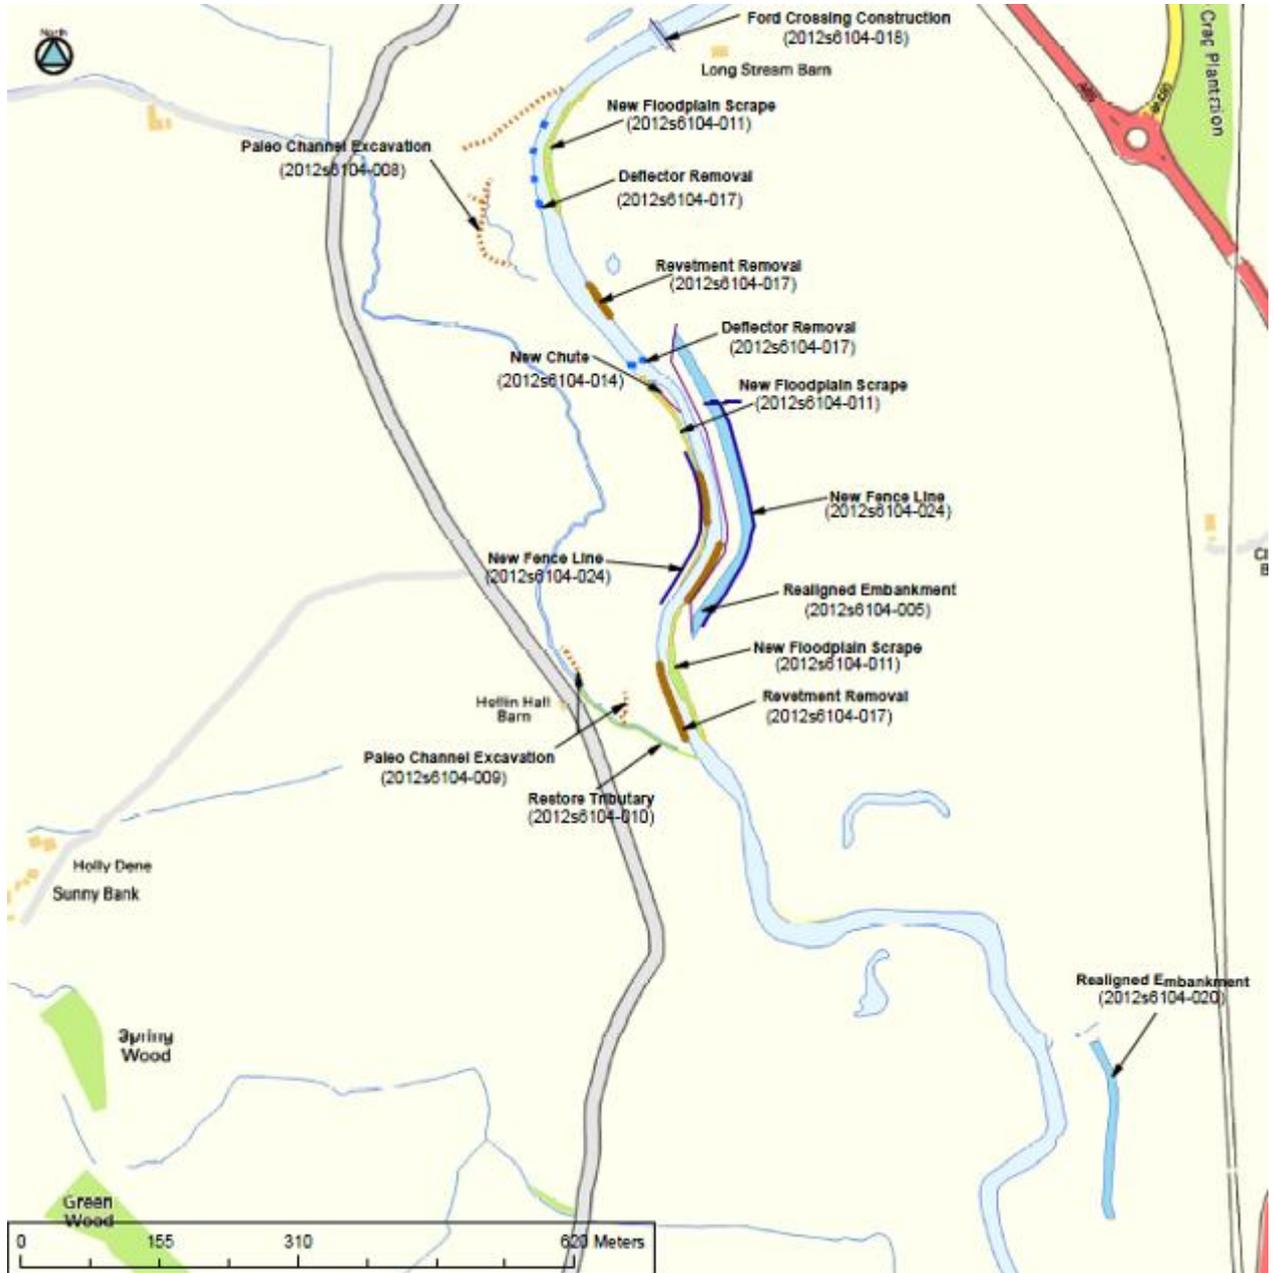
Figure 1. Proposed works under Phase II of the restoration plan for Long Preston Deep.

The restoration measures (Figure 1) planned upstream and downstream of the Phase I works at Long Preston Deeps consist of the following:

- Flood bank realignment: Around 400 m of adjacent flood bank was realigned 30-50 m away from the channel edge.
- Chute channel creation: A wide high level chute was cut across the floodplain surface.
- Inner bend reprofiling: Two lowered sections of floodplain were constructed.
- Fencing and planting: The new flood bank realignment on the left bank was fenced for later planting. Fencing continued through the next field around 30 m from the river isolating this area for later planting.
