Upper River Witham: Little Ponton

Version 2 (01.03.16)

Location:	Little Ponton, Lincolnshire (c3.5km south of Grantham)
Upstream Grid Ref:	Phase 1: SK928308; Phase 2: SK929310
Length:	Phase 1: 220m; Phase 2: c1.4km
Completion Date:	Phase 1: February 2013, Phase 2: September 2014
Cost:	Phase 1: £9K; Phase 2: £14K
Partners:	The scheme was implemented by the Environment Agency with the co-operation and agreement of the adjacent landowners (Stephen Jackson and Stoke Rochford Estate) and Grantham Angling Association Fly Fishing Section (GAAFFS).

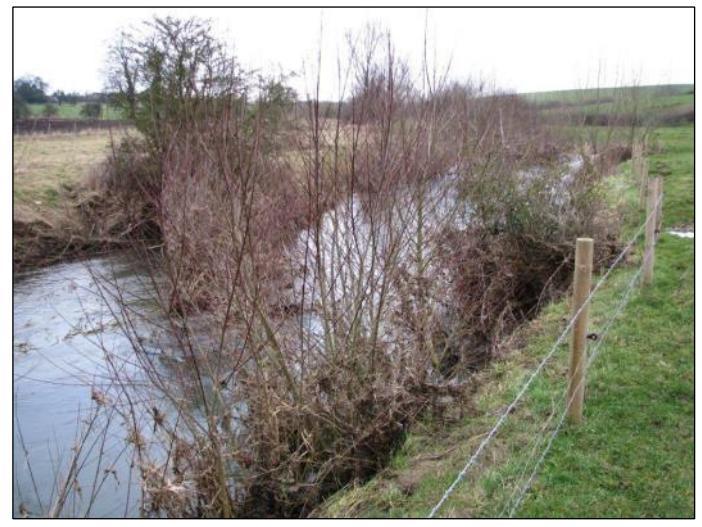
Fig 1. Regeneration of the live willow logs used by GAAFFS to narrow the channel in 2008

In 2008 GAAFFS narrowed a short section at the top of the reach using recently cut willow logs to construct channelnarrowing enclosures. These enclosures created a more sinuous watercourse with increased flow velocity resulting in beneficial bed scour, improved cleansing of the natural gravel bed and a reduction in fine sediment deposition. The enclosures also created valuable stillwater refuge pools on the margins of the channel and encouraged the development of an extended wetland margin by trapping fine sediments. Although these initial works improved the condition of the watercourse the willow logs that used to construct the enclosures rapidly regenerated in to small trees, which, whilst providing beneficial shade, also increased channel roughness and potential flood risk.

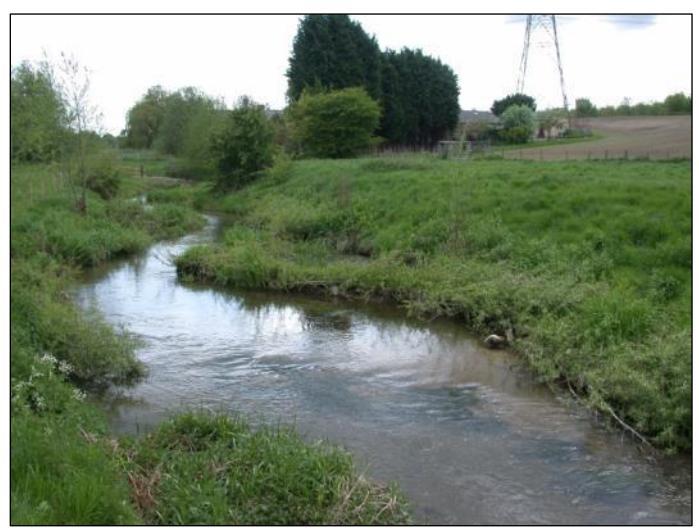
Fig 2. Willow regeneration managed to create "layered enclosures" (Phase 1)

The willow regeneration was addressed during the first phase of the enhancement scheme in 2013 using a layering technique. The regenerating saplings were partially cut at the base, leaving a narrow bark and sapwood hinge, and then bent horizontally along the bank to create "layered enclosures" - a tangle of twigs and branches providing important refuges for juvenile fish and invertebrates. Ash stakes and wire bindings were used to secure the layered trees in position. GAAFFS are now committed to a programme of regular maintenance to control future willow regeneration.

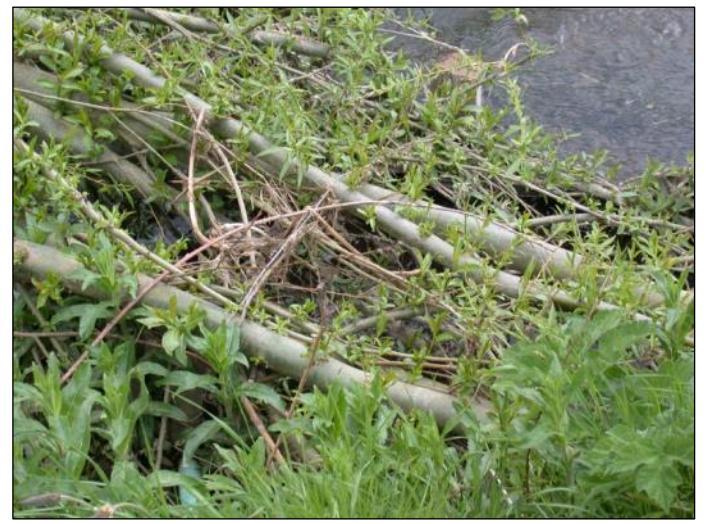
Fig 3. Willow layering detail (Phase 1)

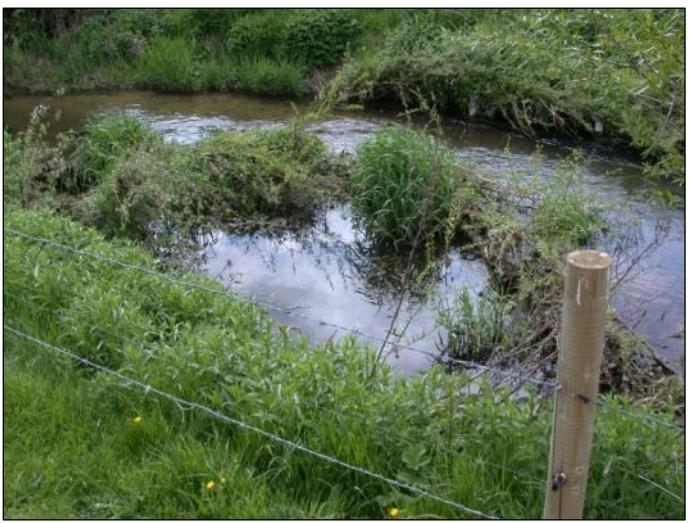
Fig 4. Layered enclosure and refuge pool (Phase 1)

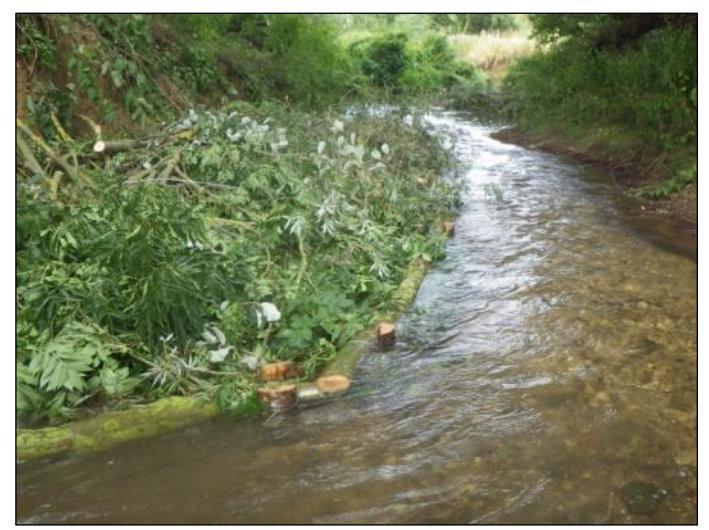
Fig 5. Log-faced brushwood mattress (Phase 2)

Log/faggot-faced mattresses: as above, but fully enclosed with either secured logs (generated from the riverside tree management) or faggots;

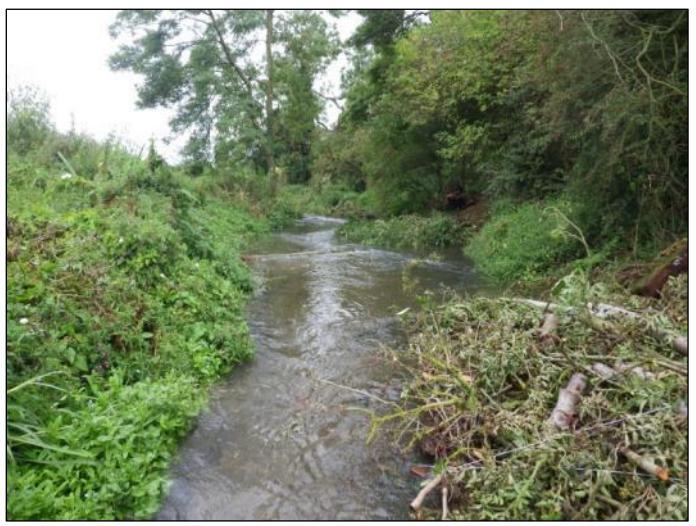
Fig 6. Open brushwood mattress (Phase 2)

Open (unenclosed) brushwood mattresses: small branches firmly secured with posts and wire bindings to create a mattress;

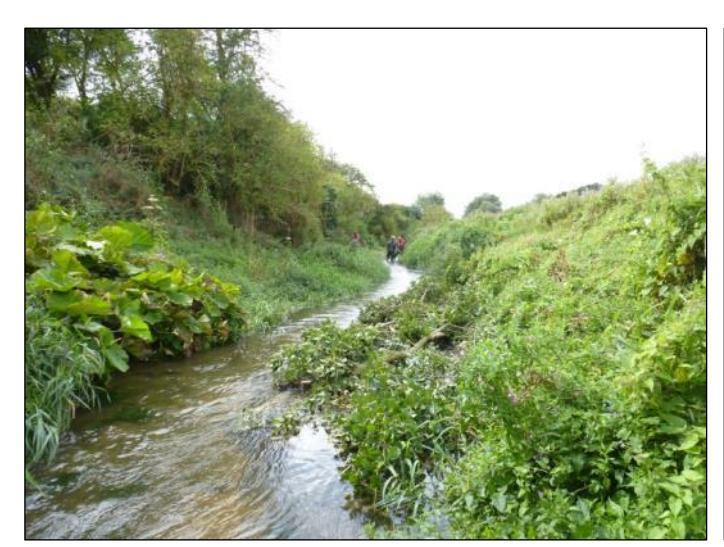
Fig 7. Recently hinged and secured ash tree (Phase 2)

In addition to the construction of structures to narrow the channel and trap silt, selected riverside trees and shrubs were hinged and securely pinned into the bed of the channel using ash stakes and wire bindings to create live flow deflectors/brushwood mattress. The technique used is similar to the "layering" described above, but the size of the trees and shrubs managed in Phase 2 was much larger.

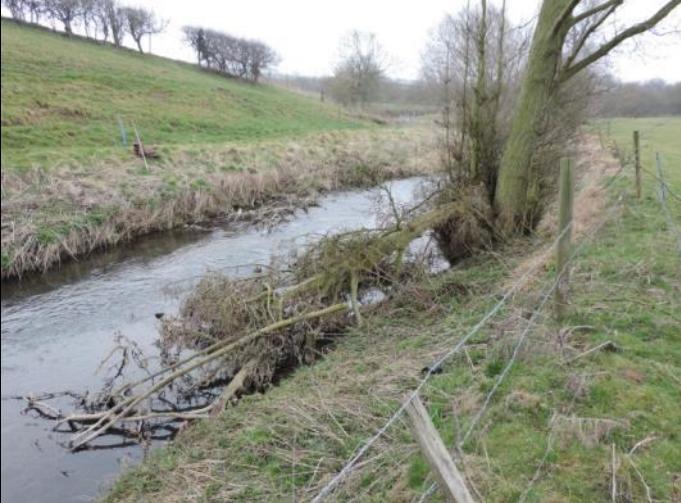
Fig 8. Hinged and secured alder following winter high flows (Phase 2)

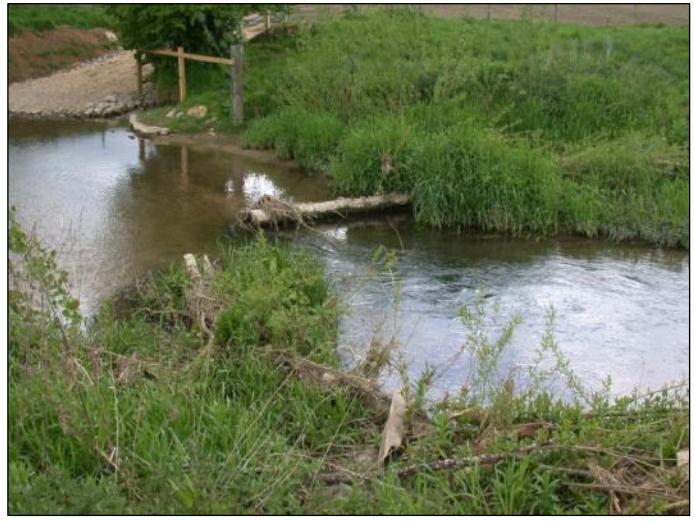
Fig 9. The paired flow deflectors below the ford installed by GAAFFS in 2008

Following GAAFFS successful use of a pair of log flow deflectors to enhance the pool below the ford in 2008, a number of log flow deflectors and vanes were installed during Phase 2 of the enhancement works, the logs being derived locally from the management of riverside trees. Flow deflectors are partially exposed above the water level and slope downwards towards the centre of the channel at a very shallow angle. Vanes, however, are permanently submerged so water flows over them at all times. Deflectors and vanes create localised flow variation, help to trap and retain gravels; improve flows over/through gravel beds to keep the free from fine sediment; and improve the bed structure through scouring. Both types of structure, either in pairs or singles, normally point upstream to direct the flow towards the centre of the channel and minimise the potential for bank erosion. In addition to vanes and

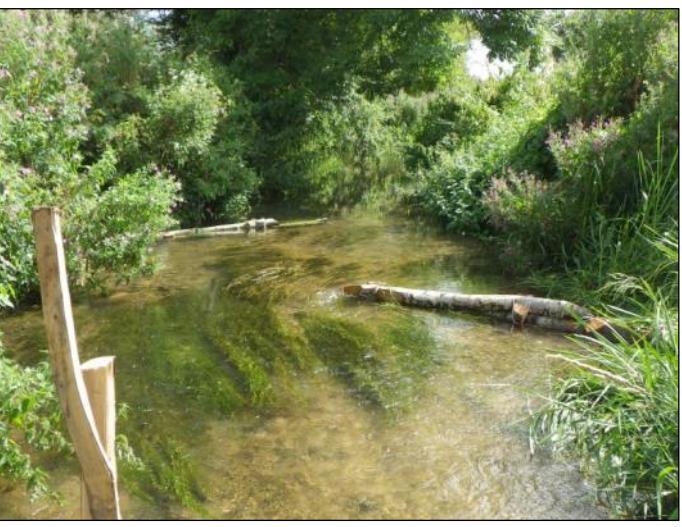
Fig 10. Off-set flow deflectors under construction (Phase 2)

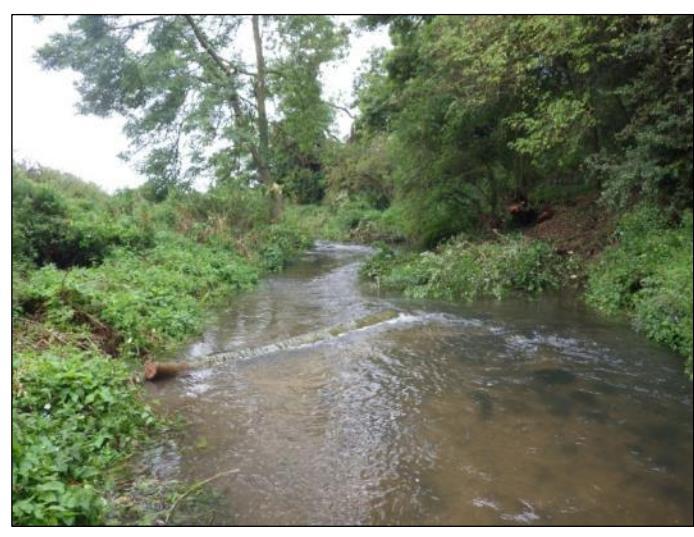
Fig 11. Single flow deflector in conjunction with brushwood mattresses demonstrating how the flow is modified (Phase 2)

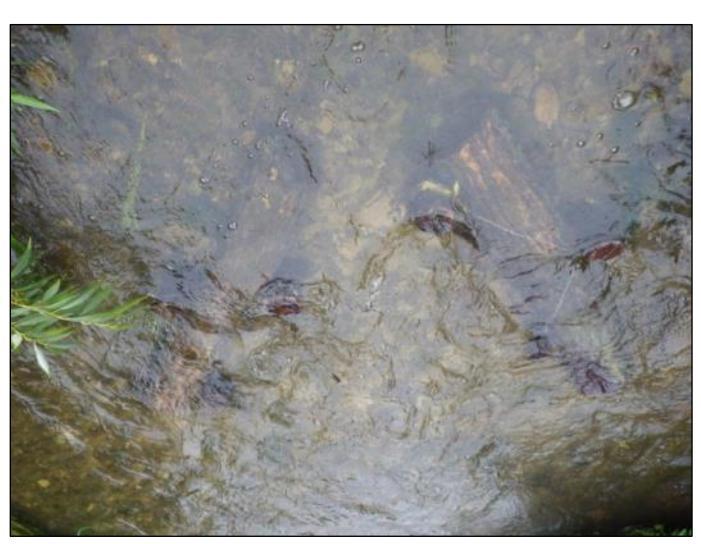
Fig 12. Paired micro-vanes (Phase 2)

deflectors keyed into the bank, paired "micro-vanes" were also installed mid-channel to create more complex flow variation and bed scour.

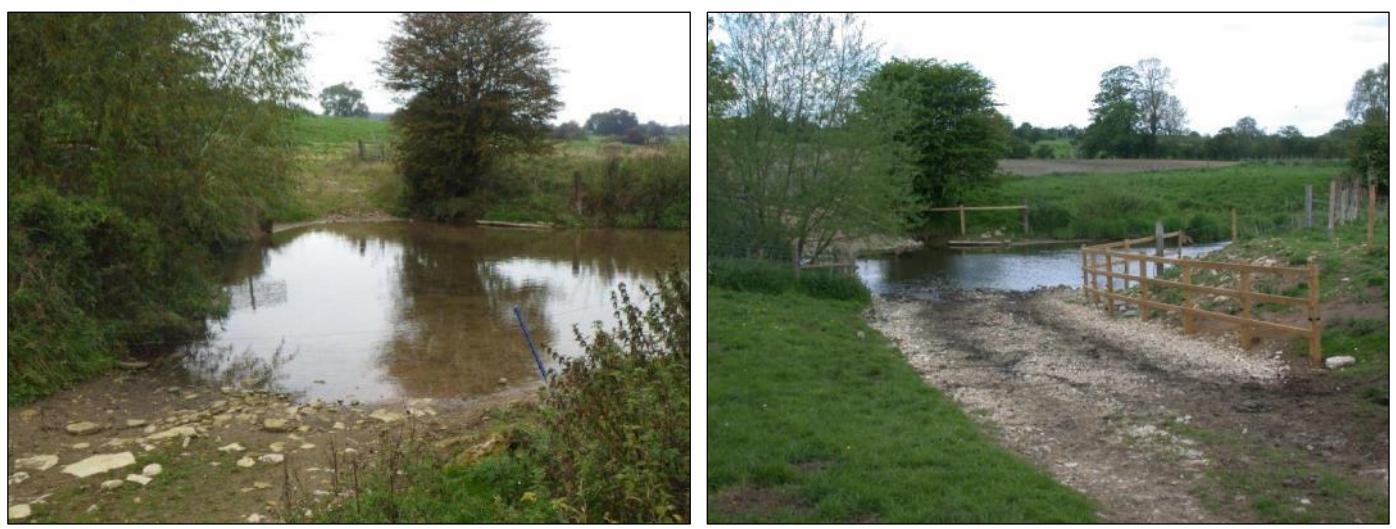
Fig 13. The ford (a) before and (b) after restoration (Phase 1)

Below the mill the river is crossed by a ford which also doubles as a cattle drinker. Prior to refurbishment the ford was in poor condition with bare, severely poached and eroded earth access ramps and nothing to prevent cattle access upstream and downstream. Refurbishment involved reprofiling the access ramps and consolidating the base with crushed limestone to create a porous hard-standing. Post and rail fencing was erected to protect the steep, reprofiled slopes and electrified "scare-wires" now cross the river to discouraged cattle from straying up and downstream.

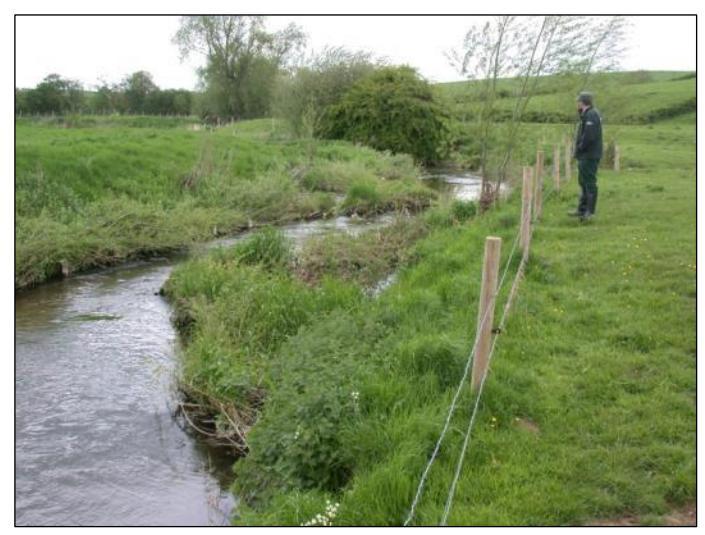
Fig 14. Riverside fencing protecting the marginal wetland vegetation and layered enclosures (Phase 1)

To prevent cattle from entering the river, maintain the integrity of the layered enclosures and allow the development of marginal wetland vegetation the right bank in the vicinity of the ford was fenced with post and 3 lines of barbed wire during Phase 1. New riverside fencing was not required further downstream.

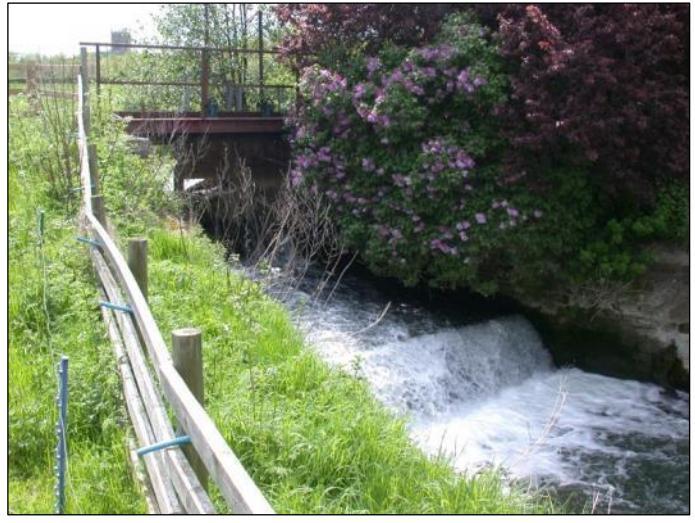
Fig 15. The sluice on the Great Ponton Mill bypass channel

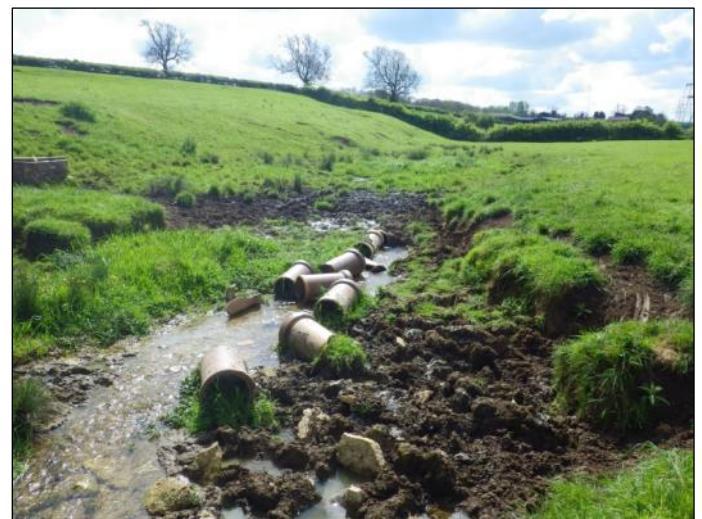
Fig 16. The poached flush

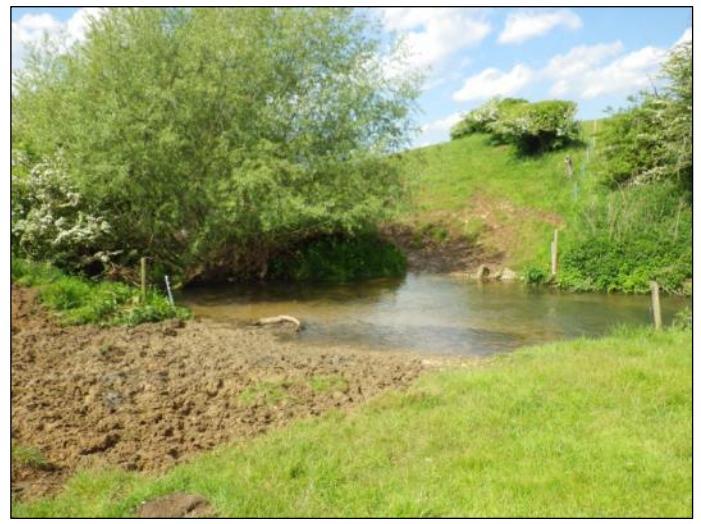
Fig 17. Heavily poached ford/drinker
