Upper River Witham: Little Ponton

Version 2 (01.03.16)

Location:	Little Ponton, Lincolnshire (c3.5km south of Grantham)
Upstream Grid Ref:	Phase 1: SK928308; Phase 2: SK929310
Length:	Phase 1: 220m; Phase 2: c1.4km
Completion Date:	Phase 1: February 2013, Phase 2: September 2014
Cost:	Phase 1: £9K; Phase 2: £14K
Partners:	The scheme was implemented by the Environment Agency with the co-operation and agreement of the adjacent landowners (Stephen Jackson and Stoke Rochford Estate) and Grantham Angling Association Fly Fishing Section (GAAFFS).

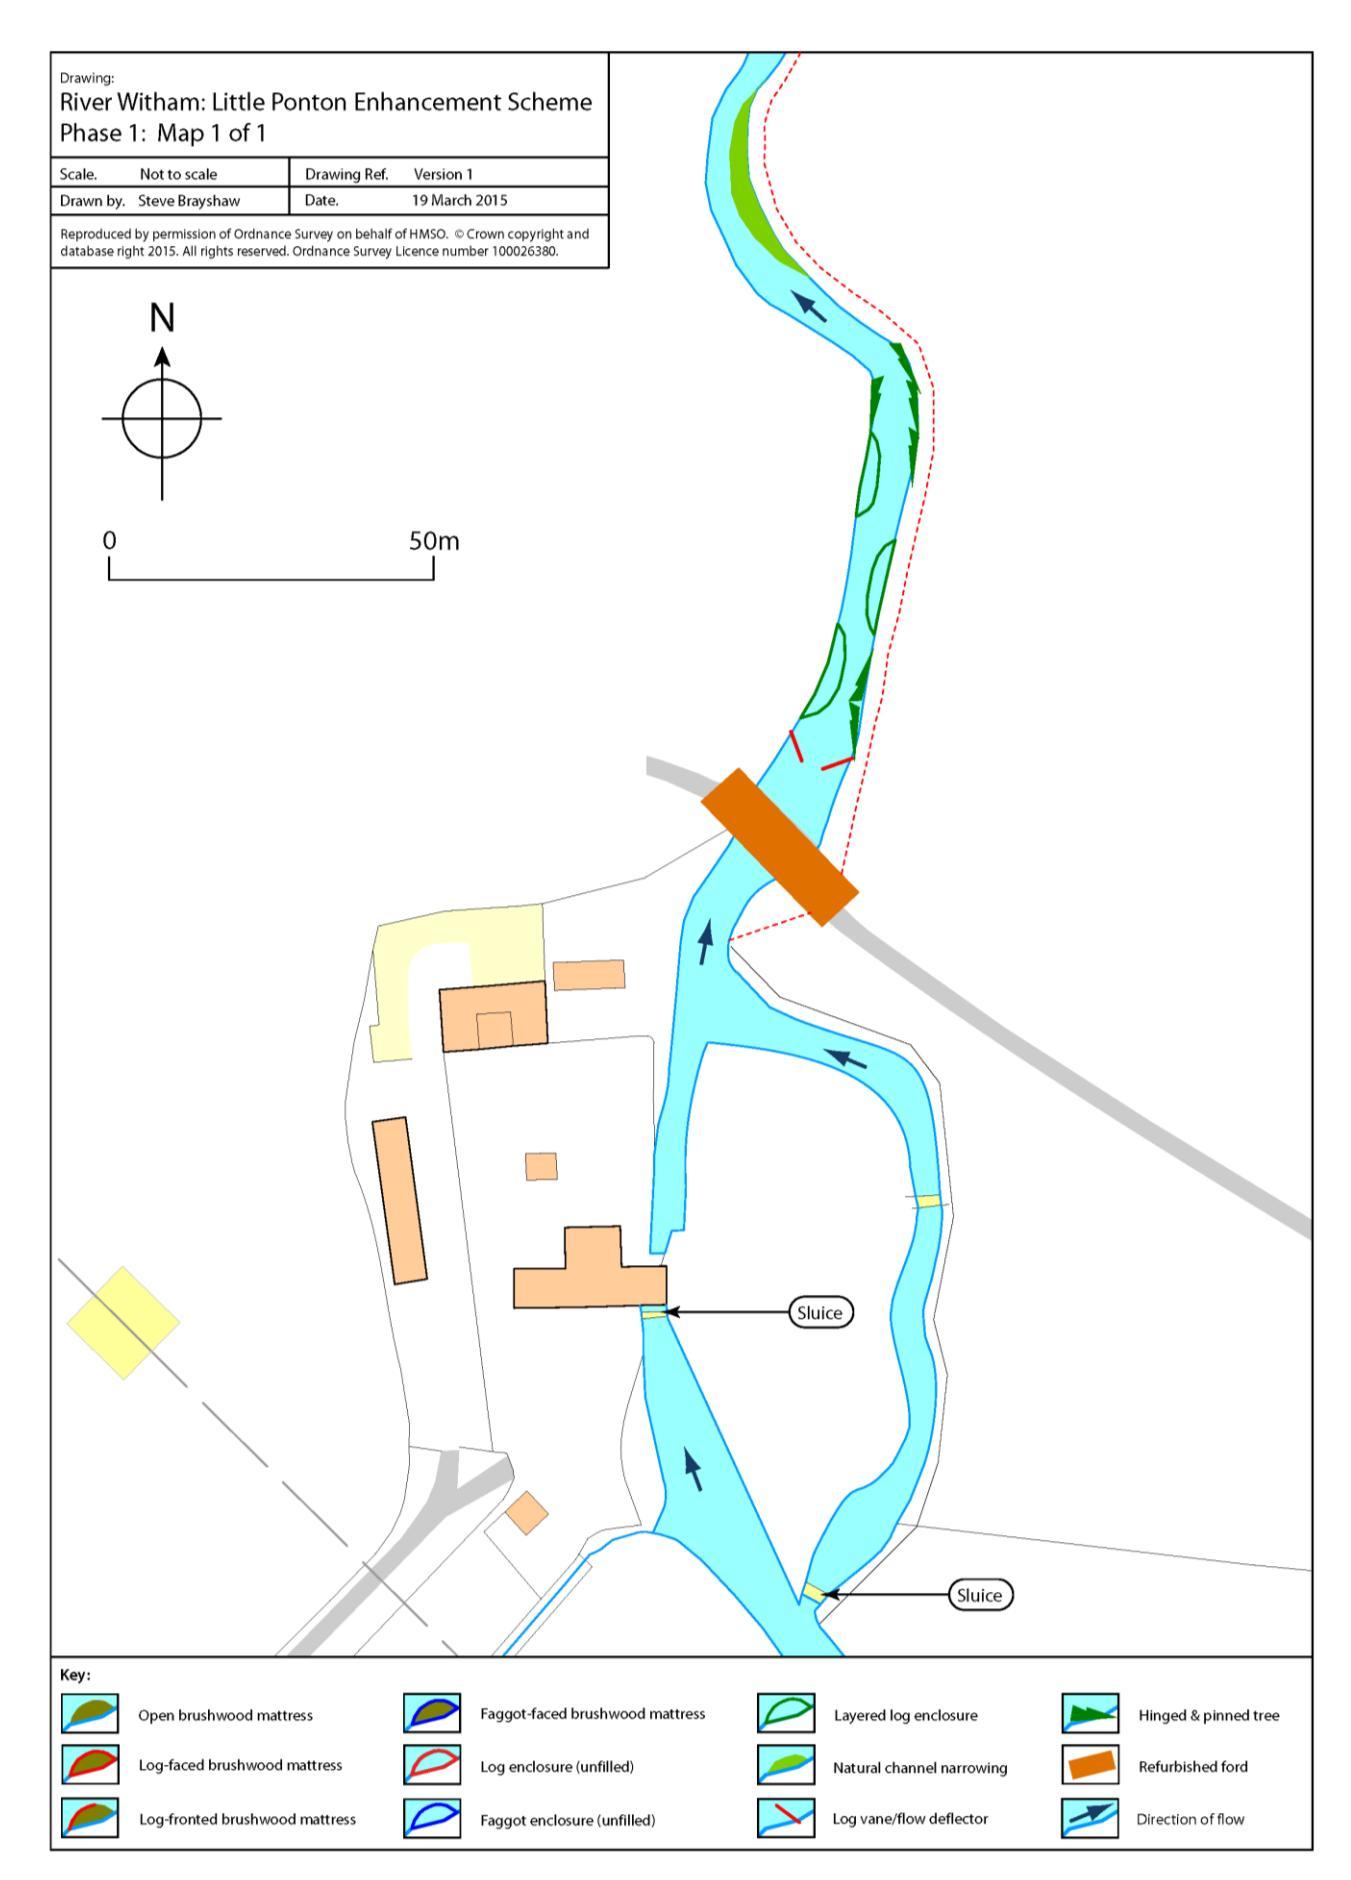
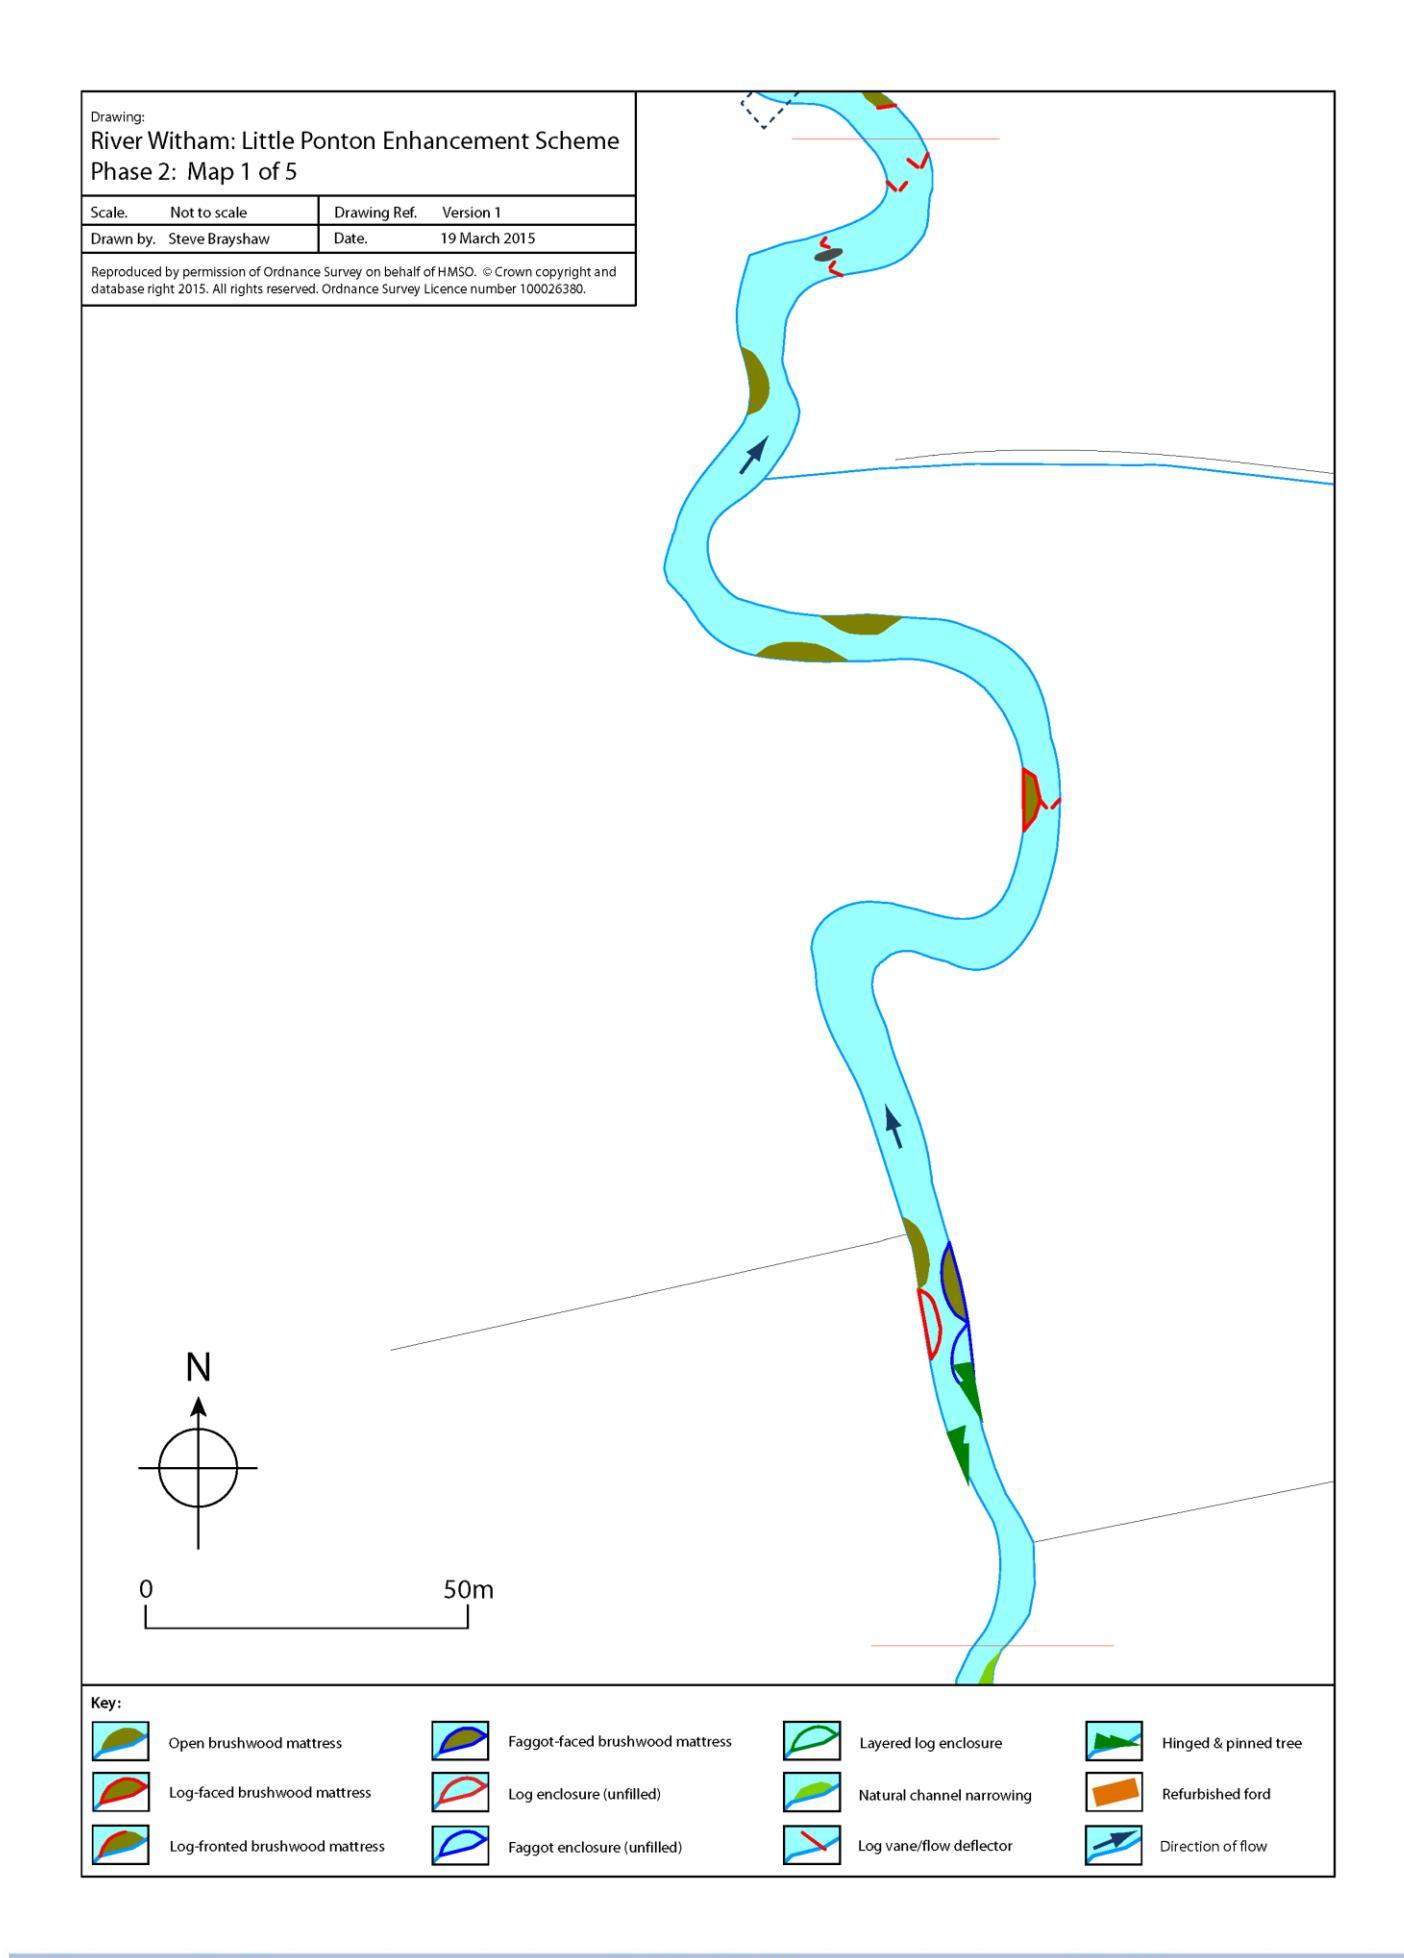
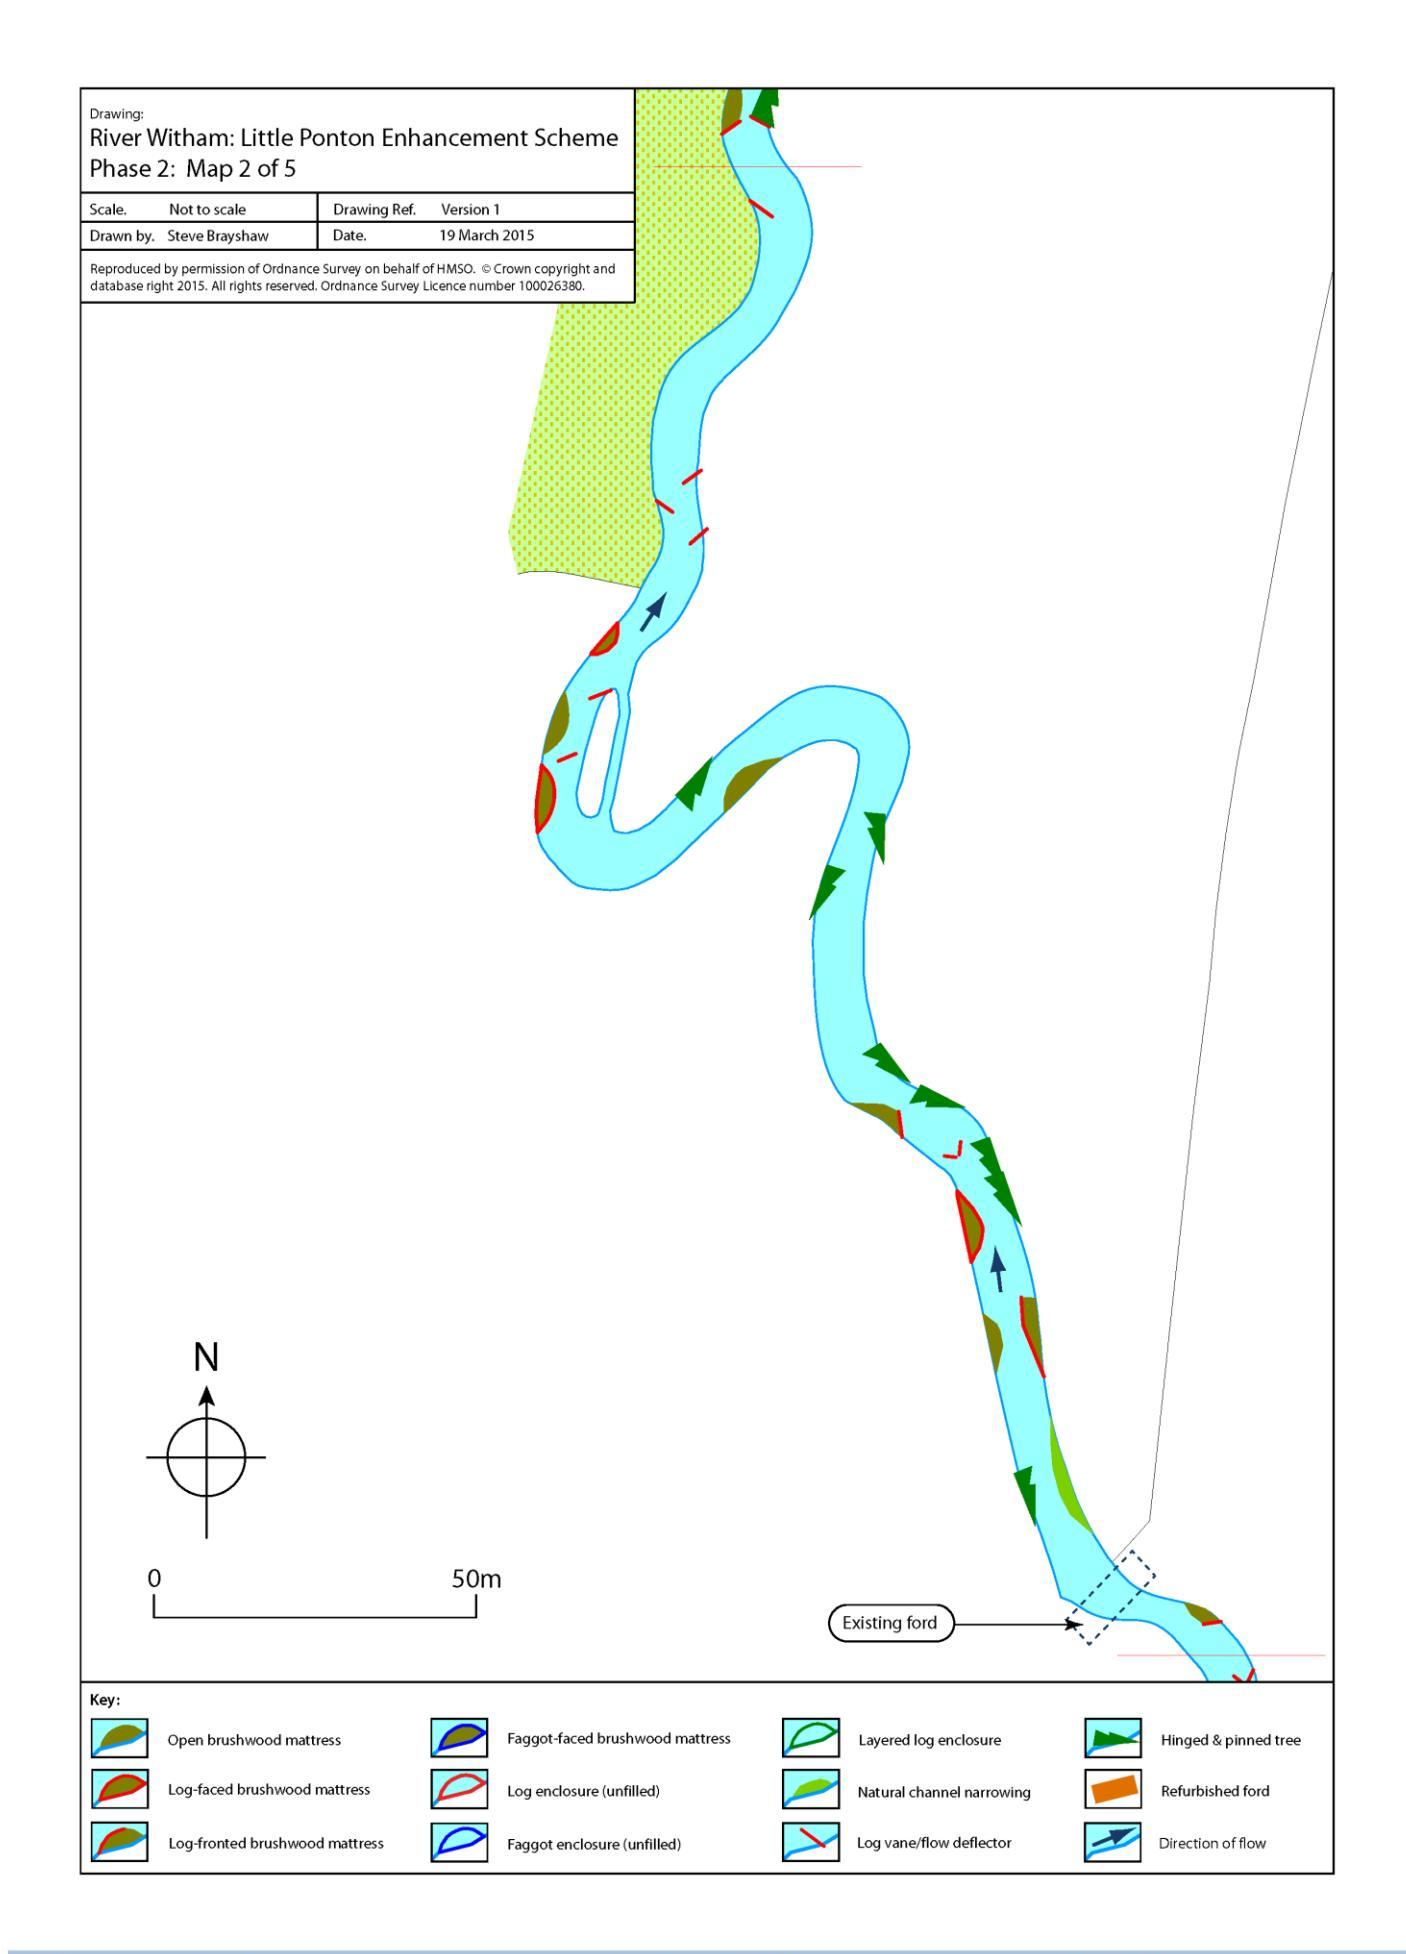
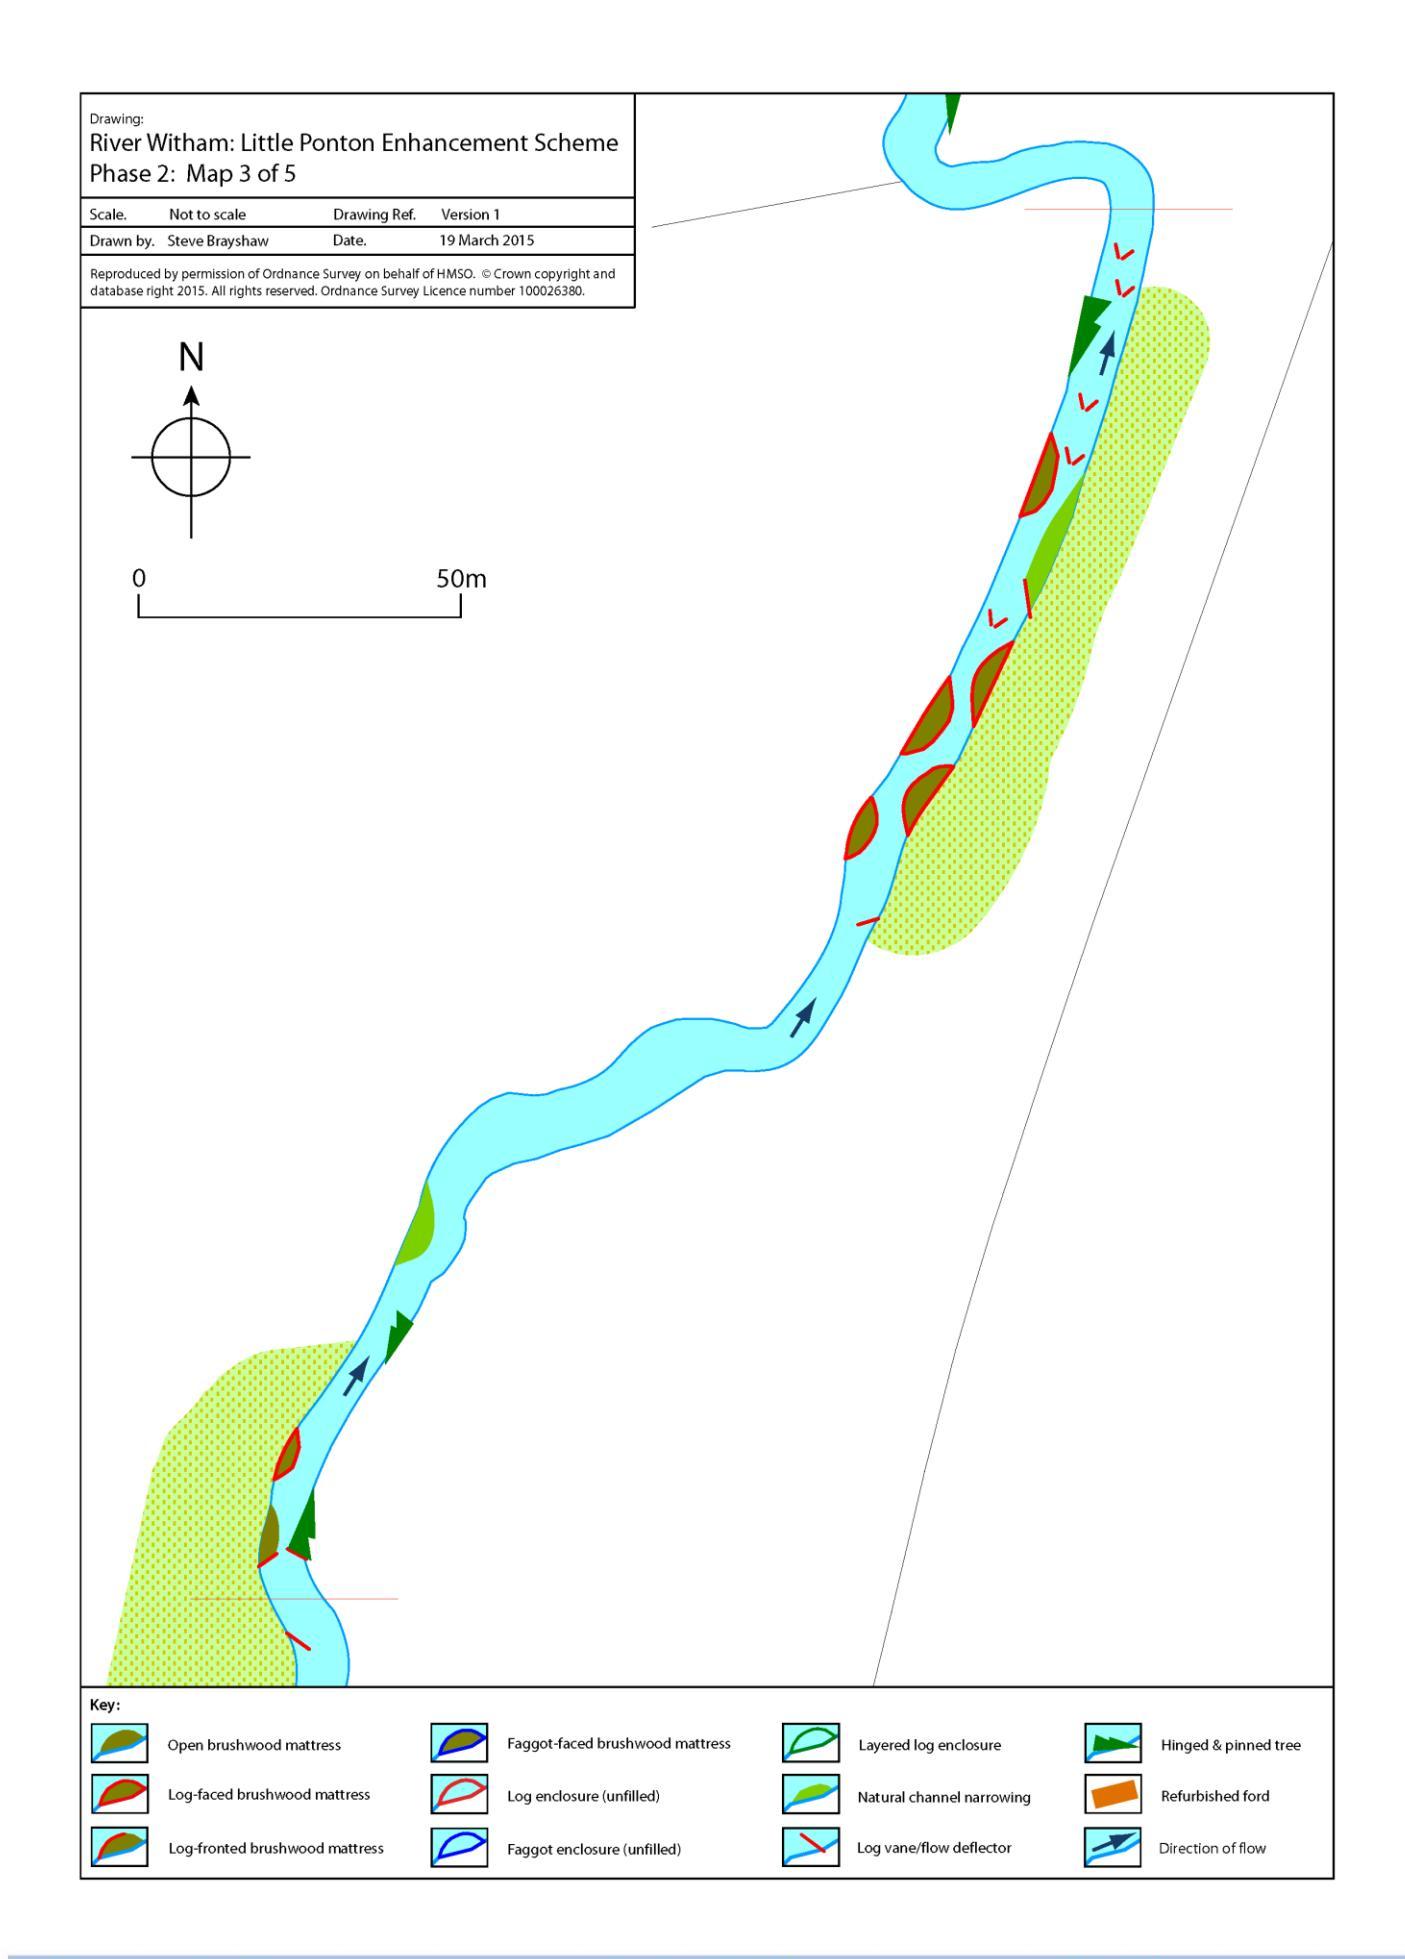
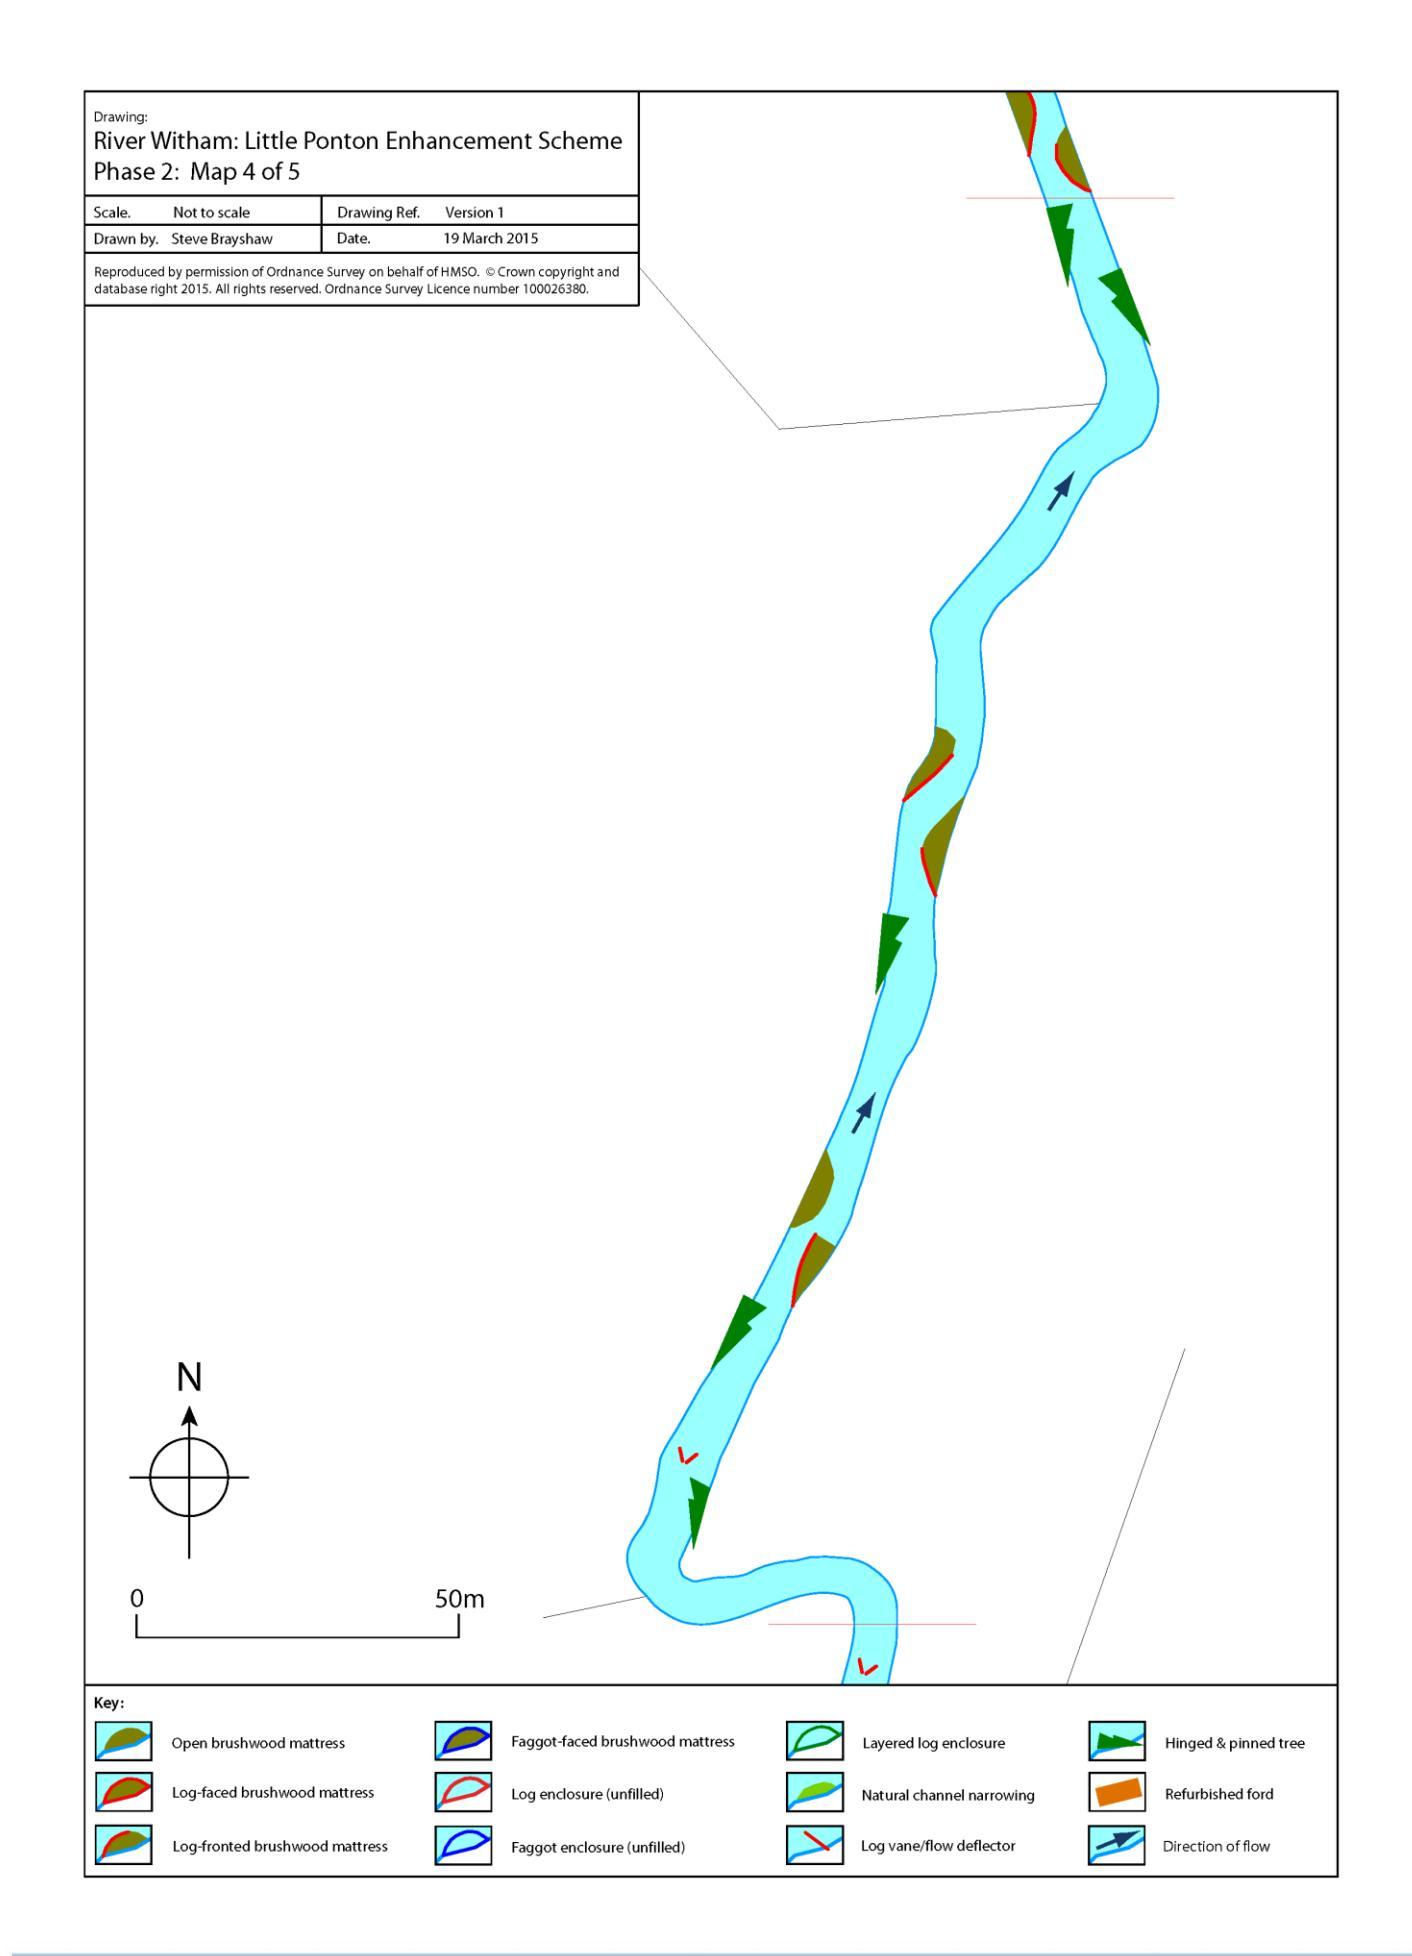
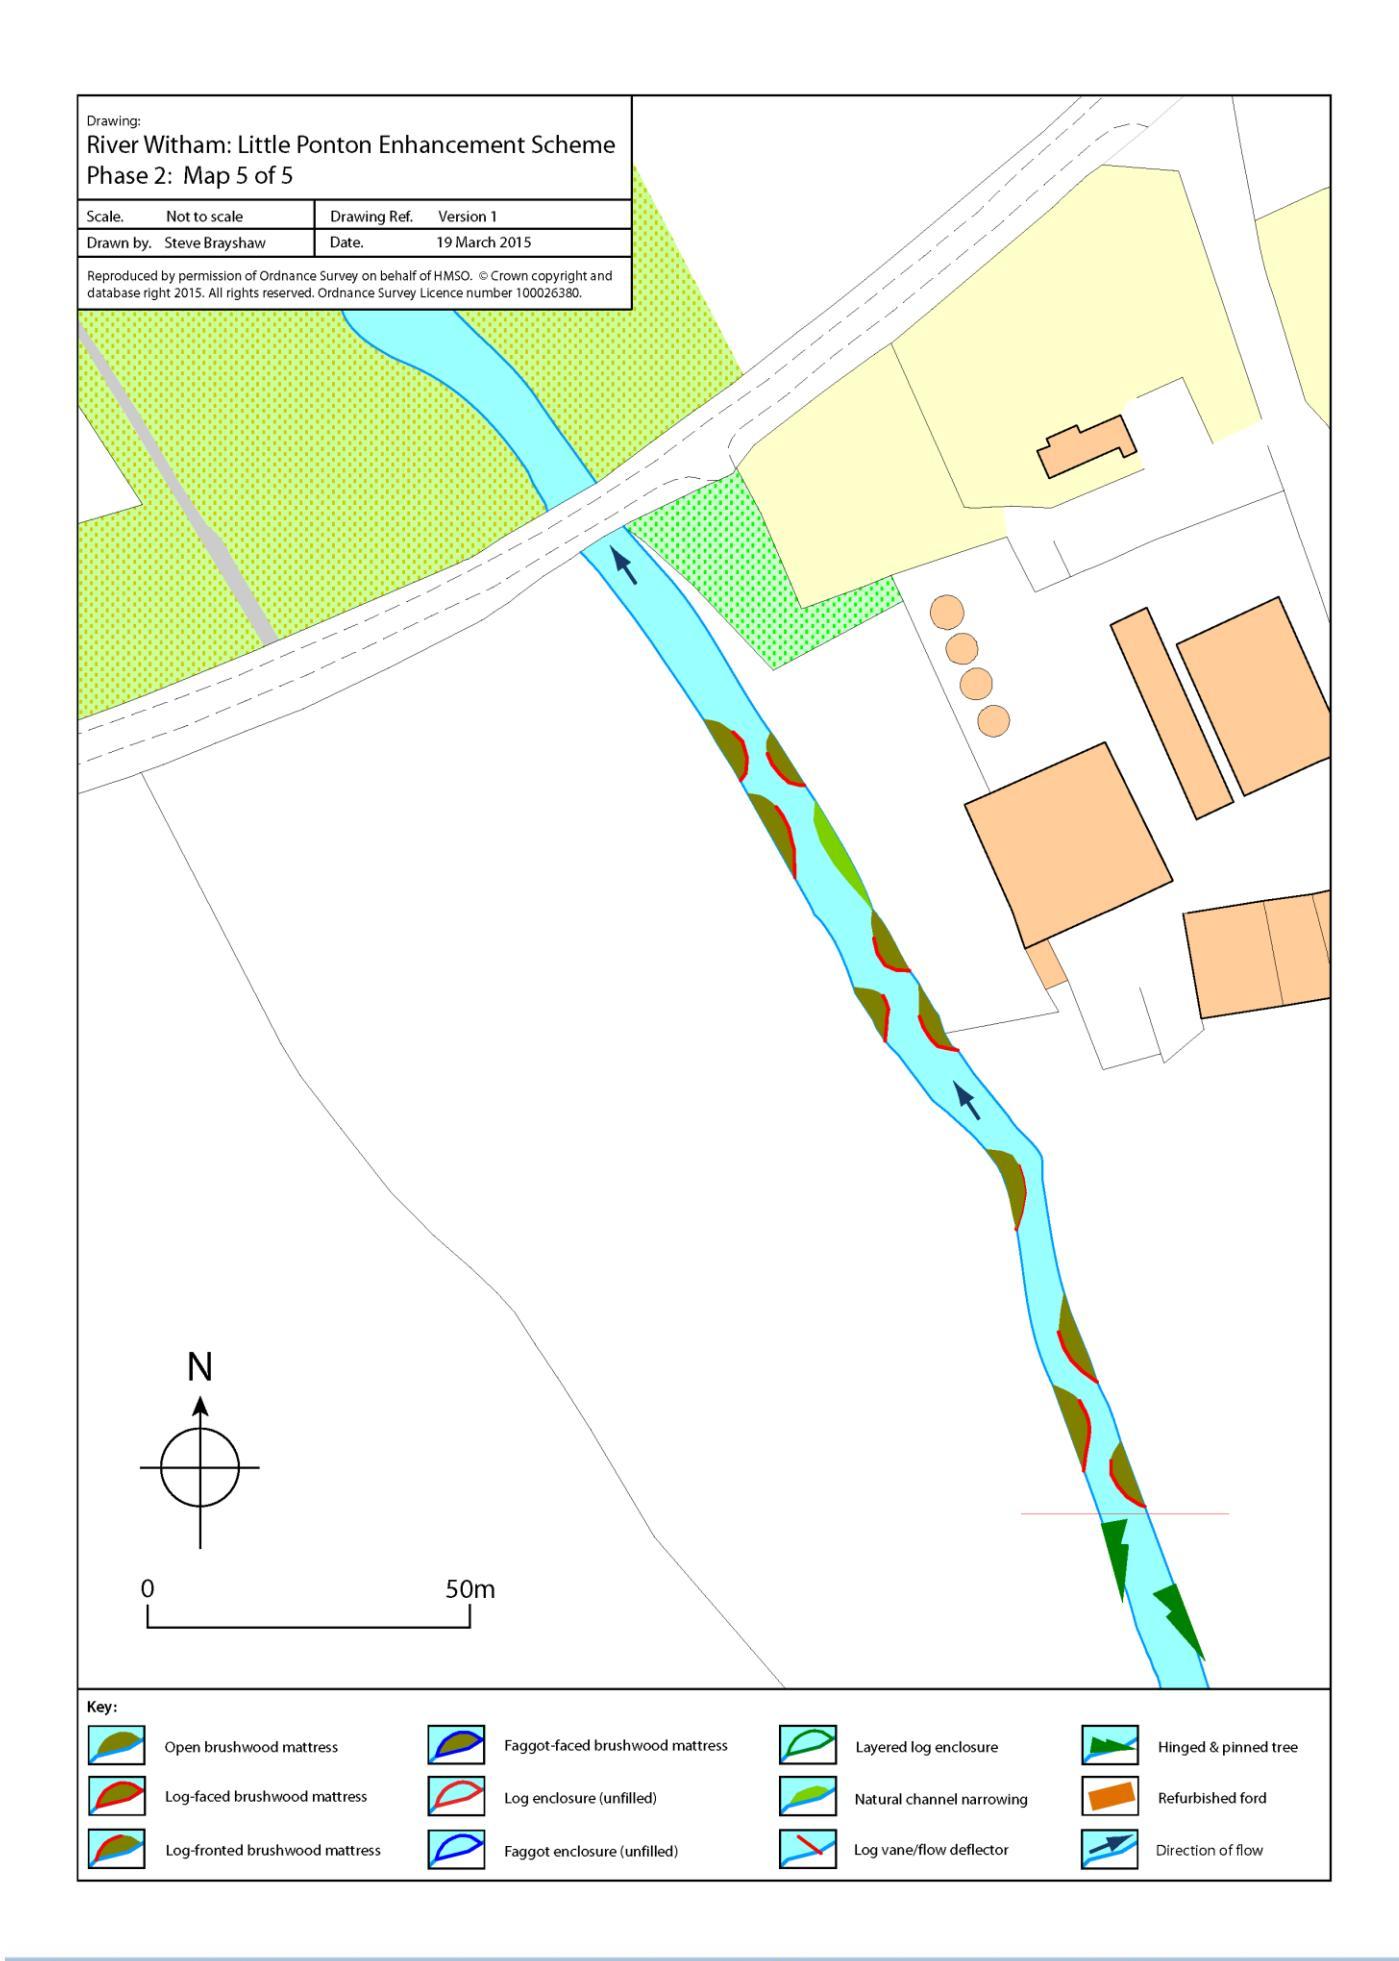
ANNEX 1: The Completed Enhancement Scheme (mapping commences at the upstream extent)

The drawings in Annex 1 show all the elements of both phases of enhancement and the techniques used are described below. Several of the techniques used have multi-functional benefits.
