RIVER NAR RIVER REHABILITATION

March 2011

‘AS BUILT’ SUMMARY OF PROJECT IMPLEMENTATIONS @ West Lexham, Castle Acre & Narborough

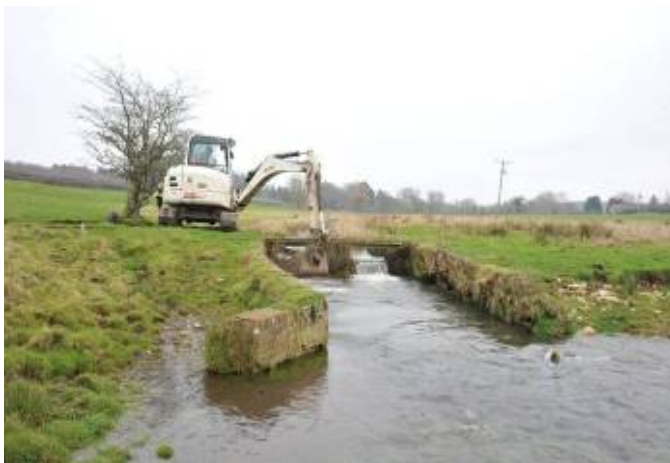
Nar West Lexham – removal of sluice impounding concrete ‘boards’ – (Photo ref: WL1)

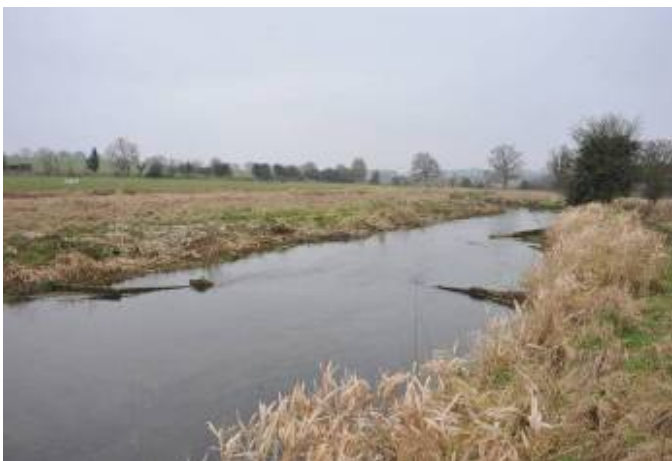
Nar Castle Acre – narrowing and pool formation (Photo ref: CA4)

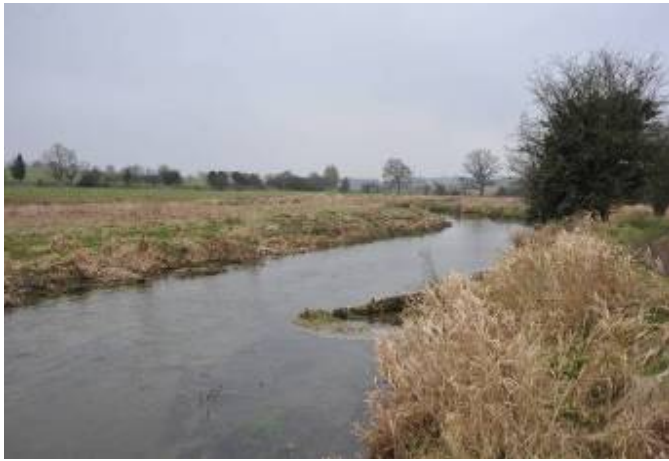
Nar Castle Acre – narrowing and pool formation (Photo ref: CA5)

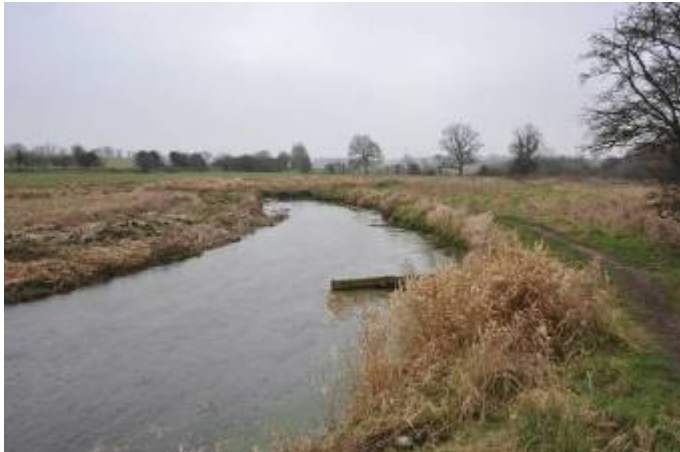
Nar Castle Acre – narrowing (Photo ref: CA6)

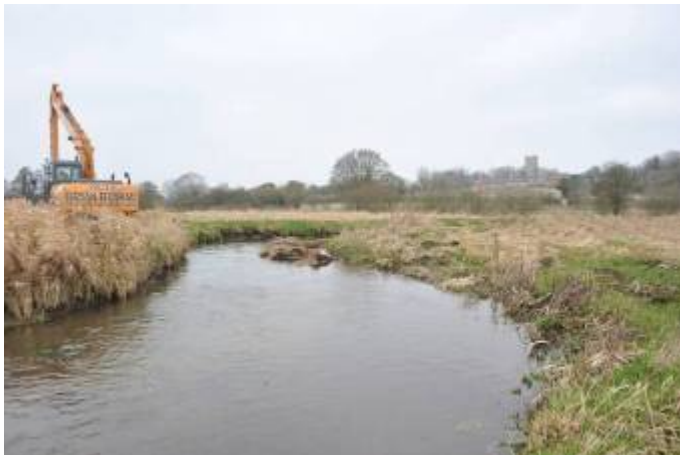
Nar Castle Acre – narrowing (Photo ref: CA7)

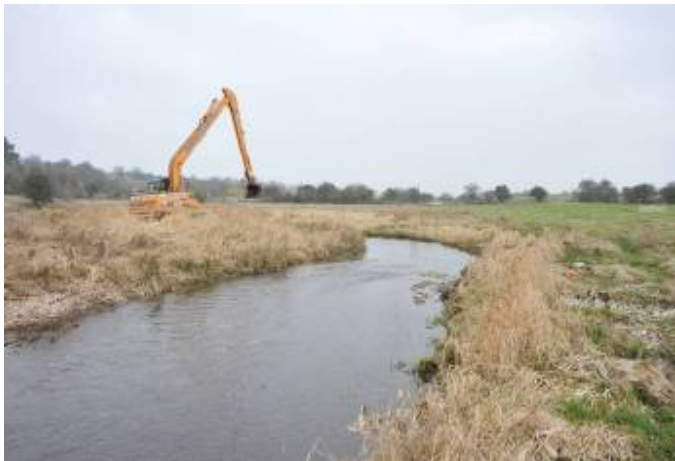
Nar Castle Acre – narrowing and shallow run/riffle formation (Photo ref: CA9)

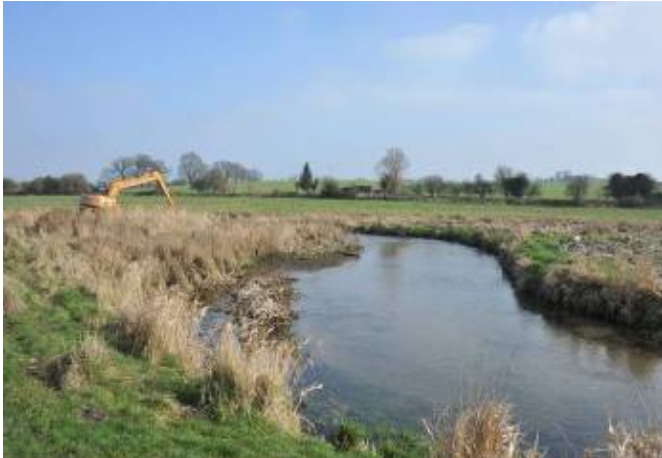
Nar Castle Acre – narrowing (Photo ref: CA10)

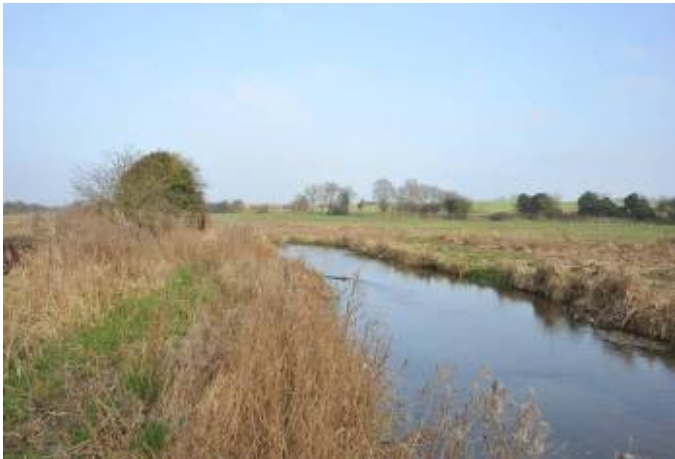
Nar Castle Acre – narrowing (Photo ref: CA11)

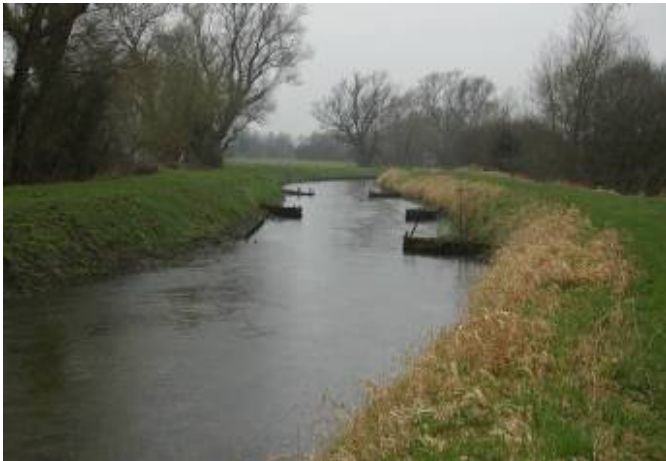
Narborough pool 1: Very distinct pool formed; upstream shoulders formed from firm chalky clay and topped by *Phalaris*. Centre seeded with gravel. Ideal form and perfect state that should be stable and enhance over time.

Nar Narborough - Pool 1 looking d/s

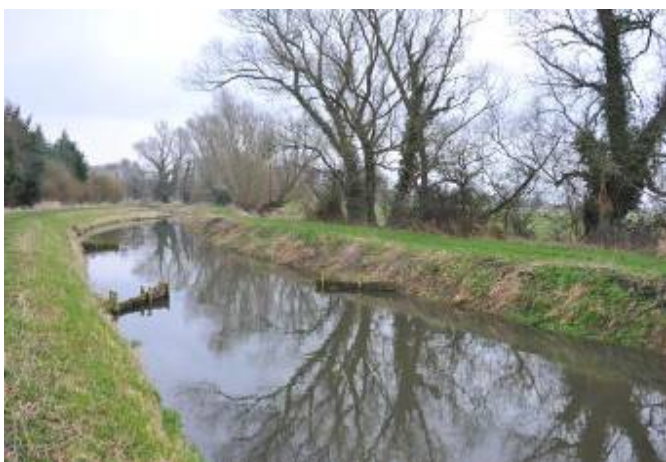
Narborough pool 2: Very distinct pool formed; upstream shoulders formed from firm chalky clay and topped by *Phalaris*. Centre seeded with gravel. Near-ideal form that should be stable and enhance over time – less dramatic contrast between upstream run and pool than pool 1.

Nar Narborough - Pool 2 looking u/s

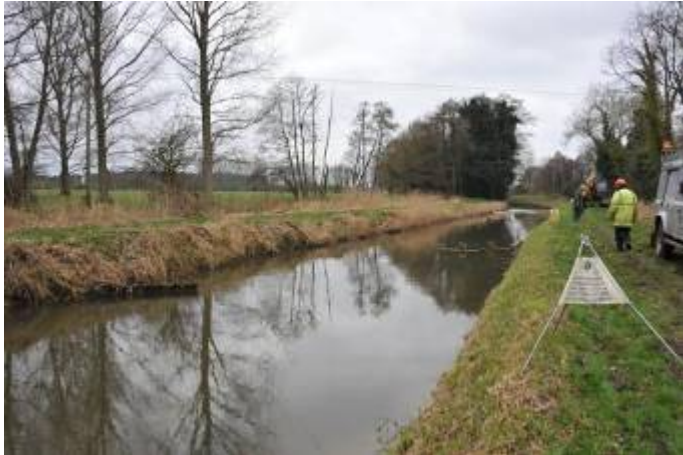
Narborough pools 9 & 10: Two very indistinct pools and shoulders formed from PURE and very soft peat; upstream shoulders topped by *Phalaris*. As Complex 8, shoulders short due to unsuitable material. Project implementation helped by presence of wooden deflectors that now form the downstream edge of the shoulders and held the very soft peat in place before reed topping added. Expect to shoulders to stay in place but pools will never be distinct.

Nar Narborough – ‘Pools’ 9 & 10 plus shoulder formed over old deflector – soft peat shoulders with reeds; indistinct deepening – non-existent pools (looking d/s with pool 11 in background)

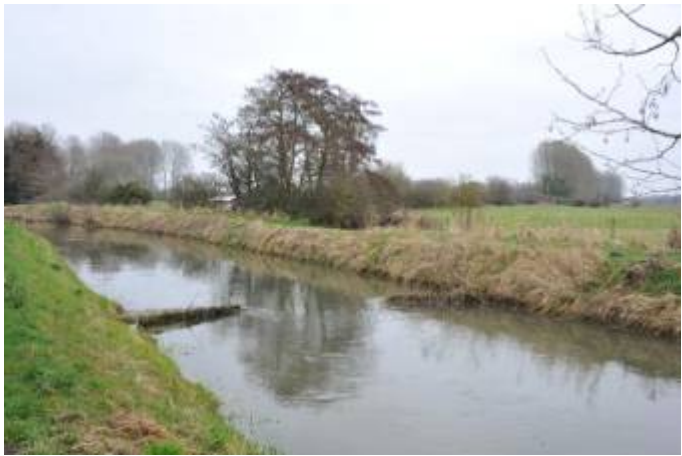
Narborough pools 13 & 14: Two very indistinct pools and shoulders formed from PURE and very soft peat; upstream shoulders topped by *Phalaris* (limited amounts available here so relatively shallow and small). Shoulders short also due to unsuitable material. Project implementation helped by presence of wooden deflectors that now form the downstream edges of the shoulders and held the very soft peat in place before reed topping added. Expect to stay in place but pools will never be distinct.

Nar Narborough – Non-existent ‘Pool’ 13 plus shoulder formed over old deflectors – very soft peat shoulders with limited reeds – looking u/s

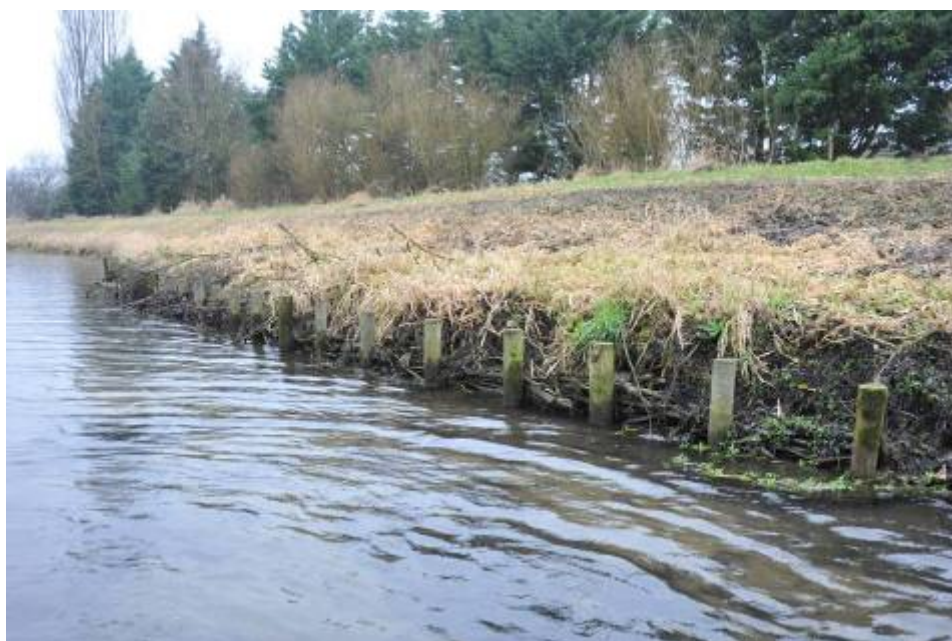
At the start of the reach there is a recently constructed vegetated ‘berm’ held in place by posts and faggots. The posts and faggots are constraining the natural encroachment of the reed, and hence stopping them trapping the silt that is deposited at the river margin. It is proposed the posts are carefully pushed into the channel, leaving the faggots in place. Reeds from the top of the berm can be deposited in front of the faggots to a depth of c20-30cm. The faggots will form a space enabling any voles, if present, to exit any burrows. This is thus an exception to rule 4 only, as strictly the berm is not part of bank and there will be a gap between existing bank and infill material.
